# Safety Investigation Report

Ref. AAIU-2020-01-31-01  
Issue date: 31 January 2022  
Status: Final

Occurrence class	Incident
Occurrence category	System/component failure or malfunction [non-powerplant] (SCF-NP)
Date and time <sup>1</sup>	31 January 2020 11:30 UTC
Location	51,235624°N - 004,437490°E
Aircraft	Partenavia P68B
Aircraft category	Fixed wing - Small aeroplane (MTOW ≤ 5700 kg)
Location of departure	Aerodrome of Antwerp/Deurne (EBAW)
Planned destination	Aerodrome of Antwerp/Deurne (EBAW)
Type of operation	Non-commercial - Cross-country
Phase of flight	Initial climb
Injuries	None
Aircraft damage	Minor

During a local flight after maintenance, when the aircraft was climbing at 1000 ft, the emergency door fell out. The door landed at short distance of a car.

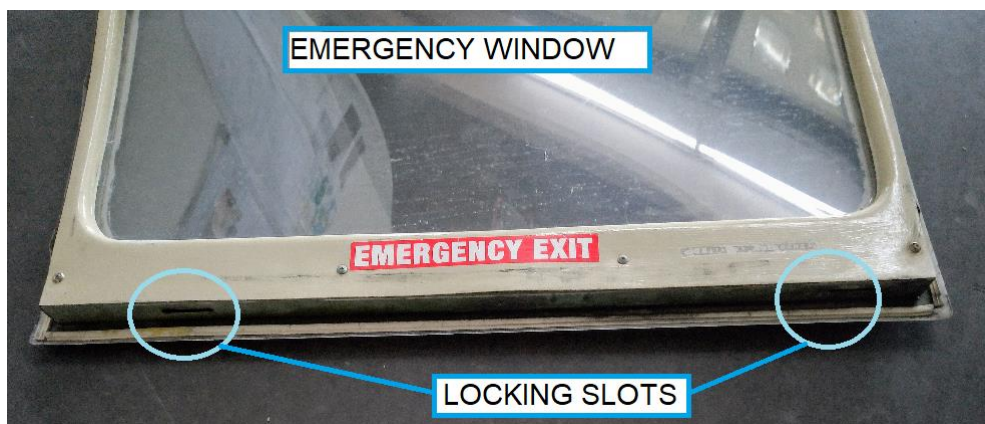
Figure 3: Emergency window

The window is held in position by two metal strips sliding into locking slots solidarizing the bottom part of the window with the aircraft structure. The top part of the window is inserted in a U-shaped angle profile.

The system was tested and found in working condition.

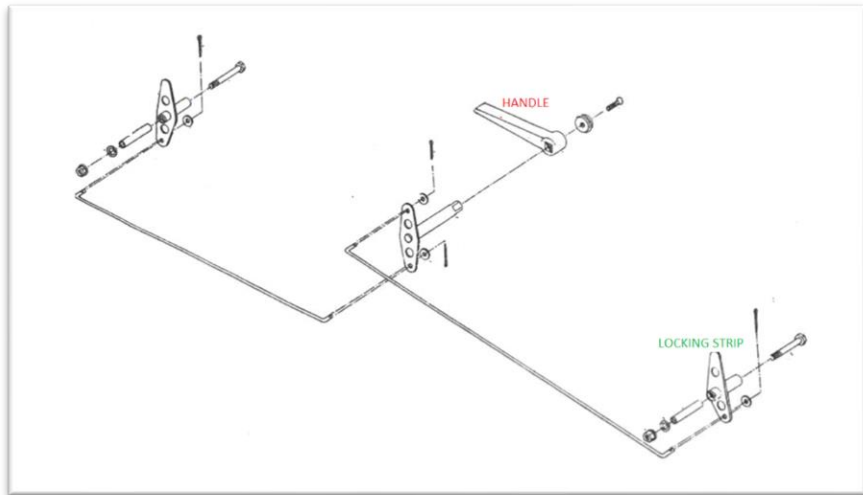
Figure 4:Emergency window operating mechanism

A picture taken after the event shows the locking metal strip stowed (window release position)

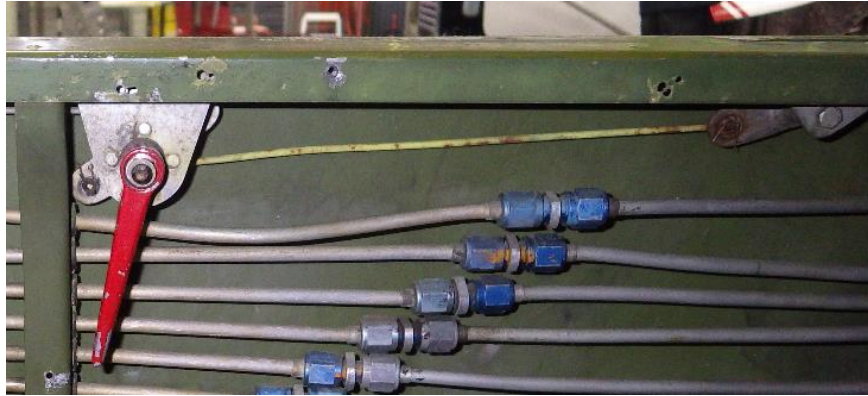
Figure 7: Handle in the 'release' position

The release of the window in flight was obviously caused by the operating handle being inadvertently left in the 'release' position after maintenance. The inadequate position was not identified during the mandatory inspections mandated by the POH and Maintenance Manual.

- The release of the emergency window was most probably due to the operating handle unintentionally left in the “window release” position after maintenance and this condition was not detected during pre-flight check.

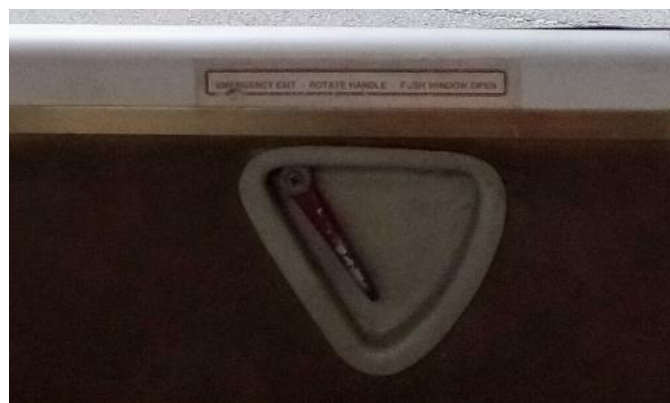
**Figure 9: Emergency window unlocking handle and marking**

The aircraft was equipped a strip showing the prescribed text.

The POH does not depict the actual placard. The aircraft was also not equipped with a marking showing the handle positions (window locked / released). Another aircraft of the same type, age and same operator, present in the hangar during the inspection, showed the same situation.

The marking present on both aircraft, although literally complying with the wording found in the POH, did not determine a clear and unambiguous position of the emergency window operating handle (window locked / released).

The absence of a clear indication makes it difficult for anyone to determine whether the handle is in the correct position, as required during pre-flight check.

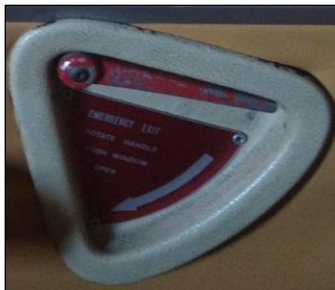
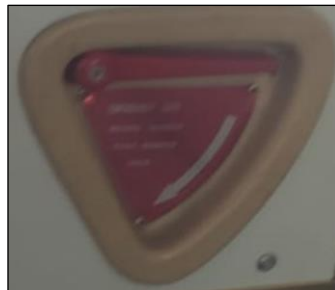
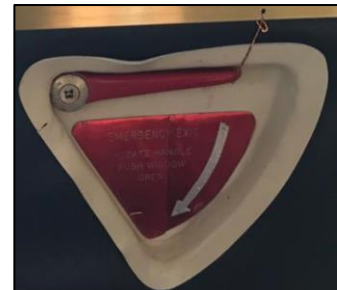
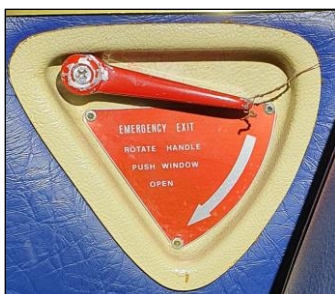
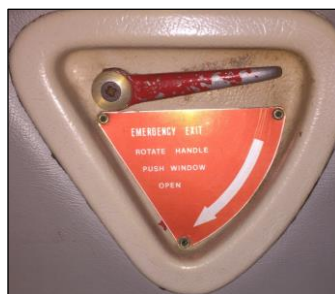
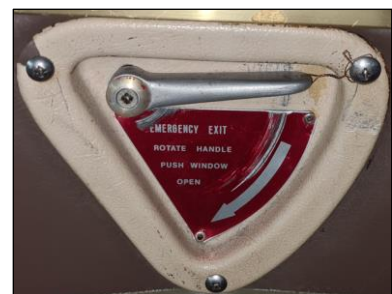
The received photos of the aircraft delivered before and immediately after the involved aircraft (P.68B S/N 16) show a red placard with relative white arrow in correspondence with the emergency exit window lock-release handle; this placard indicates clearly how to unlock the emergency exit window and then the correct position of the relative handle.

The search revealed a placard, present on many airplanes of the same age as the investigated airplane. The search also revealed small differences in the markings; the majority concerns metal plates, riveted onto the operating handle back plate; one (from S/N 17) seems of another type, glued in place. The handle back plate of the investigated airplane (S/N16) does not show rivet holes, nor evidence of previous presence of glue.

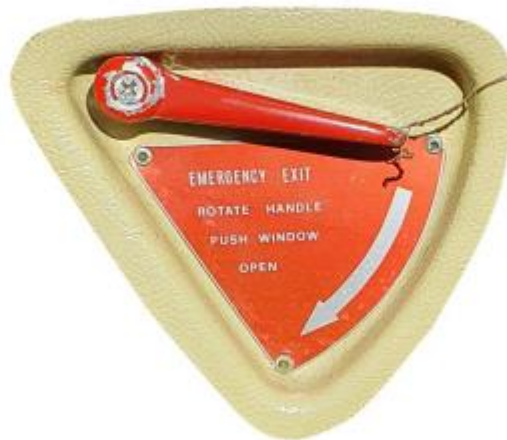
**Figure 1 Emergency exit window placard (only for reference)**

The missing of an adequate emergency exit window placard may be cause of an accidental disengagement of the emergency exit window.

The above placard should be installed in correspondence of the lock-unlock handle of the emergency exit window when complying with this Service Letter.

In presence of missing placard, send some photos about the emergency exit window with related lock-unlock handle to Vulcanair via e-mail at [continued.airworthiness@vulcanair.com](mailto:continued.airworthiness@vulcanair.com) or via fax at No. +39.081.5918172. Vulcanair will supply you the suitable placard.
