# In-progress Safety Investigation Statement

Ref. AAIU-2021-02-26-01  
Issue date: 17 February 2023

## SYNOPSIS

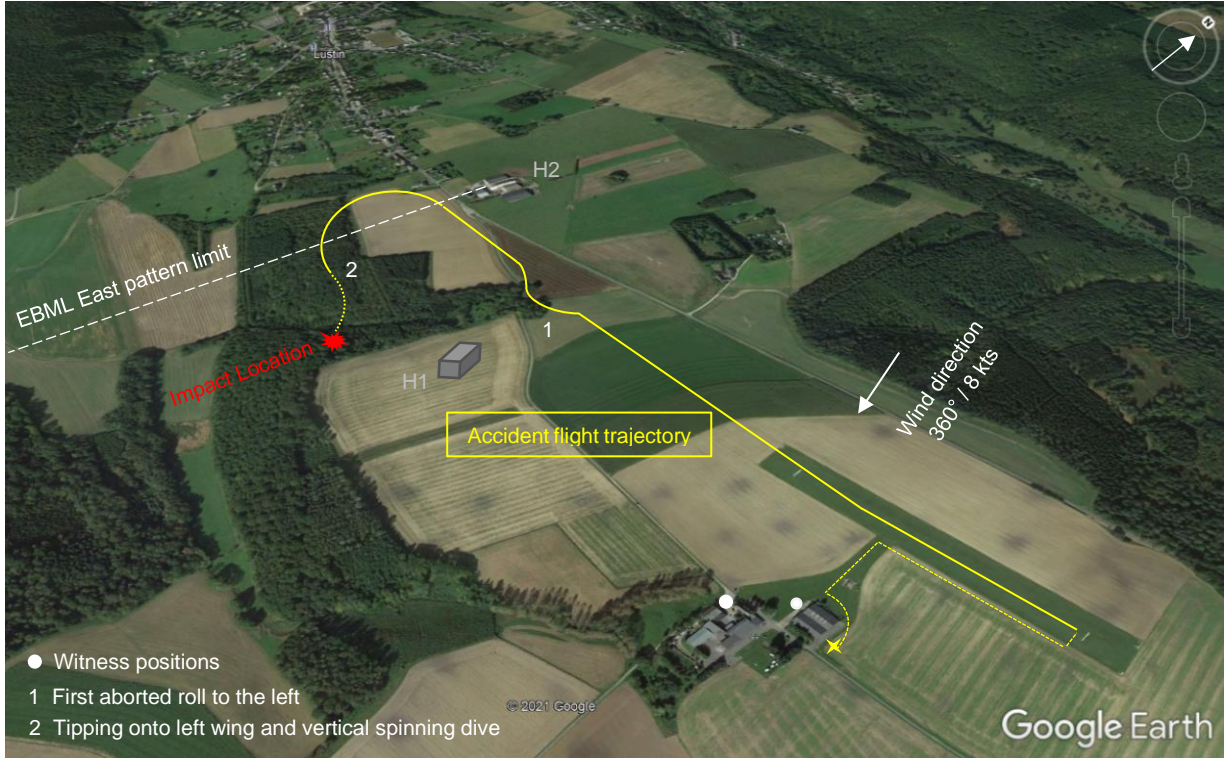
The accident with the French registered ultra-light aircraft took place during a local flight made by the pilot owner (Belgian citizen and resident), alone on board, from his home aerodrome (EBML) located in the town of Maillen in Belgium. The purpose of the flight was to verify the aircraft after maintenance and parts replacement performed the days before by the pilot owner. The take-off from runway 27 was carried out with adequate control in a full crosswind (8 kts - 330°) condition. During climb, the airplane rolled to the left before returning to the runway centreline with an angle of climb below the usual path.

The aircraft, having exceeded the normal circuit limits, then made a U-turn to the left in order to come back to the airfield. The aircraft was in straight levelled flight to the terrain when it tipped onto its left wing before diving vertically while spiralling into the grove it was flying over.

**Figure 1 : Accident flight illustration based on eye witness declarations**

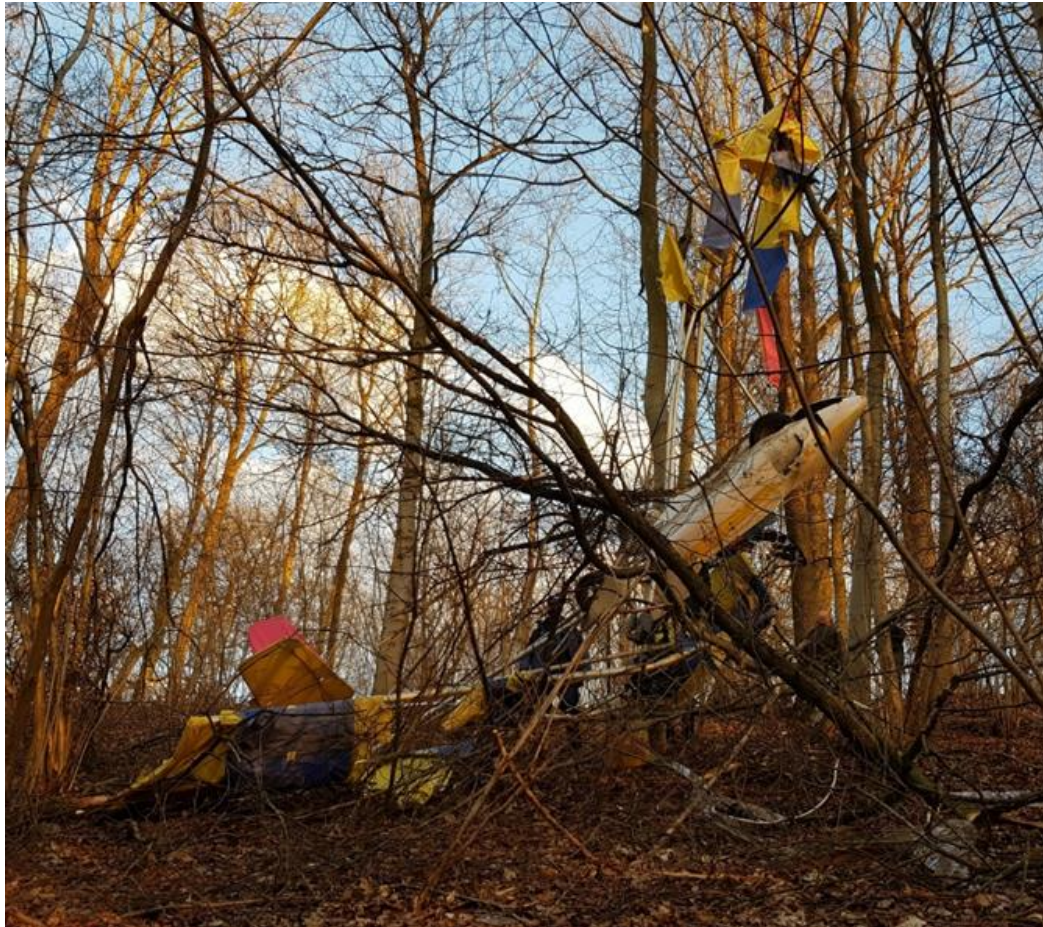
The plane was found on the ground, turned over on its back and severely damaged at the level of its structure, the engine and the propeller due to its contact with the vegetation during the fall. The pilot's lifeless body was laying on the ground next to the aircraft after having been ejected from his seat during the impact.

**Figure 3 : accident aircraft after final impact**

The investigation also discovered that the harness was not correctly installed on the pilot seat, leading of the release of the body from the seat at impact.
