Safety Investigation Report

Ref. AAIU-2022-07-02-01

On July 2, 2022, about 13 UTC, a Piper PA-25-235 airplane was destroyed when it impacted terrain during initial climb after take-off from the Tournai-Maubray airfield, Belgium. The airline transport pilot suffered only minor injuries and could escape from the wreckage before it caught fire and was totally destroyed. The aircraft was towing a Schleicher KA 6E sailplane at the time. The sailplane pilot stated that during the initial climb, the tug aircraft disappeared from his sight and he released the tow cable. The sailplane could return to the airfield for a safe landing.

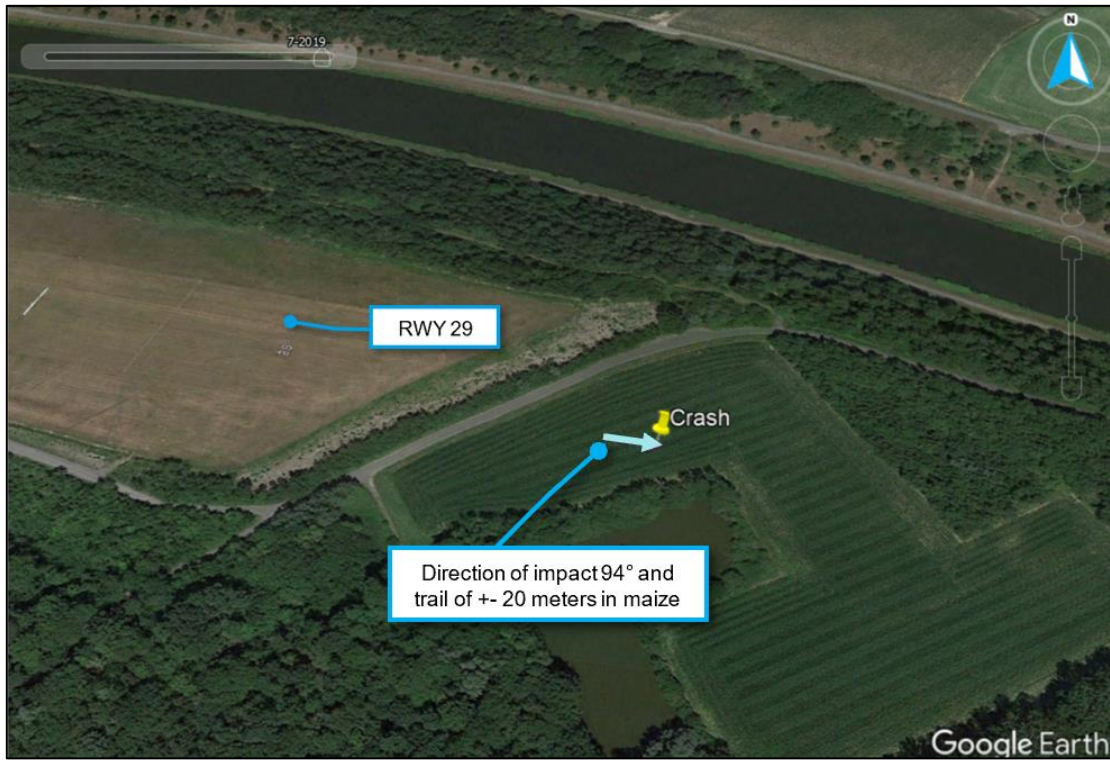
Figure 4: Crash area

Heading of aircraft wreckage: 147°

So aircraft was in angle of about 55° with the final path.

The tow cable itself was found at the beginning of the trail in the corn field.

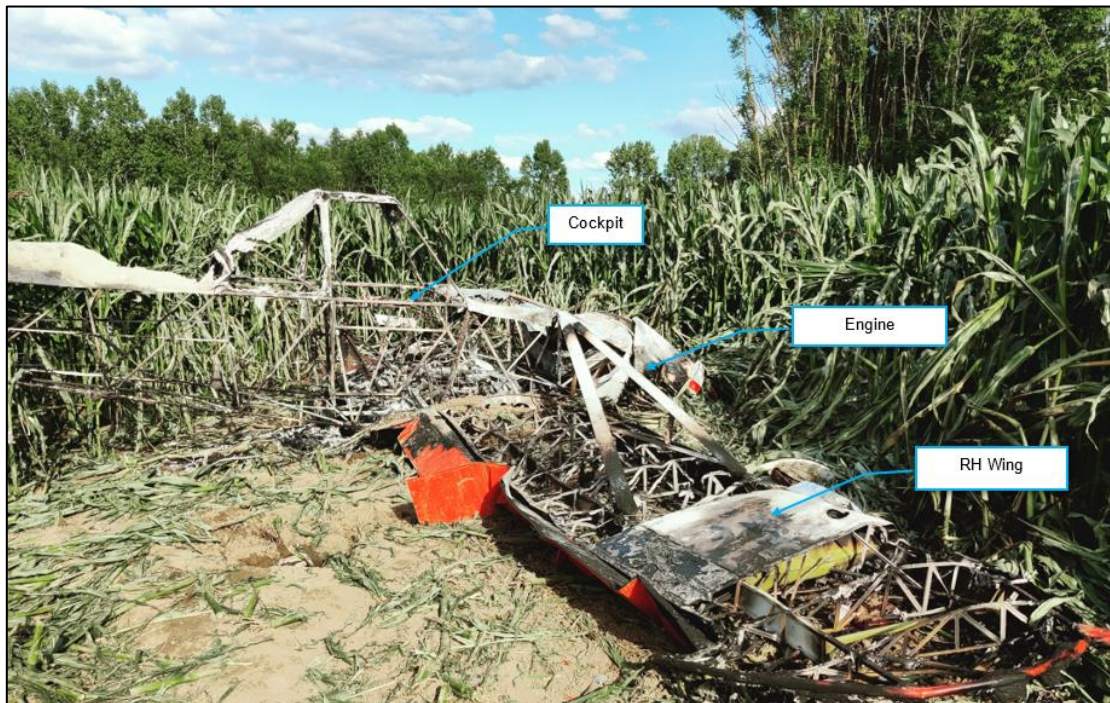
Figure 5: The wreckage of the tug airplane

Findings on the wreckage:

- Fabric was consumed by post-crash fire, but structure was overall good intact. All flight controls were still present, any in-flight break-up excluded.
- Flap handle down (so flaps up position). Cable to LH flap was ruptured (overstress), rod of RH flap to the flap horn was found broken (also overstress).
- Rudder cables were still intact and connected with pedals, rudder was free to move
- Aileron cables and pulleys still intact and connected with stick
- Elevator cables still intact and connected with stick
- Trim handle in cockpit disconnected. Not possible to determine the elevator trim setting. Cable and spring were still attached to the elevator however.
- Mixture setting full rich
- Throttle: half power
- Propeller blades and spinner had no signs of high power during impact
- Schweizer (tow) hook open and cable released.

At the RH wing it was clear that there were 2 sources of fire; one originating from the wing fuel tank and one originating from the engine compartment. The wing support struts showed no fire damage. Also the flap was only half burned from inner to outer while the aileron (which lies more outboard) was completely burned at the upper side; showing that the radiation came from 2 directions.

In the wreckage, the safety belts were not found. However, the connection cables were still attached to the structure. So no signs of impact failure (rather consumed by the fire).

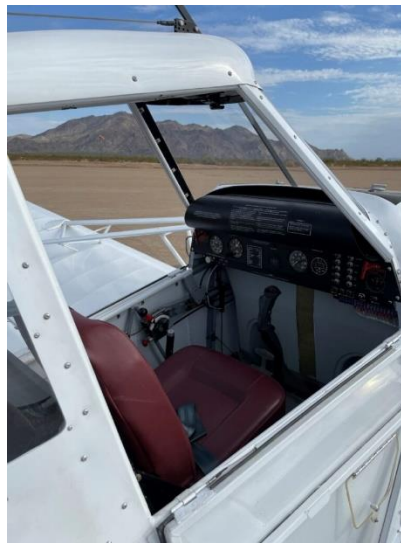
Figure 6: PA-25 Cockpit

The construction of the fuselage provides an adequate resistance to impact. The cabin frames were still standing, even after the fire. However, the cabin lay-out is such that the pilot has to exit the aircraft through the window, which in case of emergency or crash exiting the cockpit in an emergency might be difficult.

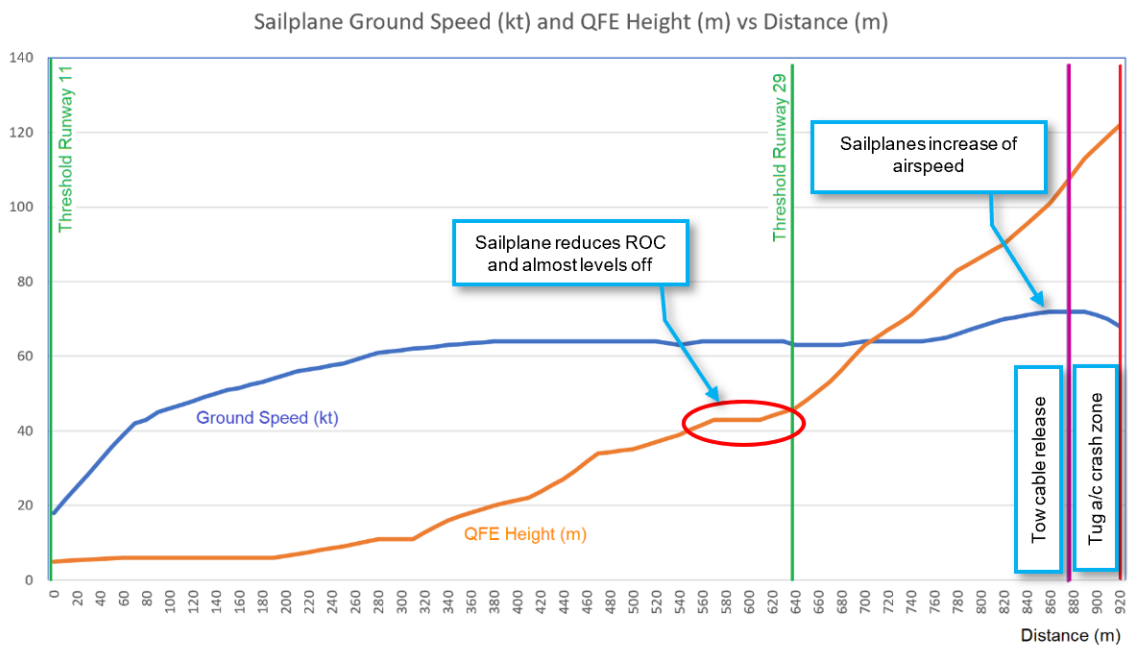
Figure 10 : FLARM data of the sailplane

- From the runway end, the sailplane is climbing up to a height of 100 -110 m before the tow cable is released, which is compatible with the cable length of 40 m and the statement of the tug pilot stating he was flying at 61 m (200 ft) high when he released the tow cable.

- The graph shows an increase of ground speed from 64 kt to the maximum ground speed of 76 kt - 142k m/h, reached in 3 seconds time. This value and rate of increase is indicative of the sling shot effect described in Chapter 1.18 of this report).

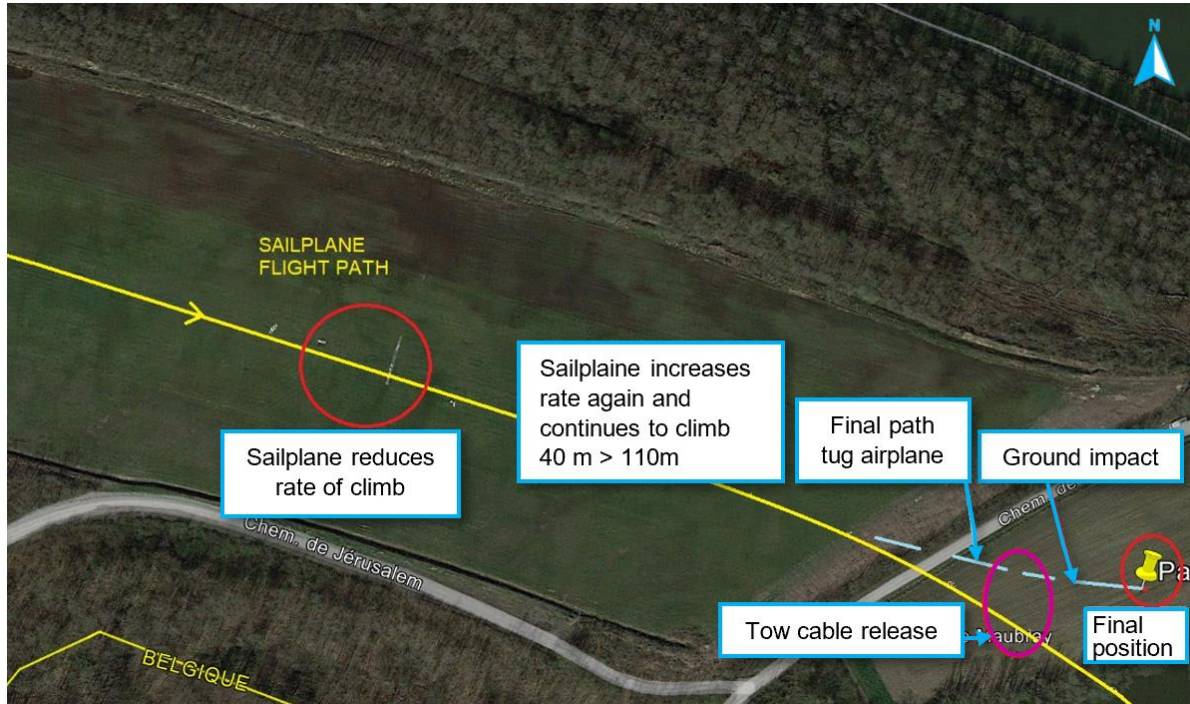
Figure 11 : reconstructed flight paths

The respective position of the 2 aircraft evolves very rapidly and the sailplane pilot did not constantly hold the tug airplane in sight. It resulted in a late detection of the problem. His first reaction was to correct the situation by pushing on the stick, but this did not have immediate effect. The sailplane pilot stated that, at that moment, he lost sight of the tug aircraft, sign that the problem increased.
