Safety Investigation Report

Ref. AAIU-2023-04-09-01
Issue date: 30 November 2023
Status: Final

Occurrence class	Accident
Occurrence category	Loss of control - ground (LOC-G) Runway excursion (RE) - veer off
Date and time ¹	Sunday 9 April 2023 15:48 UTC
Location	Airport of Kortrijk/Wevelgem (EBKT)
Aircraft	Boeing Stearman Model 75
Aircraft category	Fixed wing - Small aeroplane (MTOW ≤ 5700 kg)
Location of departure	Airport of Kortrijk/Wevelgem (EBKT)
Planned destination	Airport of Kortrijk/Wevelgem (EBKT)
Type of operation	Non-commercial - Cross-country
Phase of flight	Landing
Injuries	None
Aircraft damage	Substantial

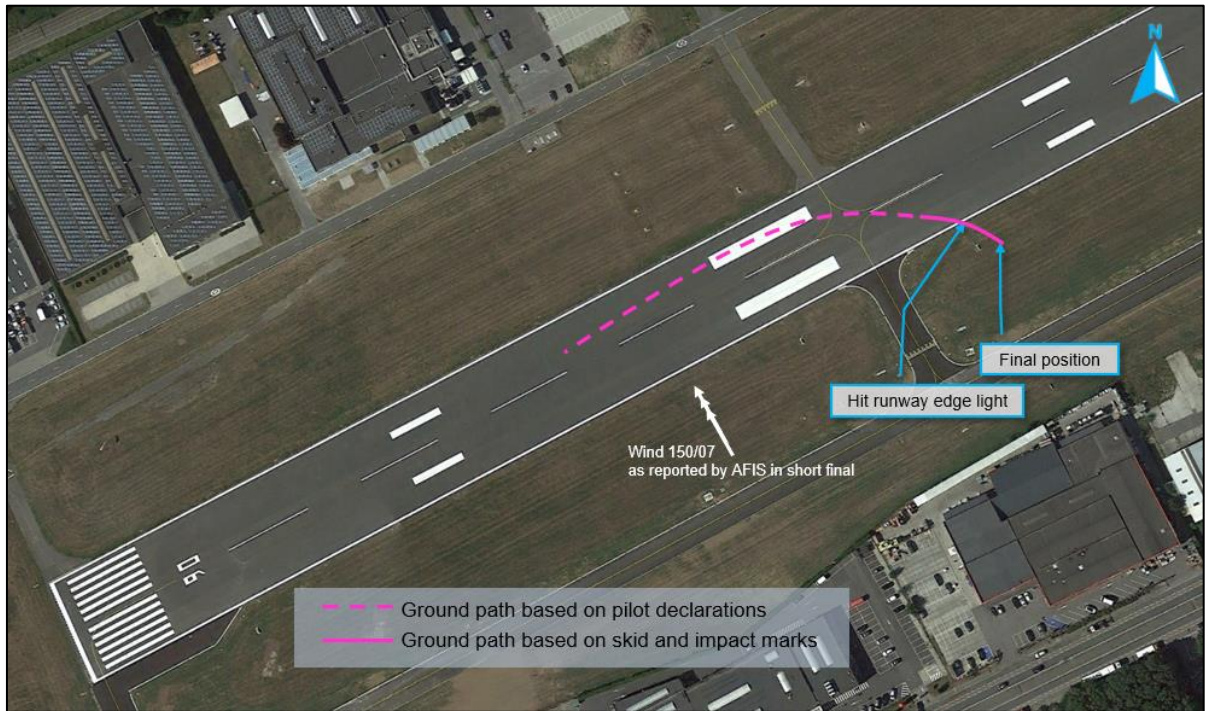
The aircraft touched down at an airspeed of approx. 80-85 mph on both main wheels in the beginning of the runway, but according to the pilot not perfectly on the centreline. The airplane landed on the left side of the centreline, moving outwards. The pilot tried to correct this situation with applying the righthand rudder pedal not touching the brakes. However, very soon thereafter, the tailwheel touched the ground and, from that moment on, the airplane became uncontrollable. The airplane swerved to the right, while the right wing rose, causing the left wing to contact the runway asphalt. The pilot tried to correct with pushing left rudder pedal, but he felt the situation was out of control, and the aircraft was riding on the left wheel of the main landing gear. There was no way to avoid the airplane to move to the right, as the RH wing was up and the crosswind taking into it. The aircraft veered off the runway hitting a runway light with its left main landing wheel.

Figure 1 : reconstructed ground path (flight was not recorded with a GNSS system)

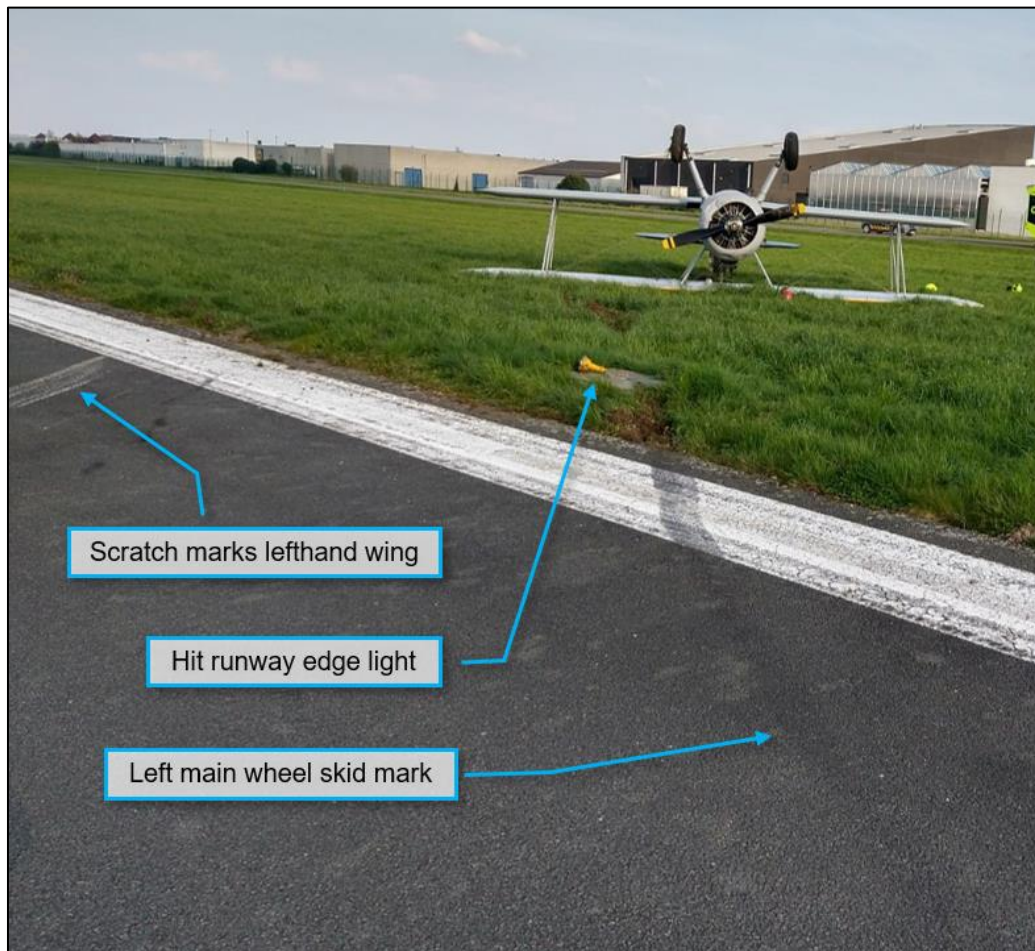
The main gear dug into the grass causing the engine cowling to hit the ground and subsequently the aircraft to tip over. The ELT was triggered, so although already at lower groundspeed, the deceleration due the impact with was quite high (+2,3 G). The aircraft came to rest inverted on its back.

Figure 2 : Final position aircraft

From the interrupted skid and ground mark on Figure 2, it can be deduced that the concrete base of the runway edge light in the grass strip acted like a sort of ramp that caused a small jump. This highly likely increased the final impact forces on the gear and thus contributed to the flip-over of the aircraft. See illustration on Figure 3.

It is advised to aerodrome operators (not only limited to EBKT) to take the above into account when planning infrastructural works on runways and to take into consideration to place the runway edge lights along the edges of the runway area (pavement) itself.
