Air Accident Investigation Unit

**FINAL REPORT ON THE ACCIDENT
TO AGUSTA BELL AB 206 A
REGISTERED OO-ACR
IN DESTELDONCK
ON 2 SEPTEMBER 2007**

Ref. AAIU-2007-15
Issue date: 25 January 2008
Status: Final

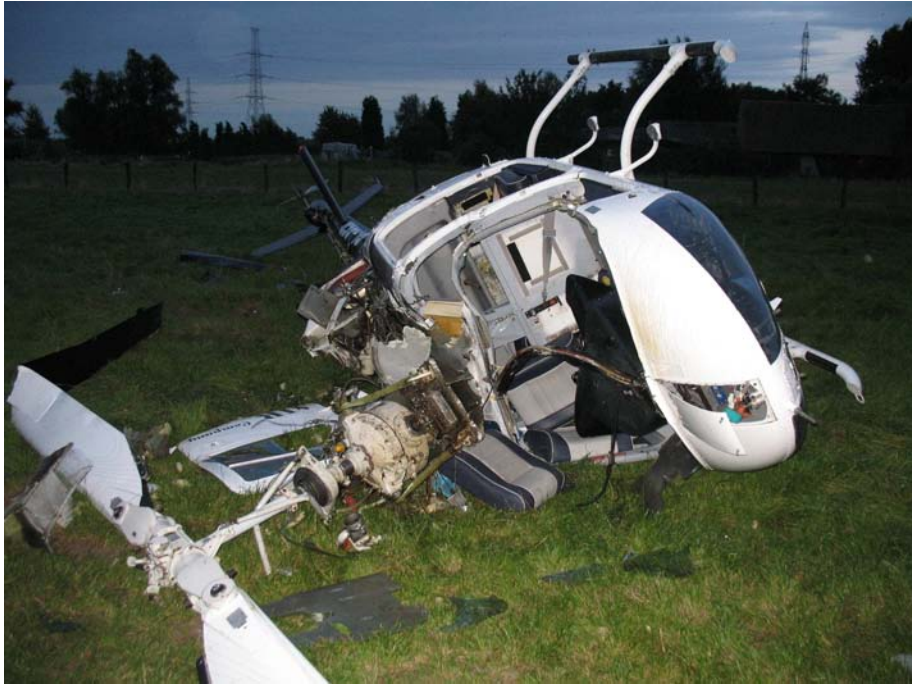
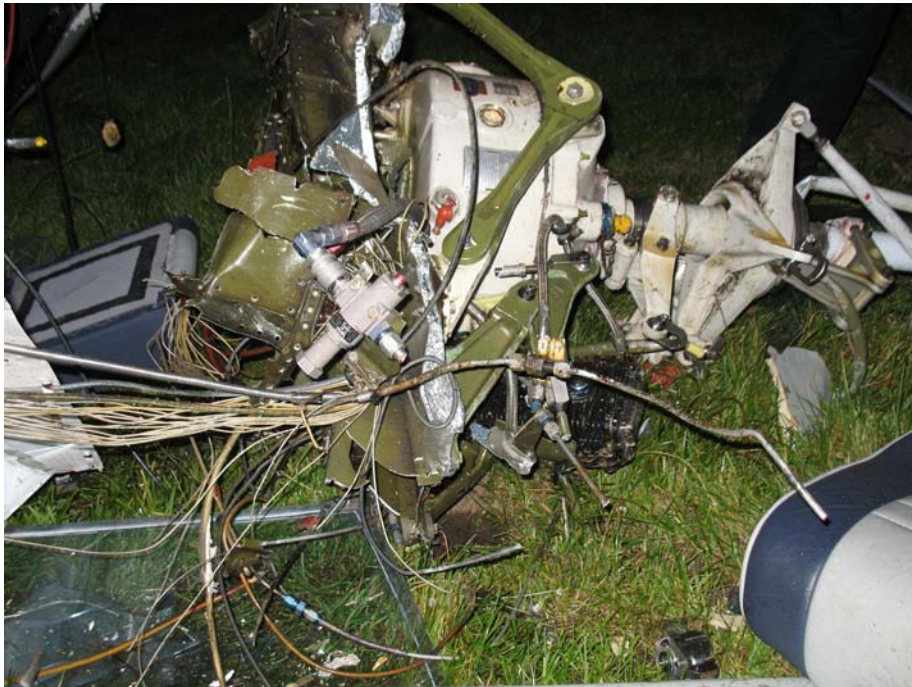
The helicopter was severely damaged; the rotor blades struck the ground and separated, the main rotor transmission was torn away, and the airframe suffered severe deformation.

The helicopter is lying on its RH side, at the point of take-off. The terrain is an agriculture field; the surface is flat but rough.

All damages were found to be caused by the rolling motion of the helicopter around the RH skid acting as a pivot.
