***Air Accident Investigation Unit***

# **FINAL REPORT ON THE ACCIDENT TO BRT EIDER (F-PMIC) IN CERFONTAINE ON SEPTEMBER 15 2007**

**Ref. AAIU-2007-14**  
**Issue date: 30 April 2008**  
Status: Final

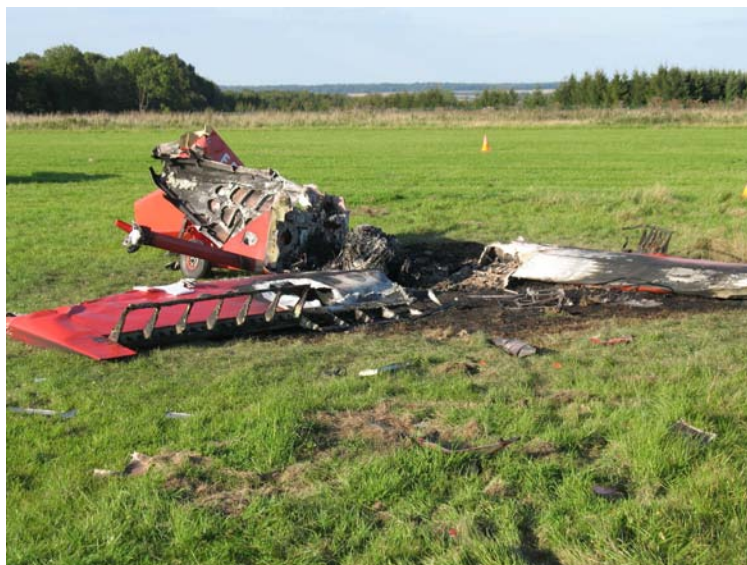
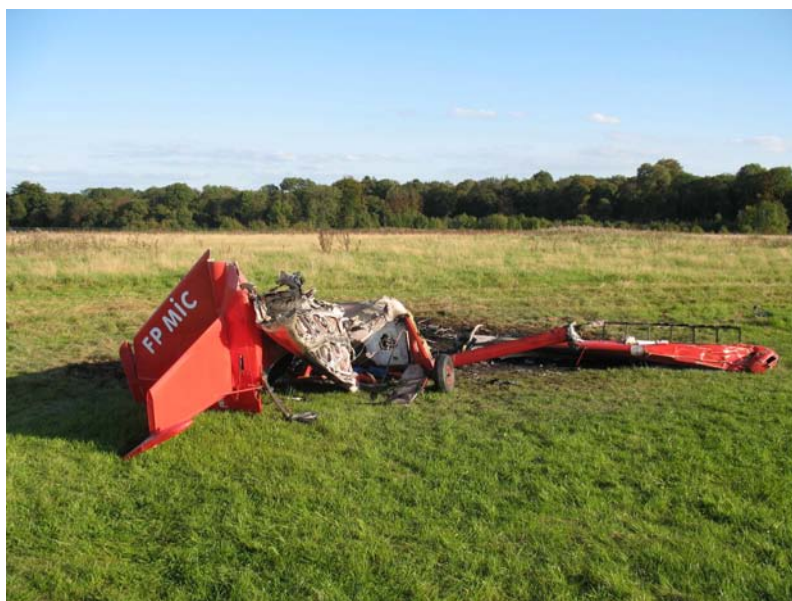
The aircraft was totally destroyed by impact and by subsequent fire.

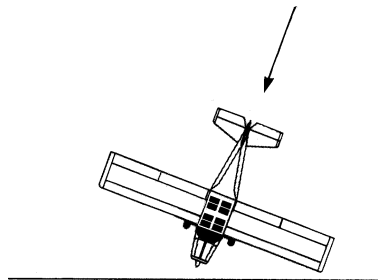
The aircraft impacted the ground with a slight angle, the left wing contacted the ground together with the engine. The engine took the first shock.

The aircraft bounced and rotated to the right, and the wings separated; the left wing separated upon the first impact, while the right wing remained attached until the fire broke out. The rotation to the right might have come from an initial movement of the aircraft, combined with the impact of the left wing with the ground.

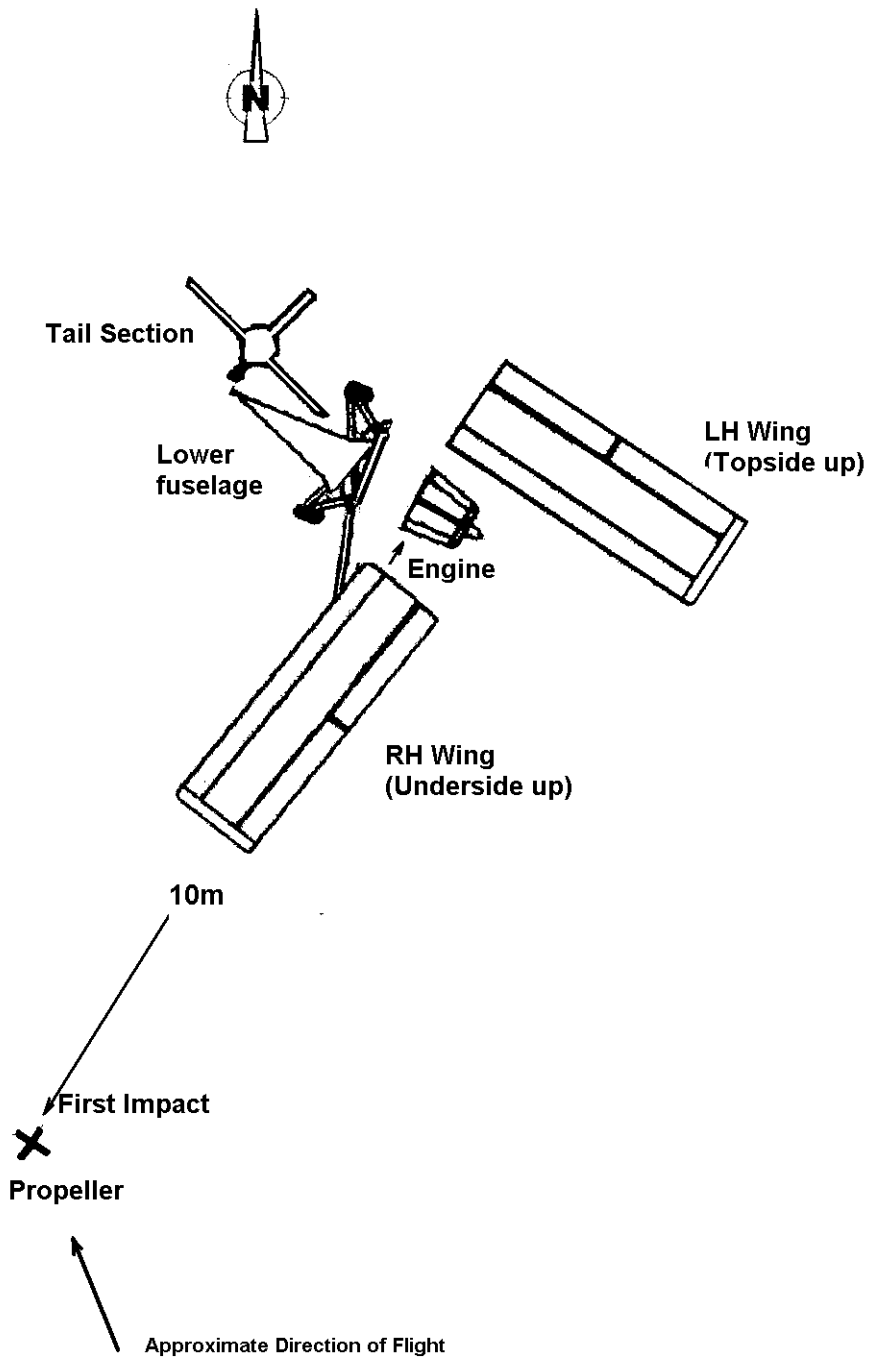
Final resting place of F-PMIC (view from the top)

The first impact, where the propeller was found, is 10m away from the final resting place.

The blades of the propeller were found together, buried in the ground, confirming that the engine did not deliver high power when the aircraft hit the ground.

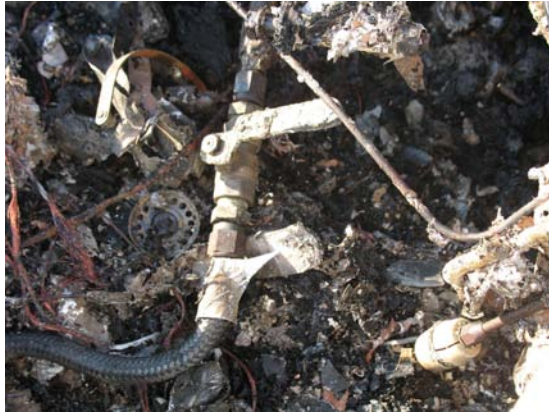
The 2 fuel valves were found in the closed position, in the wreckage:

The positioning of the valves led to an hypothesis; i.e. that they were closed during the Take-off, and that it was the origin of the shut-down of the engine.

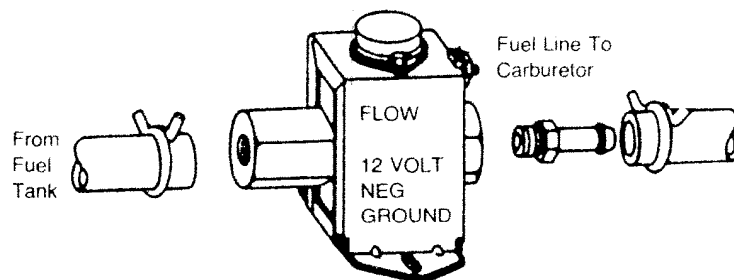
There was no mechanical fuel pump installed on the engine. Instead, an electrical pump was installed, between the fuel filter and the carburetor. The pump is a Facet Cube Solid State Fuel pump p/n 40108, used mostly in automotive applications.

The pump was installed inside the engine compartment, on the Left side of the fire wall.

The pump was not fitted with a by-pass valve but by construction, the pump would not have blocked the flow (pressure drop is believed to be “less than 1 psi” at take-off rating).

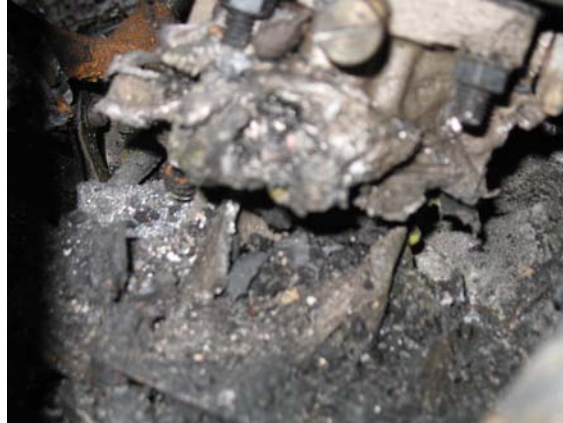
3. Improper fuel flow.  
The carburettor was destroyed, but the spark plugs showed a normal color (chocolate brown), and the aircraft flew twice during that day.

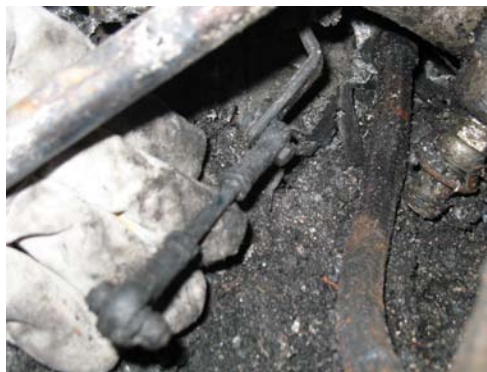
**throttle ctl**

4. Restriction in air inlet or manifold.  
The air inlet was crushed by impact force, so was the carburettor. However, owing to the configuration of the air inlet, it is improbable that the air inlet would become obstructed, so that the engine would shut down; also, there were no sign of abnormal combustion reported by the witnesses (black smoke).
5. Alternate air door leaking allowing heated air to enter carburetor.  
The air inlet was crushed by impact force, so was the carburettor, but this would not cause the engine to stop abruptly.
6. Throttle lever not properly adjusted.  
The throttle lever was found, but did not show signs of separation.

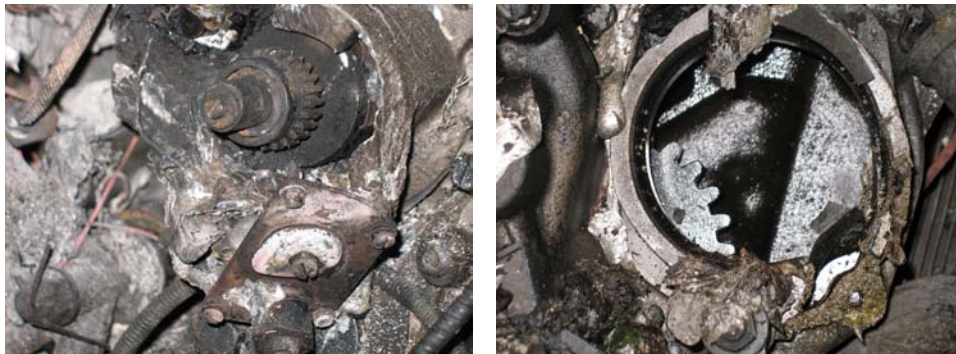
11. Magneto problem.  
Both magnetos were severely damaged; the RH magneto was ripped off, and the LH melted down, making any determination impossible; it is however believed that the simultaneous failure of both magnetos is improbable.

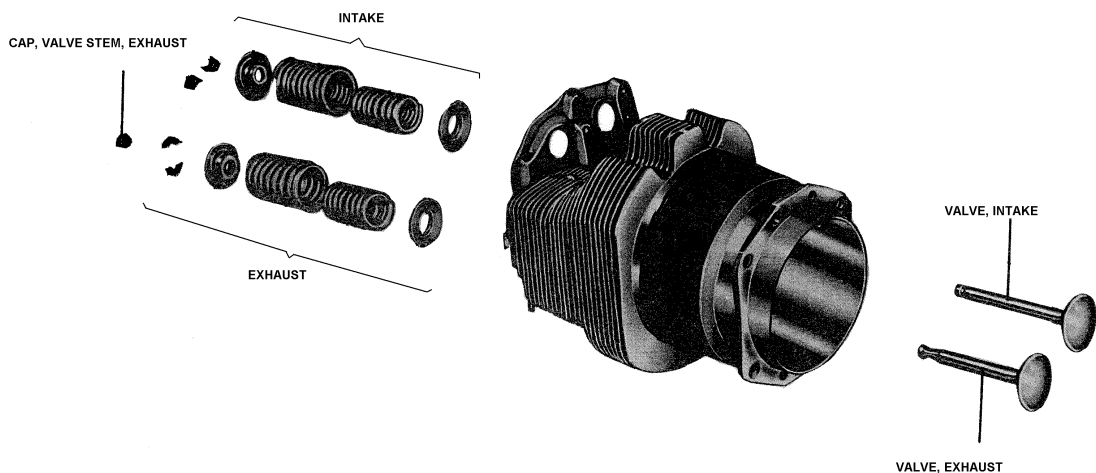
- The Cap, Valve stem, exhaust was missing on all 4 exhaust valves. This gap was not compensated by longer push rods (rod assy, push), since all four were found of the same length.

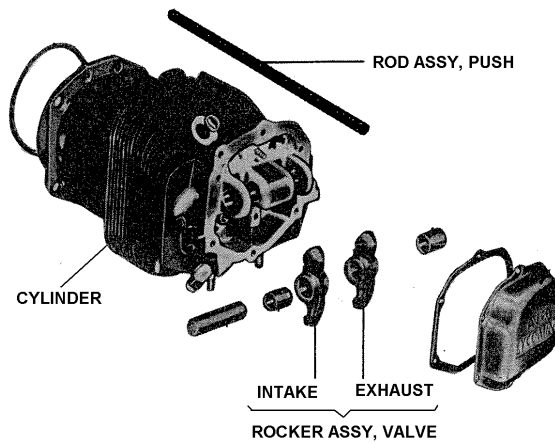
- The rocker assembly is different for the intake and the exhaust; the difference lies in cooling hole on the exhaust valve rocker. On the engine, the parts were found mixed (exhaust on intake position, and vice-versa).

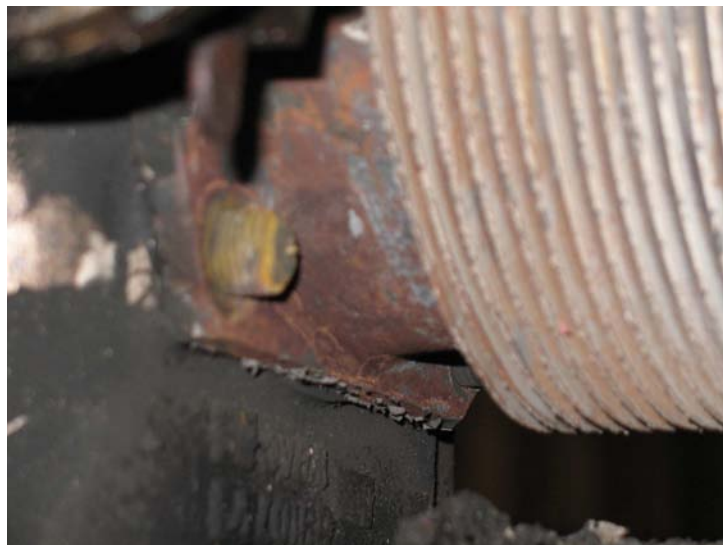
- On 2 cylinders, fixation bolts to the through-studs were found missing. These bolts are part of the fixation of the cylinders onto the engine.

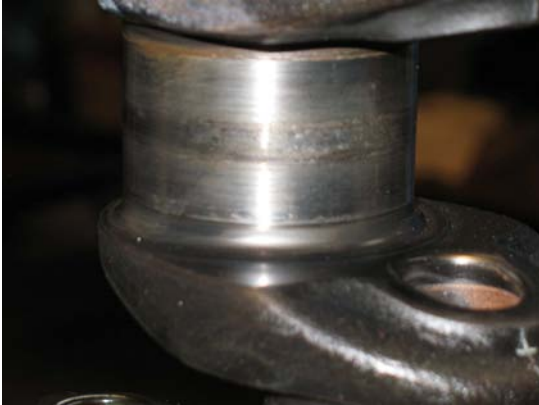
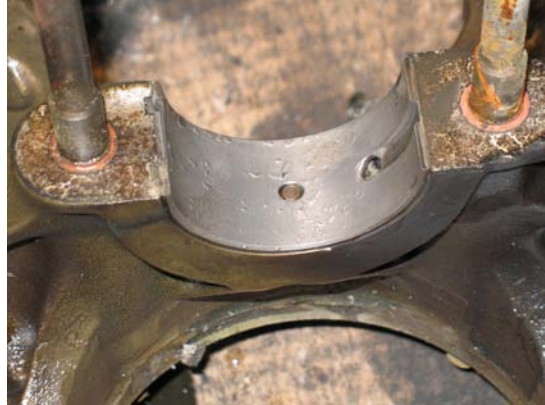
- The crank shaft and the bearings showed abnormal wear, possibly fretting due to the incorrect fixation of cylinders.

These anomalies would have induced abnormal wear of the engine, and possibly future problems, but are not the cause of the engine shut-down that led to the crash of F-PMIC.
