Safety Investigation Report

ACCIDENT TO A CESSNA 172 AIRPLANE AND AN AVEKO VL-3-B IN LES MOERES (FRANCE) ON 02 OCTOBER 2010

Ref. AAIU-2010-43-Les Moères
Issue date: 29 August 2014
Status: Final Draft

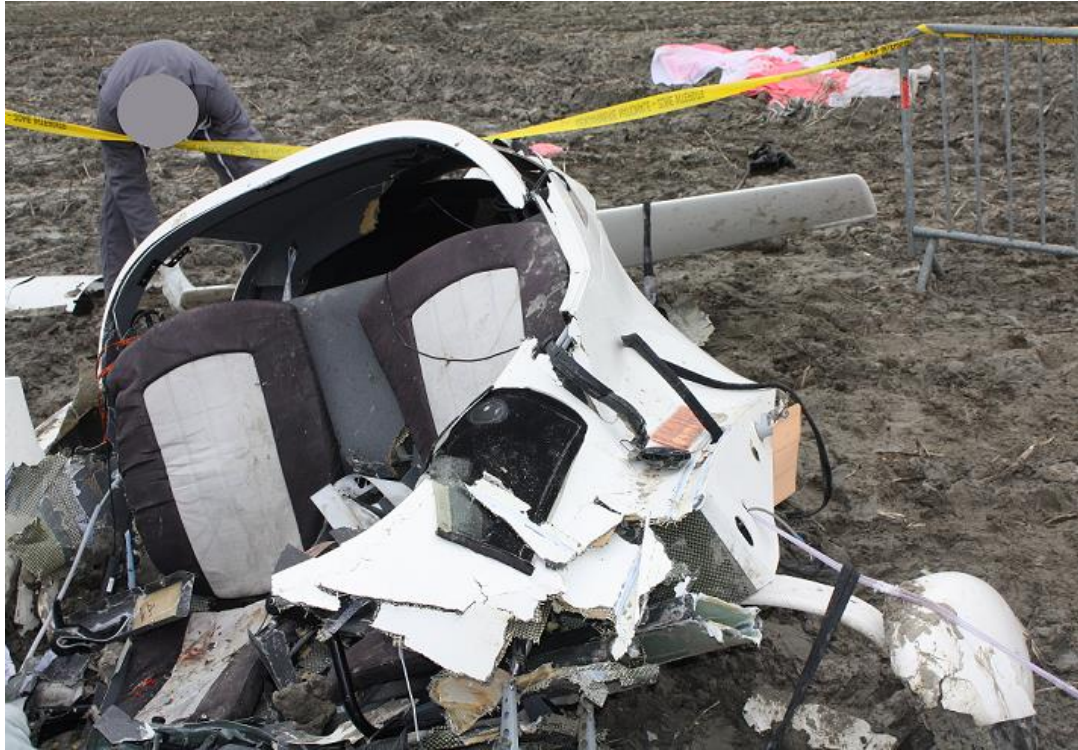
Figure 14: VL3 wreckage – front side

The main wreckage is quite concentrated, all parts being found within a small perimeter. The left wing, severed from the fuselage, rested next to it. The tail section was broken off and the front section was torn open. The engine was buried in the ground.

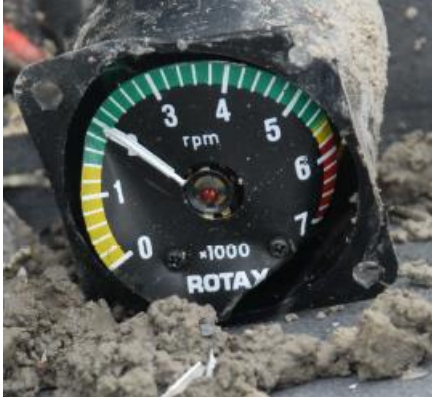
Figure 16: engine RPM gauge

The instrument panel was heavily damaged, but the engine RPM instrument was found blocked at 2000 rpm. The position of the master switch was “on”, and magnetos on “both”.

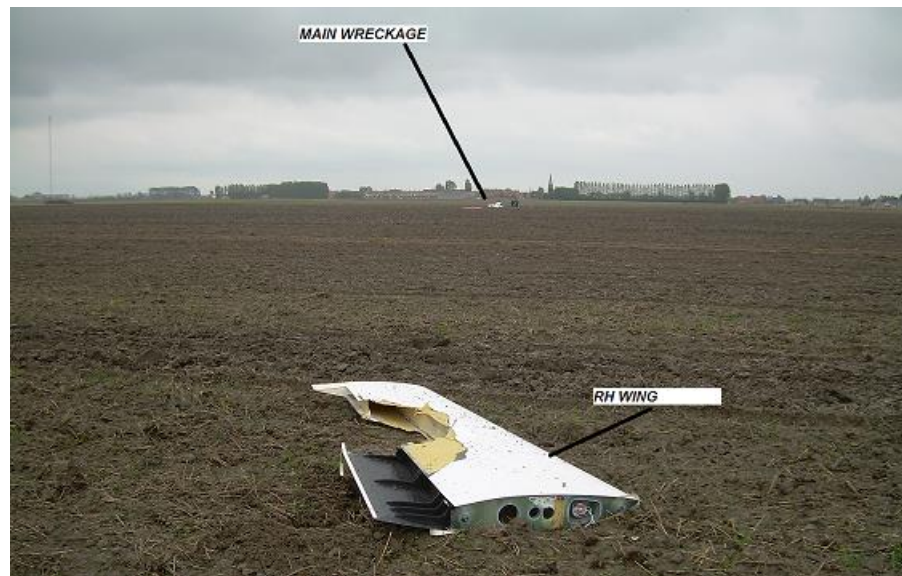
Figure 18: Location of the right wing.

The right wing was found 200m north from the main wreckage, along with several debris and a metallic part from the left wing tip of the C172.

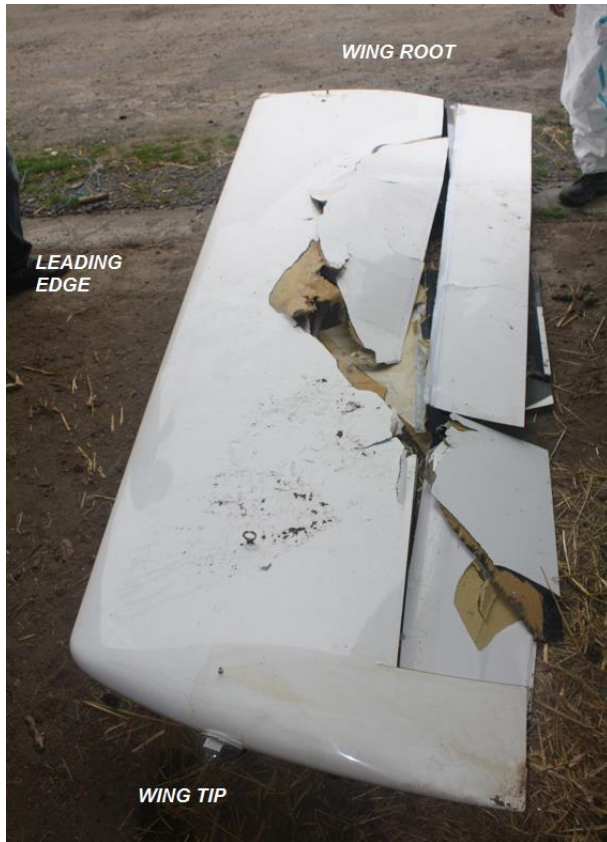
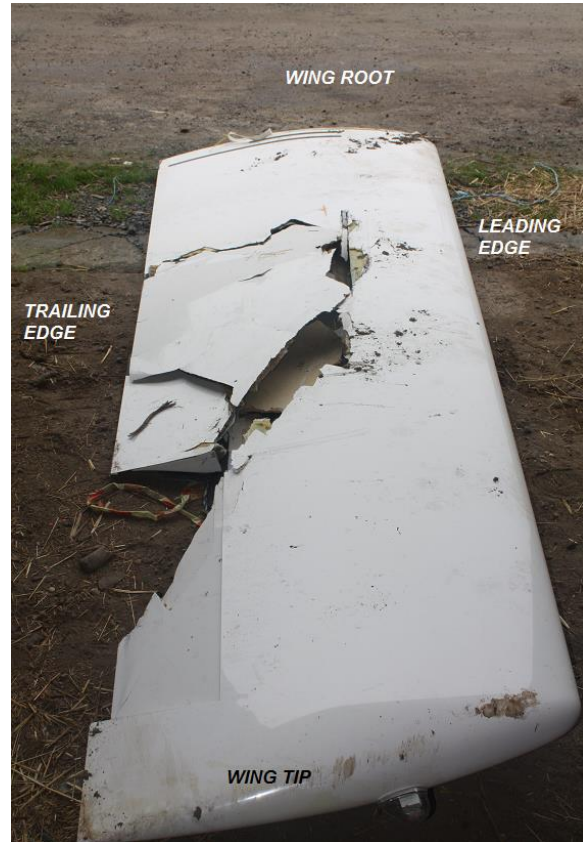
The right wing is damaged from the trailing edge to the main spar. The front part of the wing did not show any damage. The RH wing was reconstructed with the parts found around the wing.

The damage on the lower side of the wing shows evidence that an important part was ripped off in a downward movement, while the upper side shows damage caused by a cutting effect. The damage cut on the aileron is remarkably sharp.

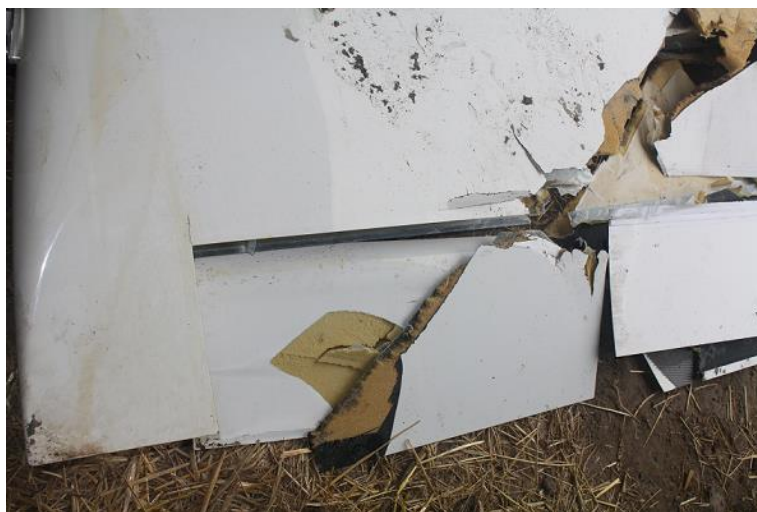
Figure 21: Right wing aileron damage (lower side)

The damages on the right wing are oriented on an angle of 45°.

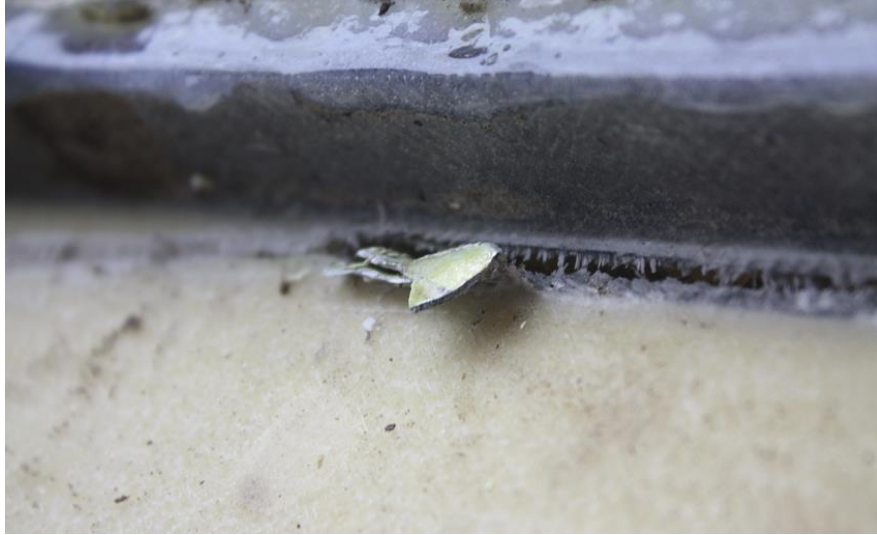
Figure 22: Metallic part in the right wing spar.

A metallic chip was found inserted in the wing spar, along with grooves caused by friction.

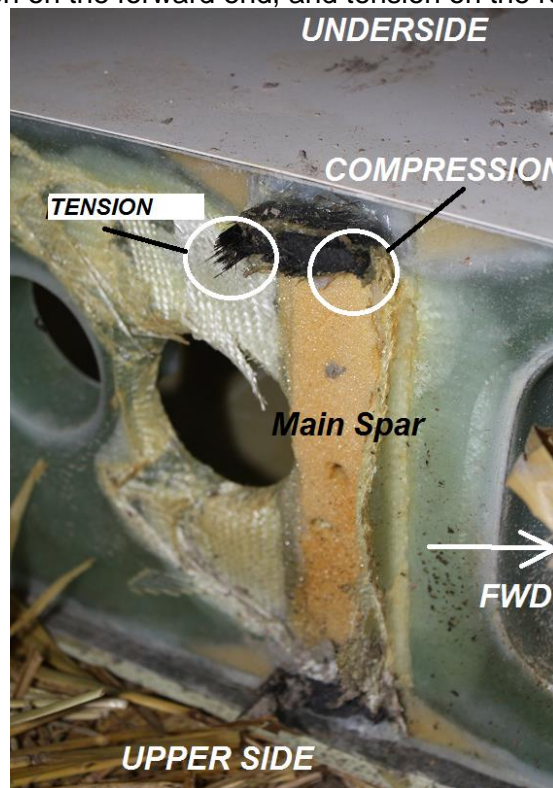
Figure 23: Right wing main spar failure

The inspection of the rupture of the main spar shows it failed by forces of compression on the forward end, and tension on the rear end.

The inspection of the C172 wreckage showed that the leading edge of the left wing of the C172 impacted the trailing edge of the right wing of the VL3, with a penetration angle of 45°. Additionally, thorough examination of the VL3 wing damage showed the lower wing skin was bent downward, and ripped off by the C172 wing impacting the VL3 from above. The forces on the wing of the VL3 caused the rupture of the main spar.

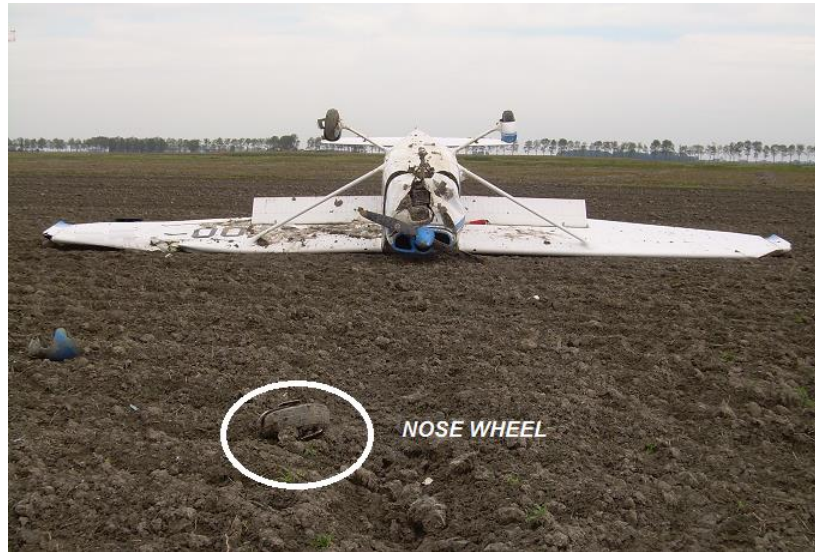
Figure 24: C172 front view

The C172 made an emergency landing. Terrain showed wheel traces over a length of 20m. The nose landing gear leg broke, and the airplane went upside down. The RH wing is relatively intact, while the LH wing shows 2 areas of impact damage near the leading edge.

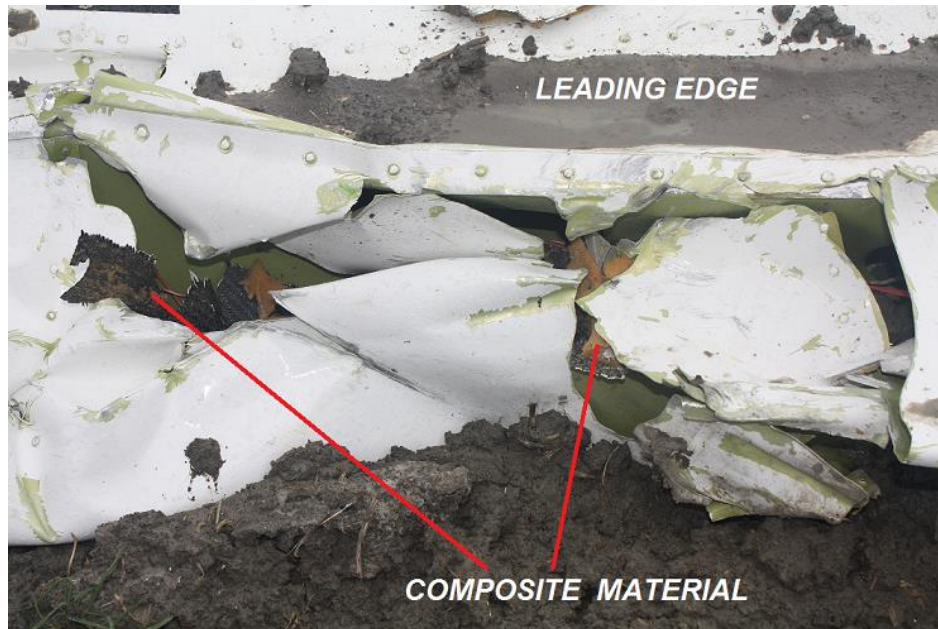
Figure 27: Impact damage on the C172 LH wing leading edge

The leading edge of the left wing shows compression damage, and composite parts, consistent with the material of the VL3 wing were found inserted.

Also, the metallic part found next to the VL3 right wing was found to be part of the C172 wing tip.

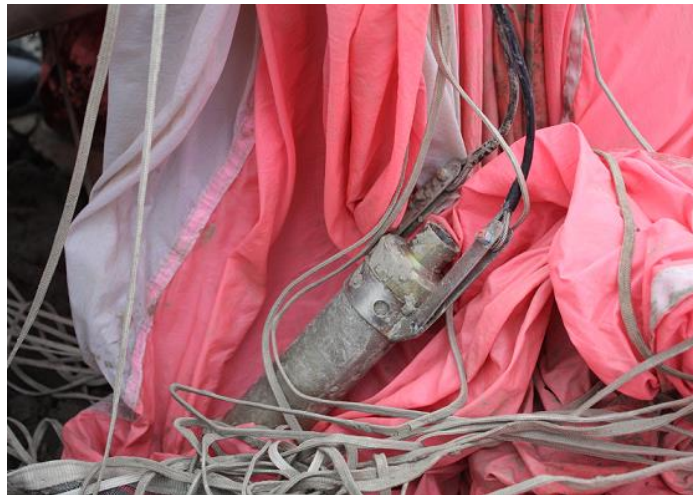
Figure 30: Extraction rocket.

The main parachute was found extracted. The extraction device was connected to its small parachute and pouch. The rocket had been fired; the exhaust showed powder residue.

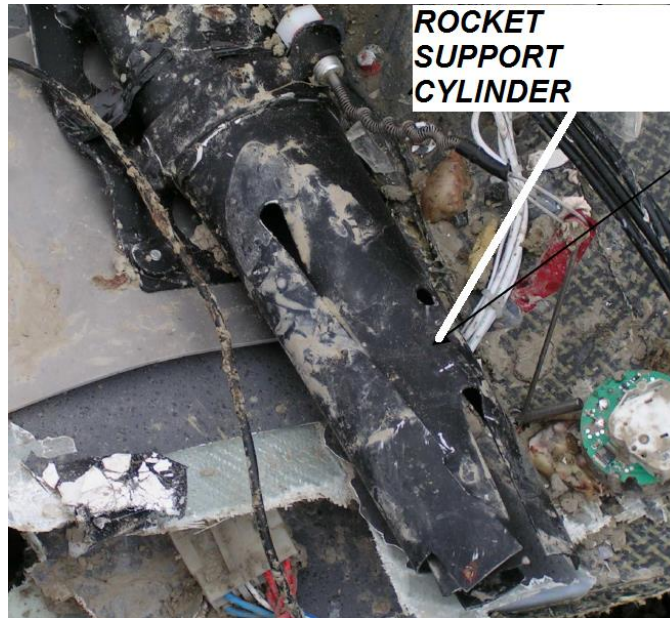
Figure 31: Rocket Support cylinder.

The rocket support cylinder in the airplane was found deformed.

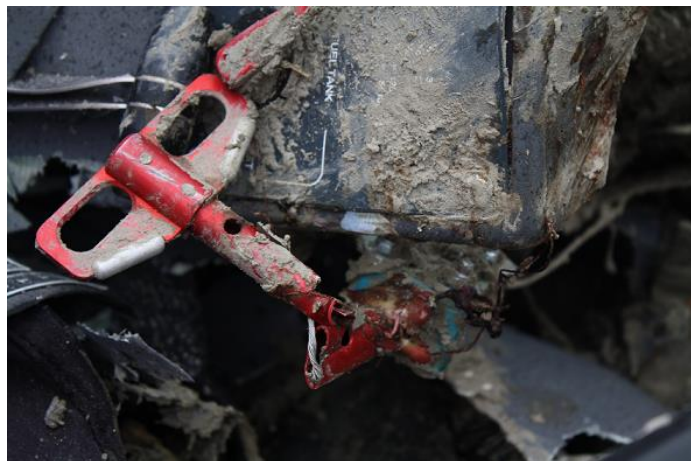
Figure 32: Operating handle

The handle was displaced from its original position, the safety pin was not in place.

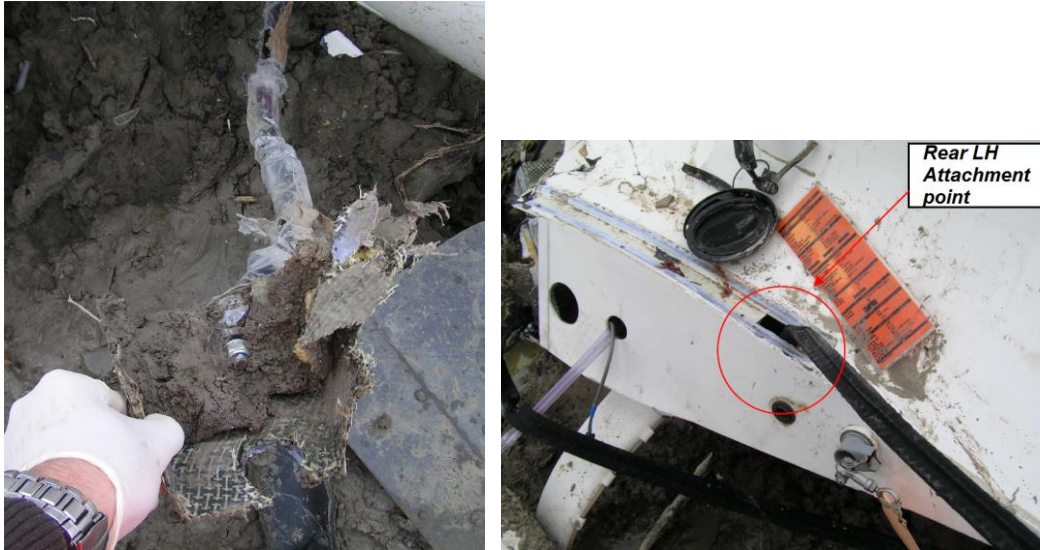
Figure 33 and 34: Attachment points

The four ropes, attaching the airplane to the parachute were found connected to the respective attachments. However, three attachments were found separated from the airplane's structure. Only the rear left attachment was still connected.

The crew of the VL3 succeeded in pulling the handle of the rescue ballistic parachute, but too late for the parachute to deploy. Also, the failure of the wing caused the disruption of at least one of the attachment points of the parachute rope.
