Safety Investigation Report

ACCIDENT TO THE SCHLEICHER Ka6CR SAILPLANE IN EBSH ON 13 AUGUST 2010

Ref. AAIU-2010-39-EBSH
Issue date: 29 August 2012
Status: Final

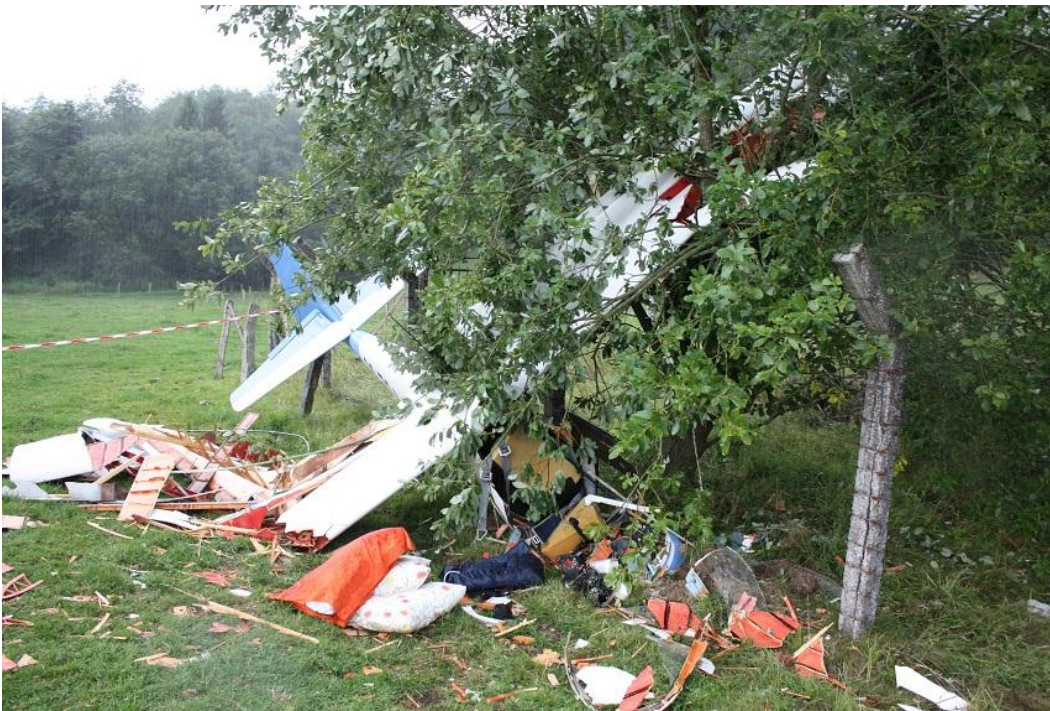
Fig.4 The wreckage

The sailplane nose is shattered, and RH wing is broken to pieces. The LH wing was stopped by the branches of a tree.

The aft section (rudder and aft fuselage) is intact.

The flight control cables are still attached.

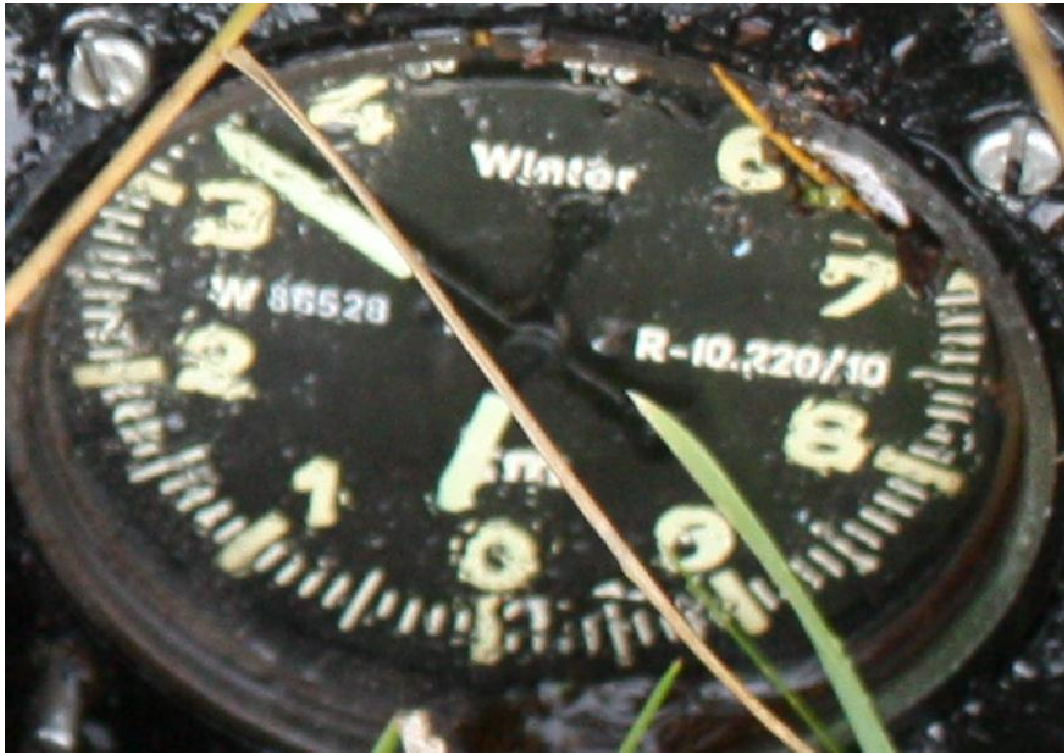
Fig 5. The altimeter

The altimeter shows an altitude of 350m.

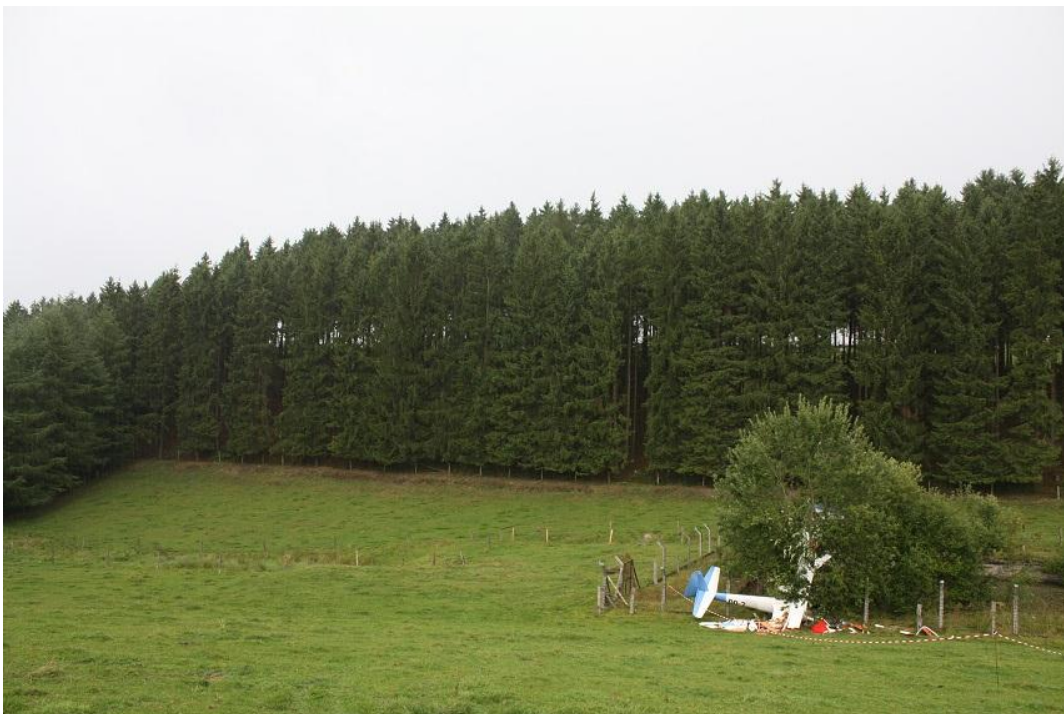
Fig. 6 crash area

The sailplane was seen coming down quite vertically in a field next to a former pool of the neighboring detention center.

The open field is 300m x 300m, bordered by trees, with a slope. The field has an elevation of 460-480m.

The damage to the vegetation shows the sailplane fell vertically.
