FINAL REPORT ON THE ACCIDENT TO THE SAILPLANE EIRIAVION PIK 20D REGISTERED OO-YEB IN WEELDE ON JUNE 12, 2010

Ref. AAIU-2010-27
Issue date: 7 January 2011
Status: FINAL

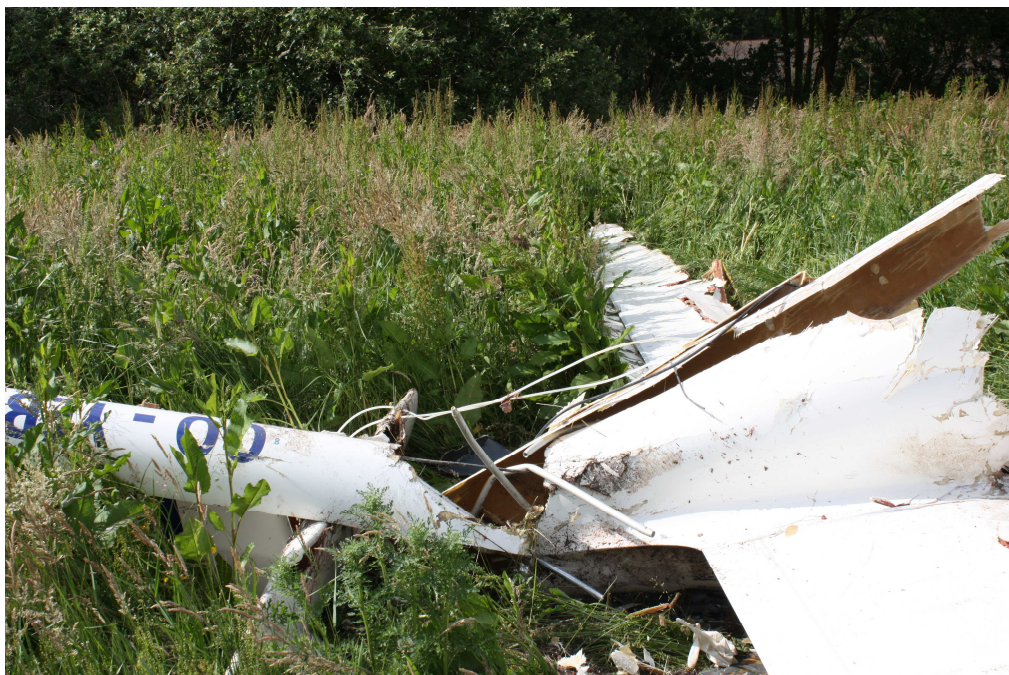
The sailplane was totally destroyed upon impact.

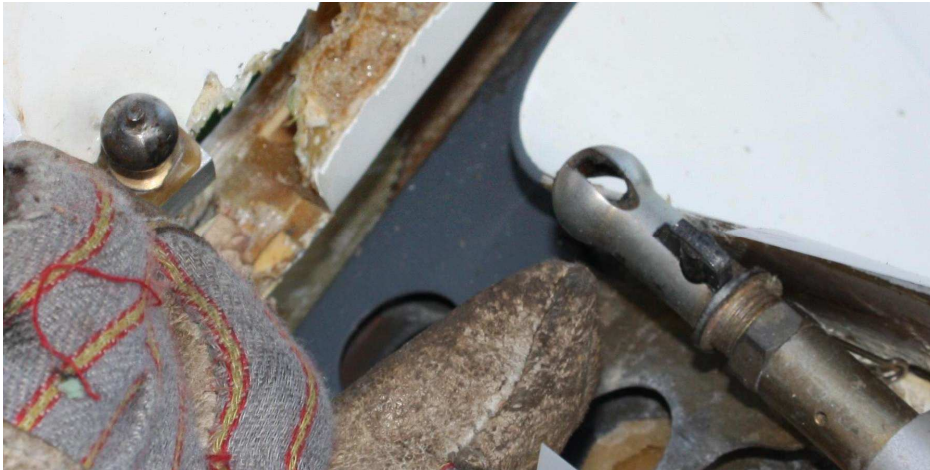
On the wreckage, the l'Hotellier couplings of the flight controls of OO-YEB were found connected at the exception of the elevator which was found separated. The safety pin of this connector was not engaged as well.

The elements of this coupling were inspected and measured, as per Instruction for the maintenance L'Hotellier Ball and swivel joints, N°10.01 Rev.E, dated 03/94. LBA AD 1993-001/3 mandates this inspection to be performed every 500 FH, or annually, whichever is the soonest.

On the wreckage, the l'Hotellier coupling of the elevator was found not connected; as the safety pin does not show any sign of damage, it is obvious that the safety pin was not installed upon sailplane assembly.

The l'Hotellier coupling itself does not show obvious sign of damage, or deformation that would be subsequent to a brutal opening at impact.

AAIU(be) recommends the Belgian Gliding Federation to issue a recommendation to all pilots, clubs and instructors to support the performance of a "positive check" after assembly of a sailplane in particular for those sailplanes equipped with l'Hotellier couplings or other non-fully automatic connections.

AAIU(be) recommends EASA to incorporate a requirement for a "positive check" after assembly of sailplanes equipped with l'Hotellier couplings, such as the ones used on OO-YEB. This requirement could be incorporated in the existing Airworthiness Directives, or in another adequate document.

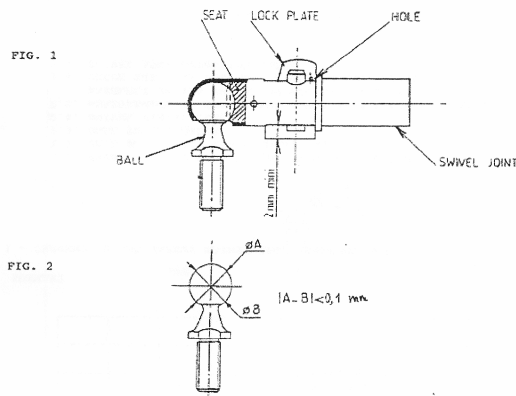
- Free movement of the ball into the housing.
 - * The ball movement is free of friction points.
 - * The angular displacement is normal.
 - * There were no crack detected at the base of the ball (visual inspection with magnifying glass 10x).
- Ball sphericity measurement.
The IA-BI measurement is < 0.01 mm, 10x better than the requirement.

- Ball thread check.
Not verified; the ball assembly is fixed into a fixture, and glued into position. The assembly is intact, with no sign of rotation.
- Swivel Visual check
There is no deformation or penning visible in the ball location or in the locking device seat.
- Measurement of the locker part projection after assembly of the swivel on the ball
The measure of the projection is 3 mm (required: 2mm)
- Check of the link between drive rod and swivel.
The swivel is secured onto the drive rod.
- Swivel assy operation check.
There was no clamping felt during operation of the seat or the locker.
- The safety pin is of the type prescribed by the AD, and its diameter is 1.2 mm

All elements were in good shape, and did not show abnormal sign of rupture. The metallic surface of the ball and inner side of the socket show no discontinuity (shiny side) as would be expected in a case of a brutal opening of the assembly.

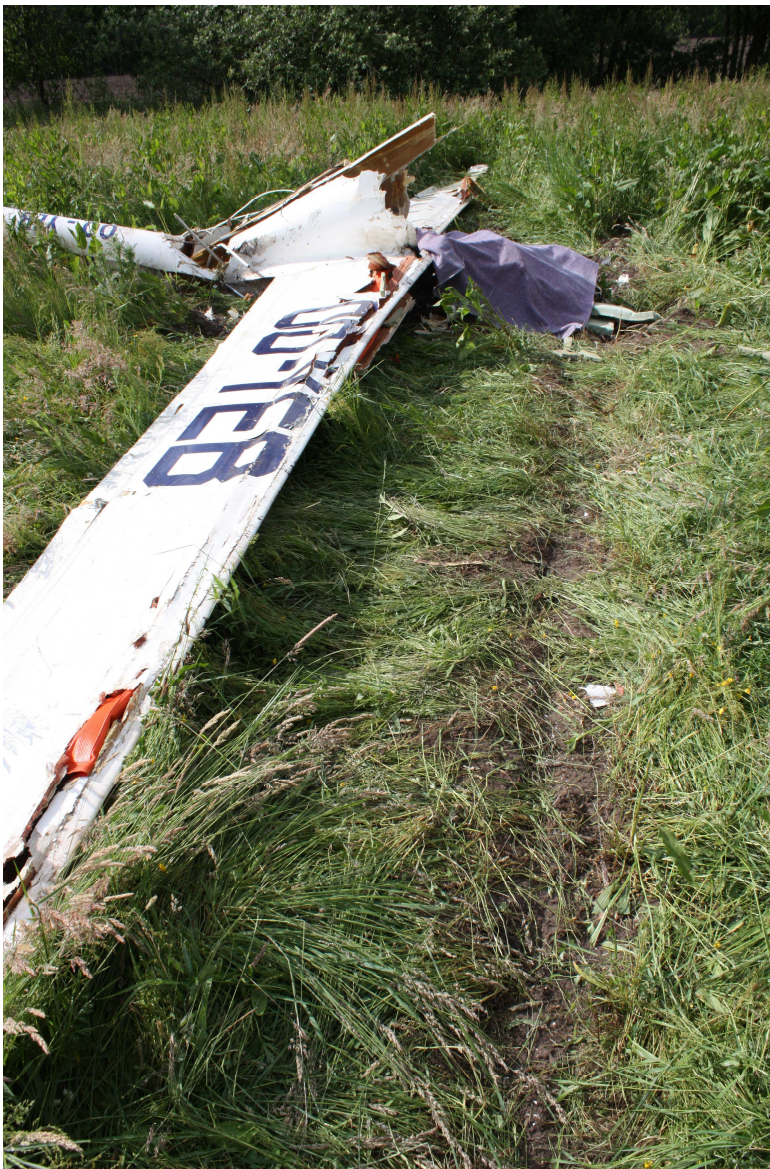
The wreckage lies inverted, at 0.50m of the impact traces. The tail section, and aft fuselage are separated.

The cockpit section is smashed.

The deformation of the wing show a near-frontal impact with the ground.
