**FINAL REPORT ON THE ACCIDENT  
TO B&F TECHNIK FK 14B POLARIS  
REGISTERED OO-G15 AT NIVELLES  
ON 25 JULY 2010**

25 July 2010 at 14:40 UTC

B&F TECHNIK FK 14B Polaris

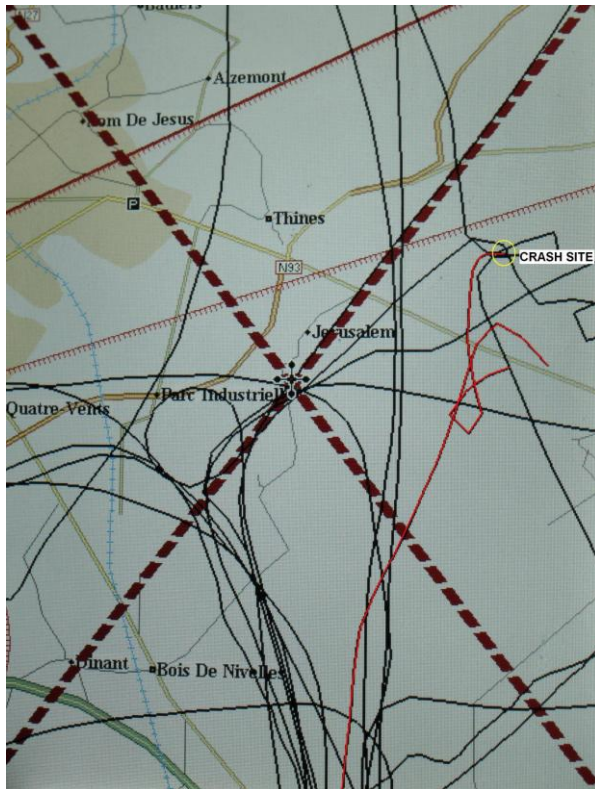
The next picture shows the last flight paths that were recorded by the GPS. The last flight of OO-G15 was colored red for the purpose of the investigation.

This GPS was set to record the geographical position of the airplane every five seconds.

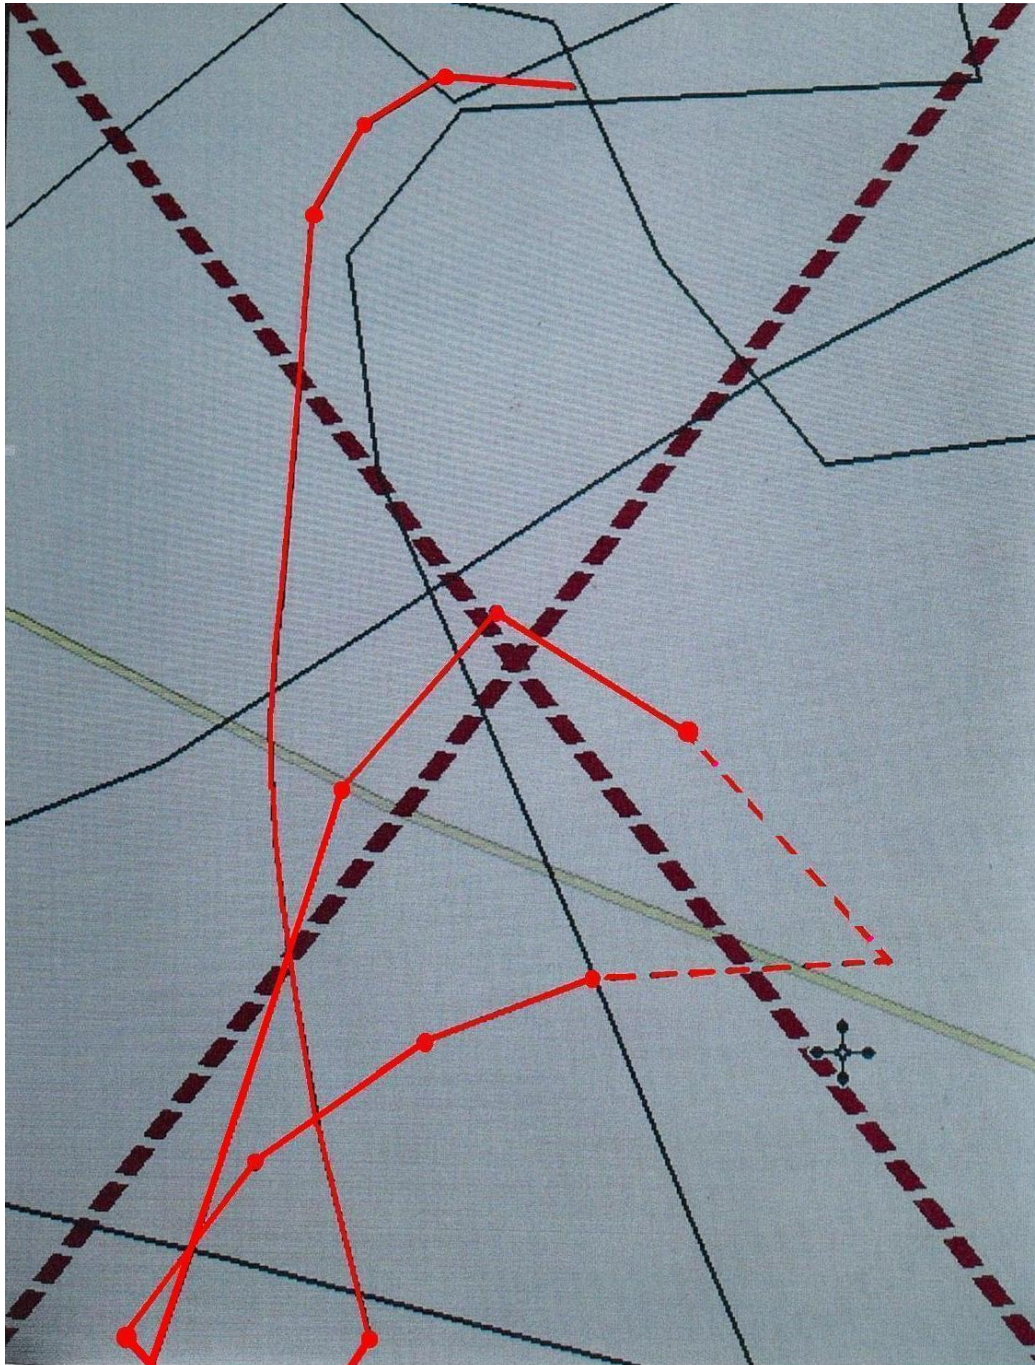
The geographical position of the wreckage which was N50° 35.625' E04° 23.751' corresponds with the end of the red path on the GPS.

There was a loss of satellite reception of the GPS during the first turn to the right. This is shown on the picture by a dashed red line.

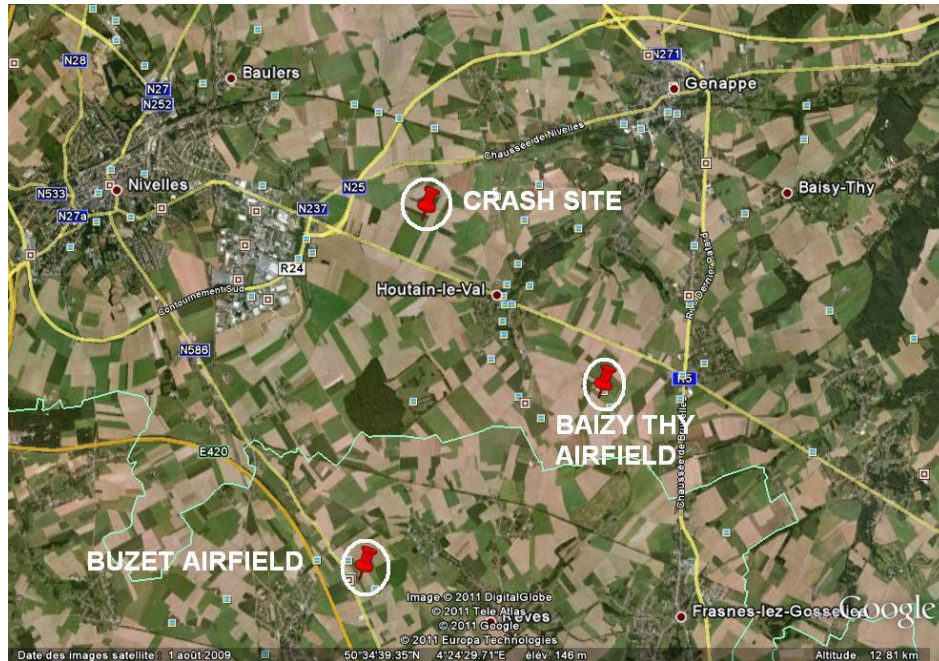
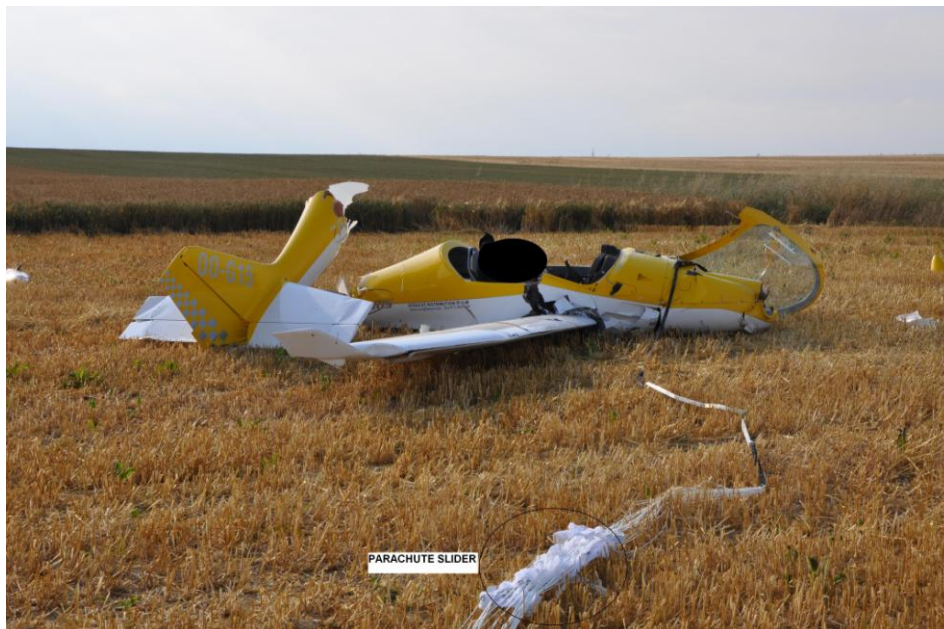
The airplane impacted a reaped cornfield 5,8 kilometres north of the departure airfield of Buzet.

Due to the very dry and hard ground, practically no trace of impact was found.

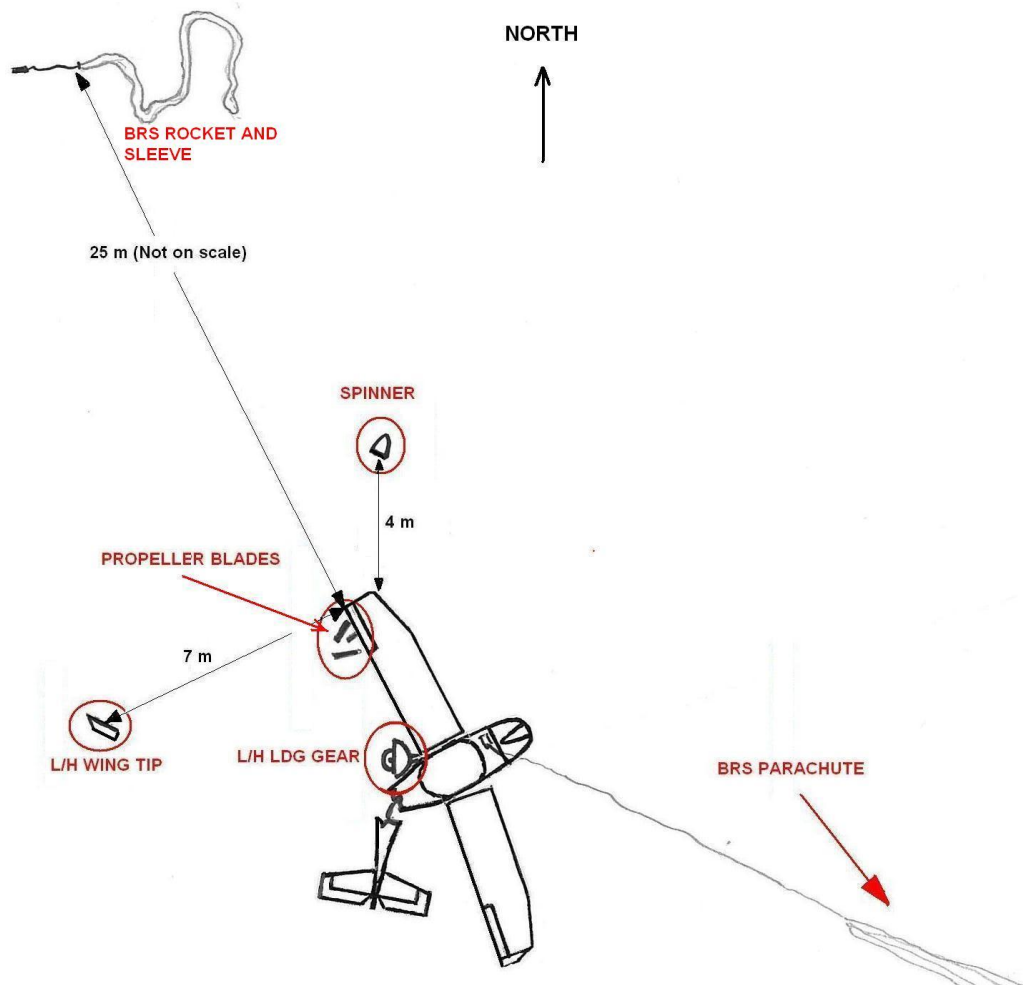
The fuselage was orientated with the nose looking towards the northeast (70°) and the wings leading edges were orientated NW/SE.

The airplane wreckage was found complete but the tail was separated from the fuselage except that the elevator connecting rod and the two rudder cables were still connected to the fuselage.

The left hand wing tip was found about 7 m to the rear and left side of the fuselage. The propeller spinner was found at 4 m from the L/H wing.

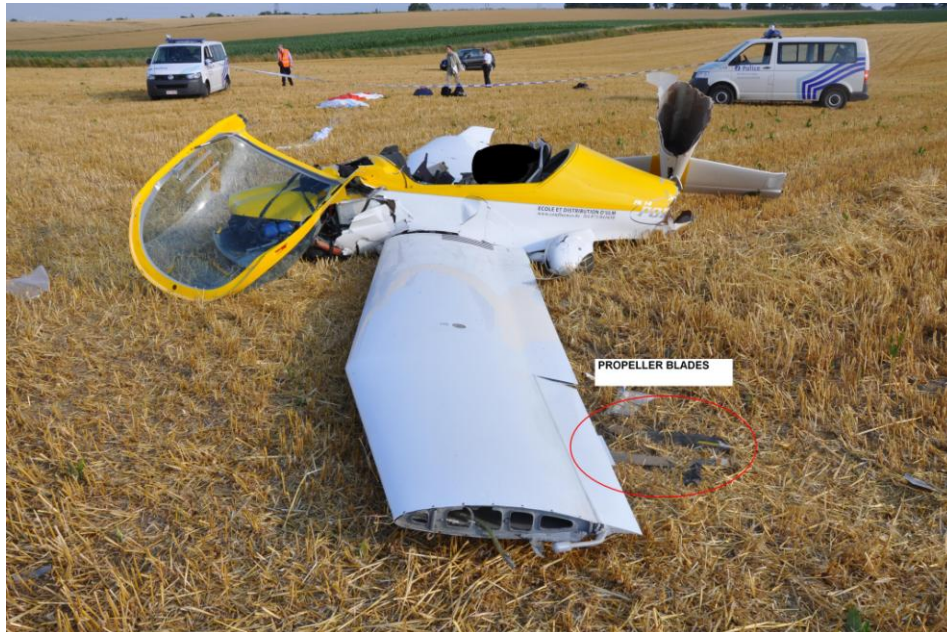
The two vertical sides of the fuselage were broken above the wings

The R/H wing was more damaged than the L/H wing.

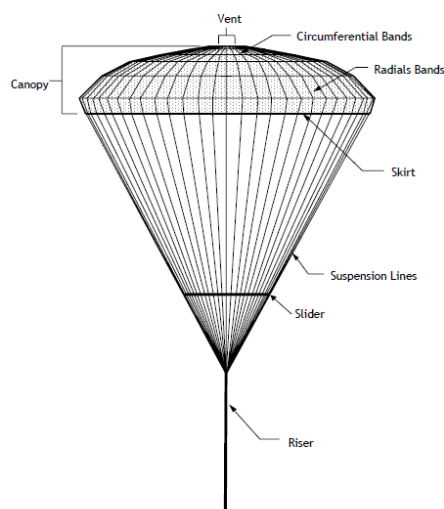
The B.R.S. activating red handle was pulled out and its safety pin was found lying on the fuselage floor under the handle and between the legs of the pilot.

The safety pin being found on the fuselage floor could mean that it was still engaged in flight. However this couldn’t be confirmed.

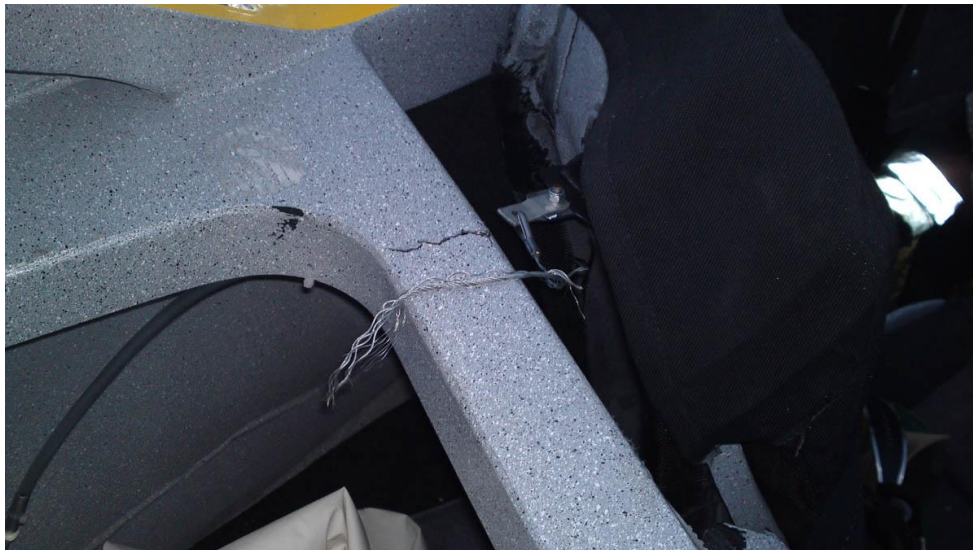
The steel cables connecting the shoulder harness to the structure of the fuselage were found broken (2,5 mm diameter cables).

The rupture was due to the force of the pilot's upper body inertia.

The 2,5 mm diameter cables connecting each shoulder harness to the structure of the fuselage were found broken by the impact force of the accident.

AAIU(be) recommends the manufacturer B&F TECHNIK install stronger cables to connect the shoulder harnesses to the structure of the airplane.

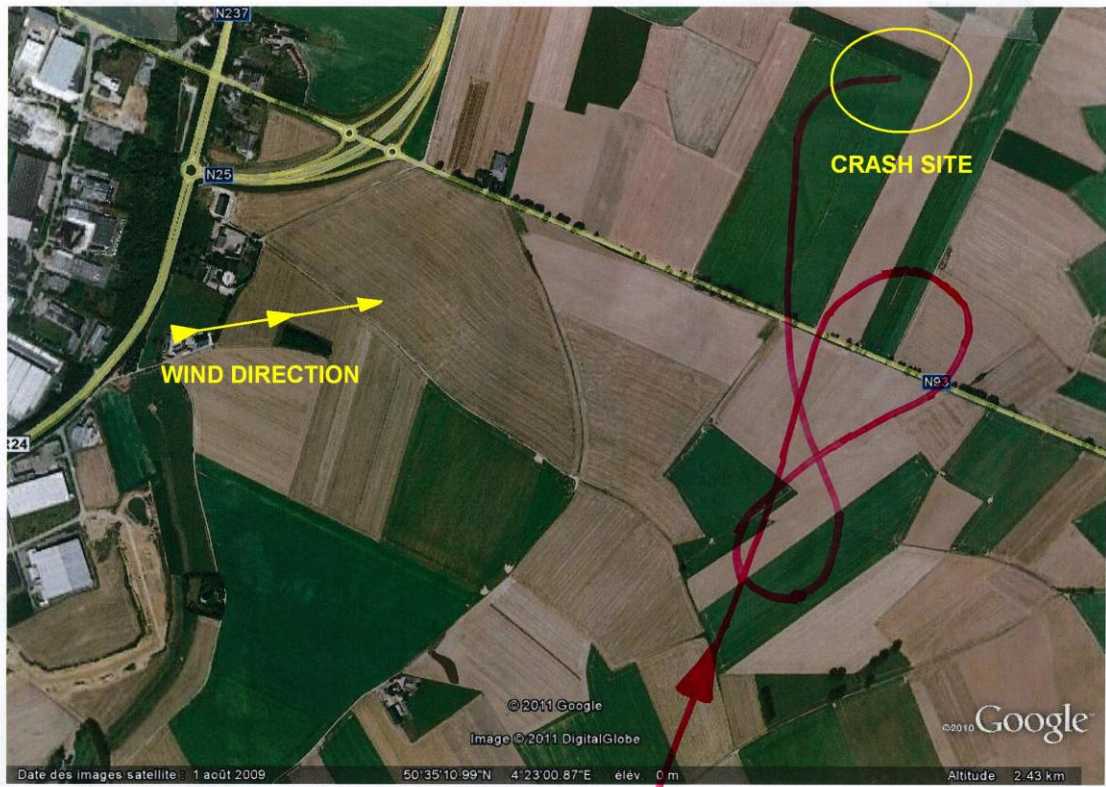
Based on the GPS data, the last flight path has reconstructed and has been red coloured on the following Google Earth picture.

The airplane came from Buzet airfield and made first a right hand turn followed by a left hand turn.

These two turns were probably the “unconventional manoeuvres” reported a few days after the accident by a witness.
