Safety Investigation Report

ACCIDENT TO CESSNA F152 AT LOMMEL ON 09 JUNE 2011

AAIU-2011-17

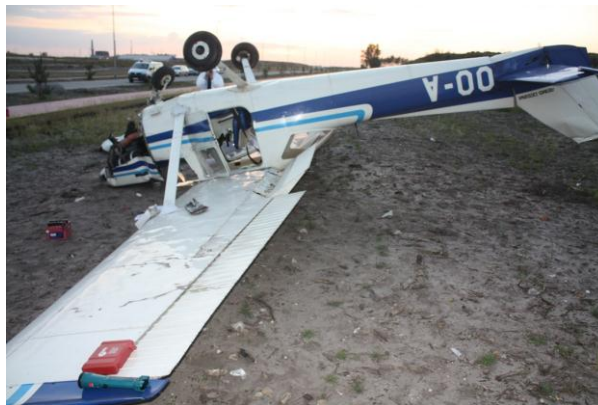
Figure 3

The aircraft was damaged beyond repair

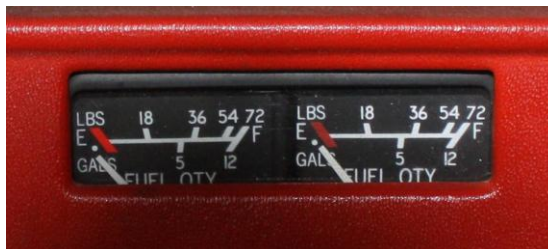
Figure 8: Zoom on the Rochester Fuel Quantity Indicators

- As the quantity indicators are of the moving magnetic type, they can be influenced by external magnetic field changing the magnetic orientation of both the moving and the permanent return magnet;
- As the floats are installed in the forward part of the tanks and the fuel surface aligns with the gravity, they only give a correct value when the airplane is level;
- Mechanical damage to the float arm (bending) may lead to incorrect readings
- The gauges need (periodic) calibration

- Not performing a completely pre-flight inspection leading to an inadequate evaluation of the fuel on board.
- Fuel quantity indicators notoriously unreliable.

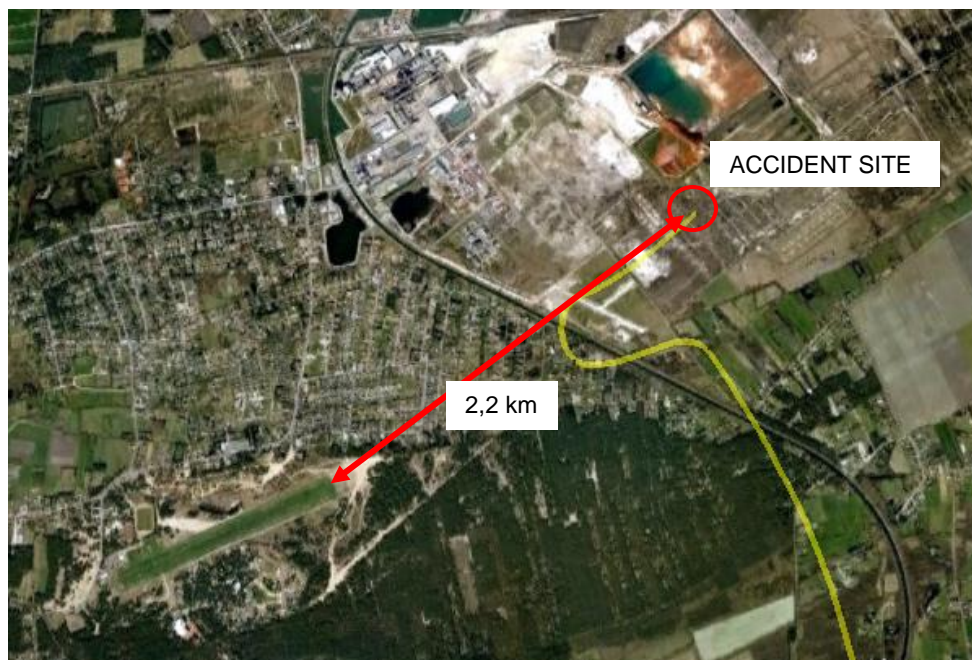
Figure 14: Accident site

The aircraft crashed in a derelict field in the industrial area 'Balendijk' of Lommel (N 051° 11.715' - E 005° 15.263') approx 2,2 km from the threshold of RWY 25 of EBKH.

It first touched the ground on a field, just before a road that was surrounded by 2 ditches the pilots first didn't notice. During this manoeuvre, the nose landing gear probably suffered some damage by hitting this ditch. The aircraft was slightly pulled up again to cross the road but upon entering the second ditch, the nose landing gear broke. The engine ploughed into the ground and the plane flipped over.

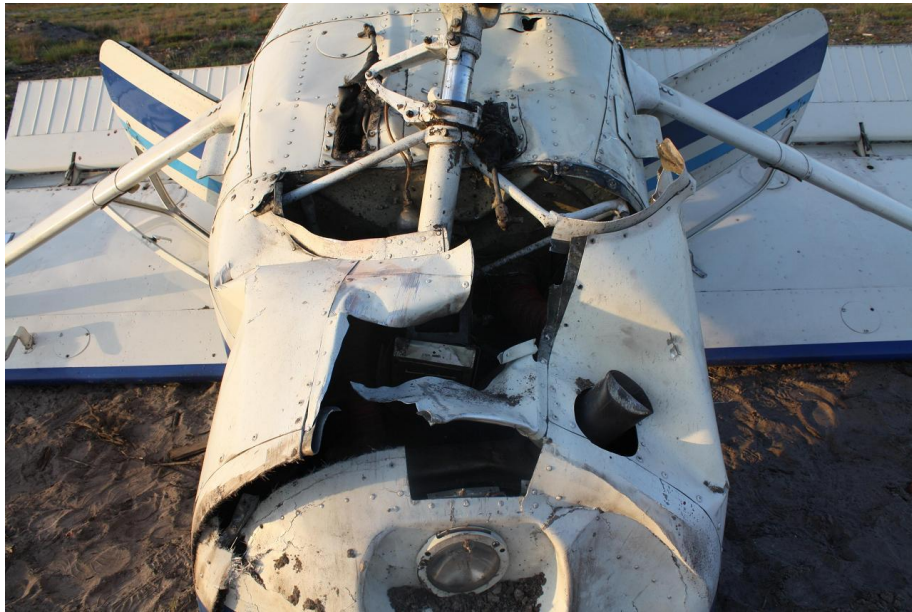
The nose landing gear was broken by impact causing severe damage to the engine compartment with broken carburettor and fuel lines.

The windshield was exploded, the tail crushed and left wing twisted.

Figure 16: Wreckage with view on broken nose landing gear strut.

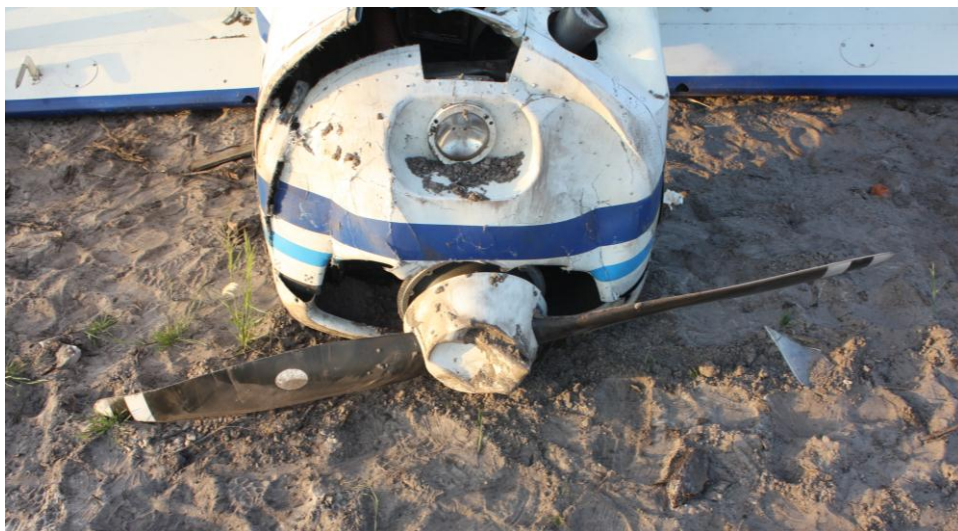
The propeller blades were only slightly damaged, confirming that the engine delivered no power during impact.

Figure 17: Propeller blades slightly damaged

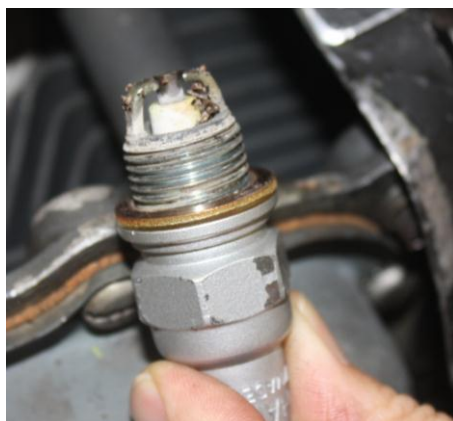
Per cylinder a spark plug was removed. All 8 spark plugs were replaced during the 200hr maintenance prior to the accident flight. On two plugs, traces of combustion deposit were found. On one of them this was severe deposit of carbon/lead residue. A mechanic said that this could be due to deposit still present on the inside of the cylinder head, not removed during the maintenance.

Figure 18: Spark plug with combustion deposit

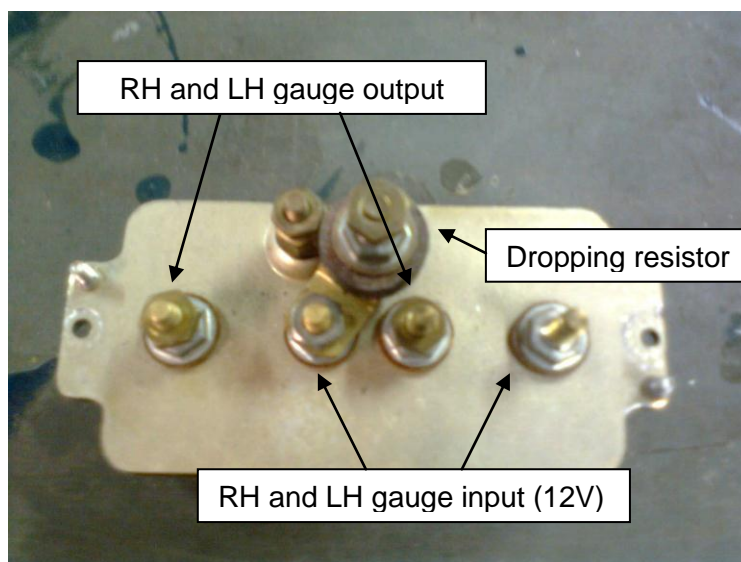
Figure 19: Backplate of fuel gauge

The fuel quantity indicators were removed from the aircraft to inspect their working. During the removal it was found that a dropping resistor was installed on both gauge inputs, although it had to be discarded as per SEB91-7 Revision 1 (see paragraph 1.6.9).

The fuel gauges were tested with and without the dropping resistors installed. In both cases, the deflection of the needle was the same with the same voltage applied. Only when placing the dropping resistors on the gauge outputs, the deflection was different. The pointer always indicated the maximum, independent of the applied voltage.

The backplate was replaced by an aluminum one. However one cannot exclude that other metal parts didn't induce the same phenomenon.

AAIU (Be) recommends Aeroclub Keiheuvel to provide itself with a calibrated dip stick for each type of aircraft to visually check the fuel level and to teach at student pilots and encourage all club members the use of it.

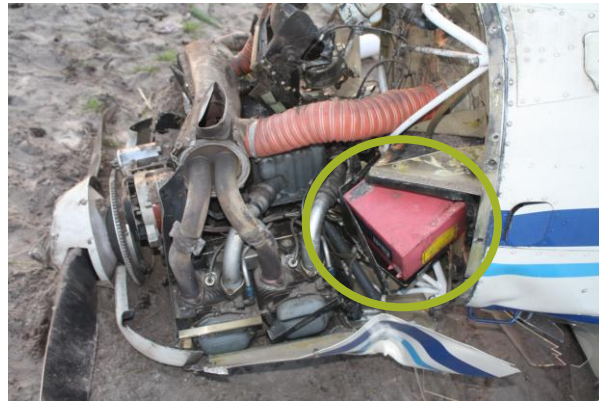
The aircraft's battery was fitted in a box mounted on the right forward side of the firewall. Due to the crash landing, leading to the aircraft to flip over, this box was separated from the firewall and its cover opened. Because the battery was upside down, acid was leaking when rescue workers and accident investigators arrived at the scene. This situation contained 2 risks:

- establishment of a short-circuit leading to a fire
- causing burn marks to people

Figure 20: Loose battery
