Safety Investigation Report (Interim Report)

ACCIDENT TO THE BOEING B737-45D REGISTERED SP-LLB IN EBBR ON 26 MAY 2011

Ref. AAIU-2011-16-EBBR-SP-LLB
Issue date: 25 May 2013
Status: Interim

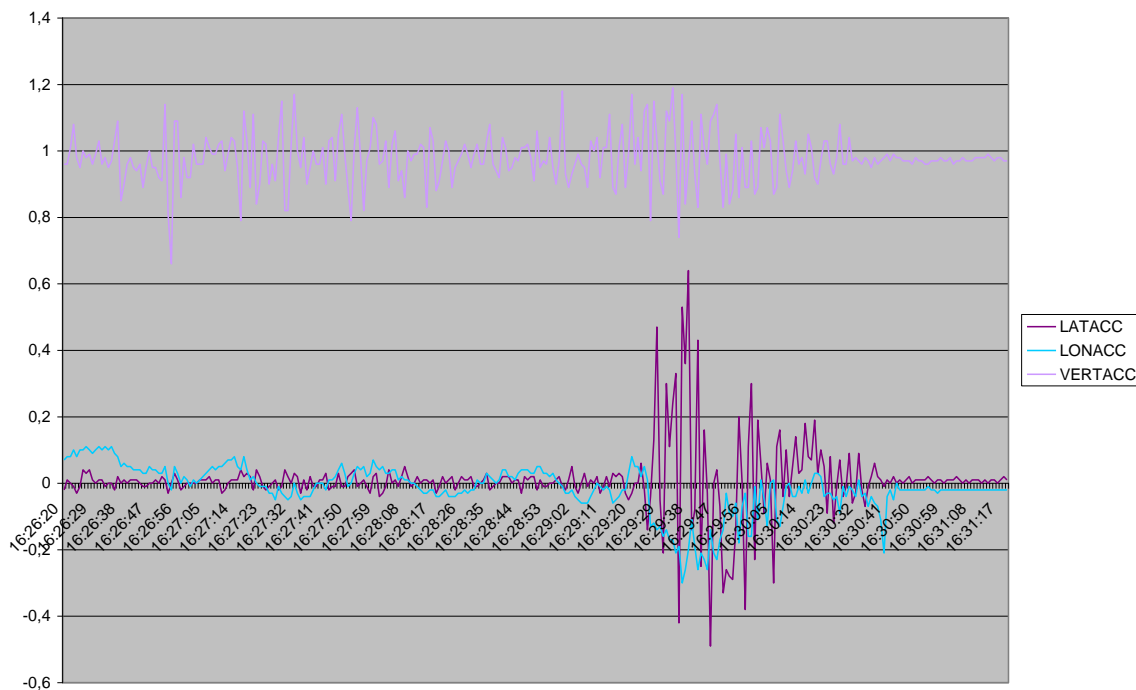
The record shows severe lateral acceleration, up to 0.6 G, from touch-down and decreasing with the ground speed.

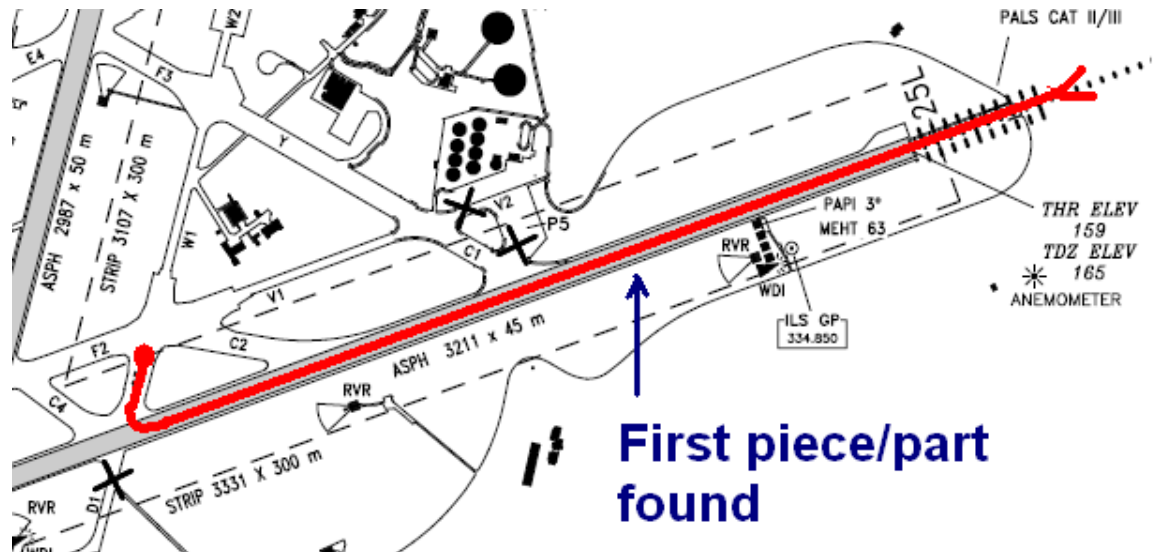
The airplane exited via C3 and stopped at the stop bar.
Most piece / parts that fell on the runway were found near C3 exit.

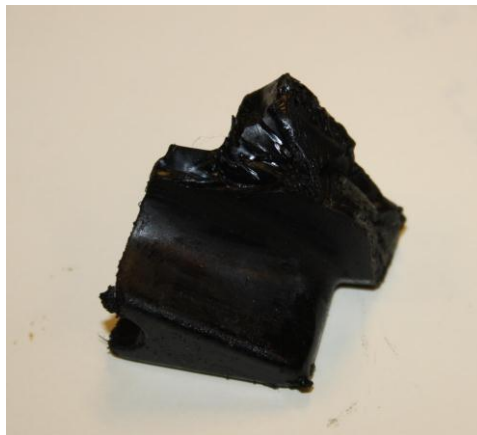
A black plastic part (from the fixture retaining the hydraulic hose) was found near the threshold.

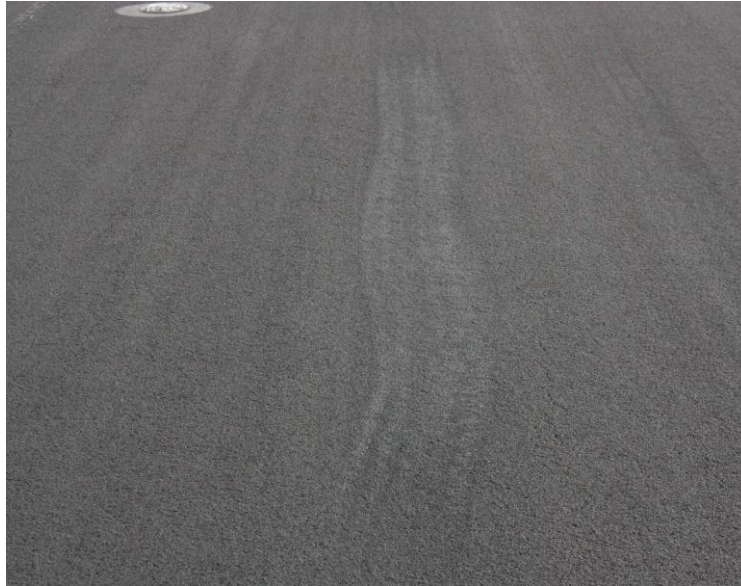
The traces left on the runway confirm a zig-zag of the RH MLG tyres, and are visible from the threshold on.

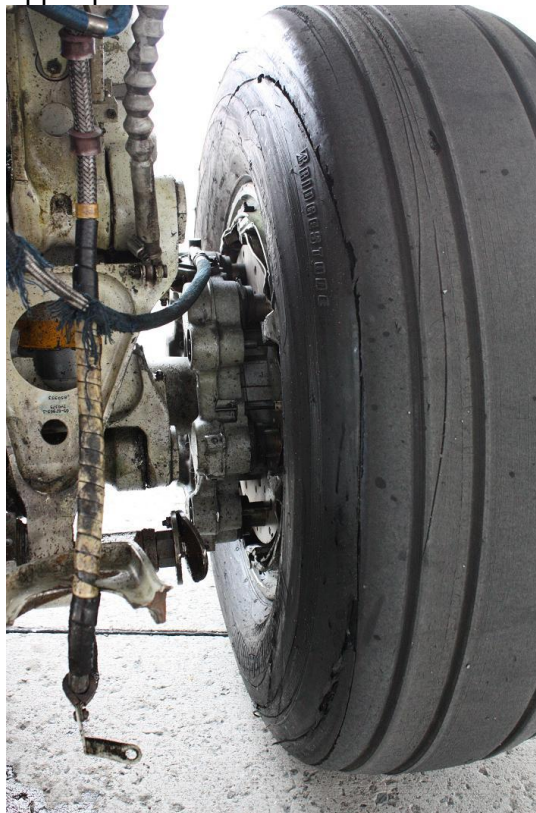
The damage to the tyre and wheel flange seem consistent with contacts between tyres / flange and the upper part of the lower torsion link.

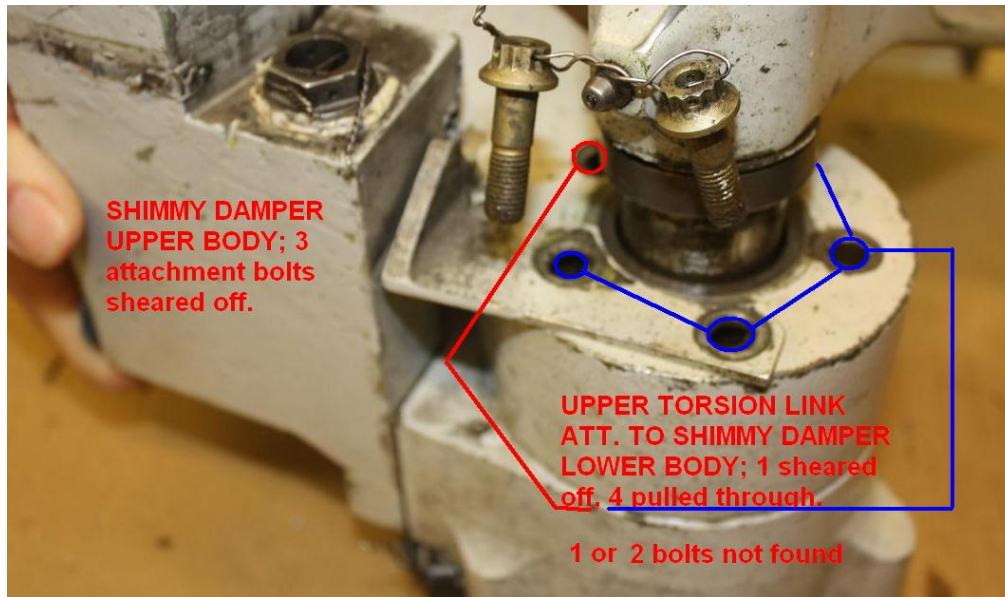
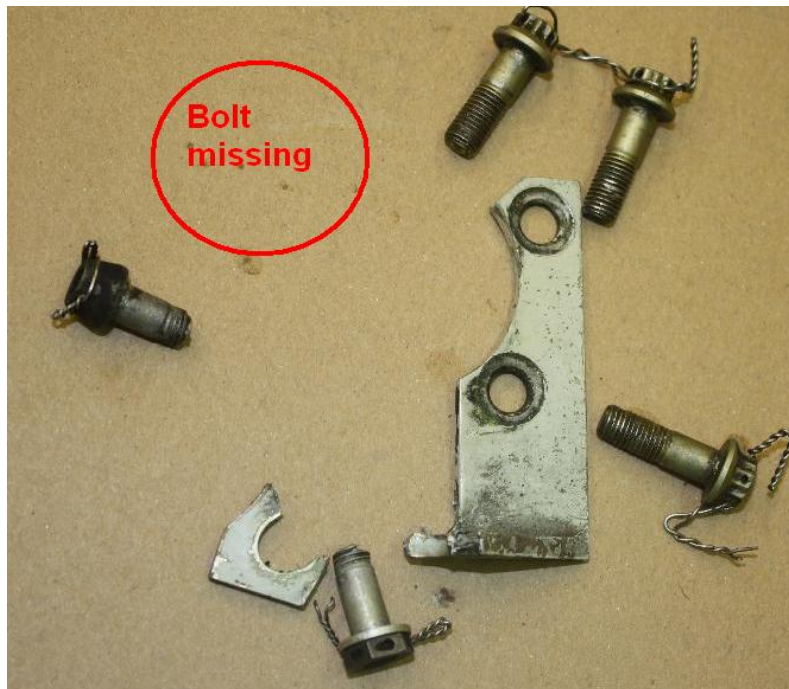
The shimmy damper upper body (manifold casing) was found separated from the lower body.

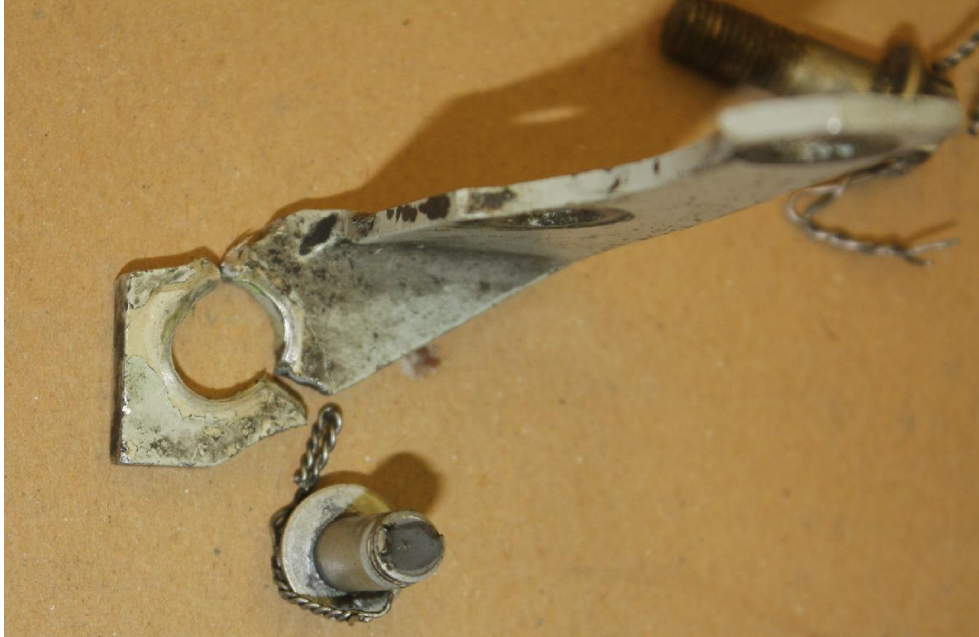
The attachment bracket was broken, showing deformation.

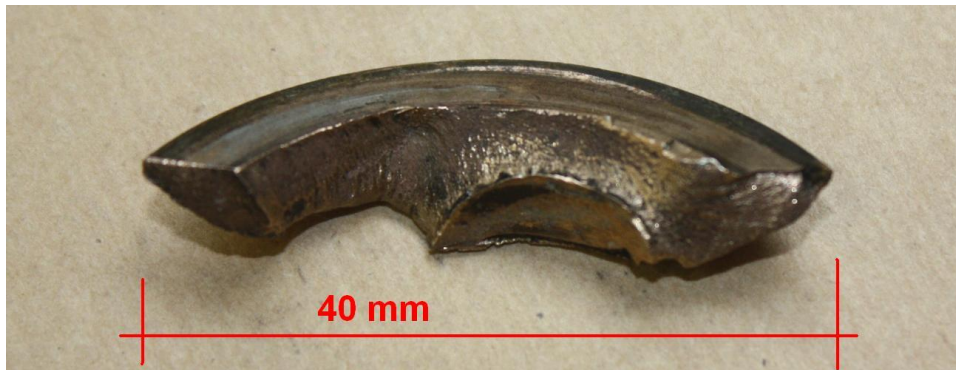
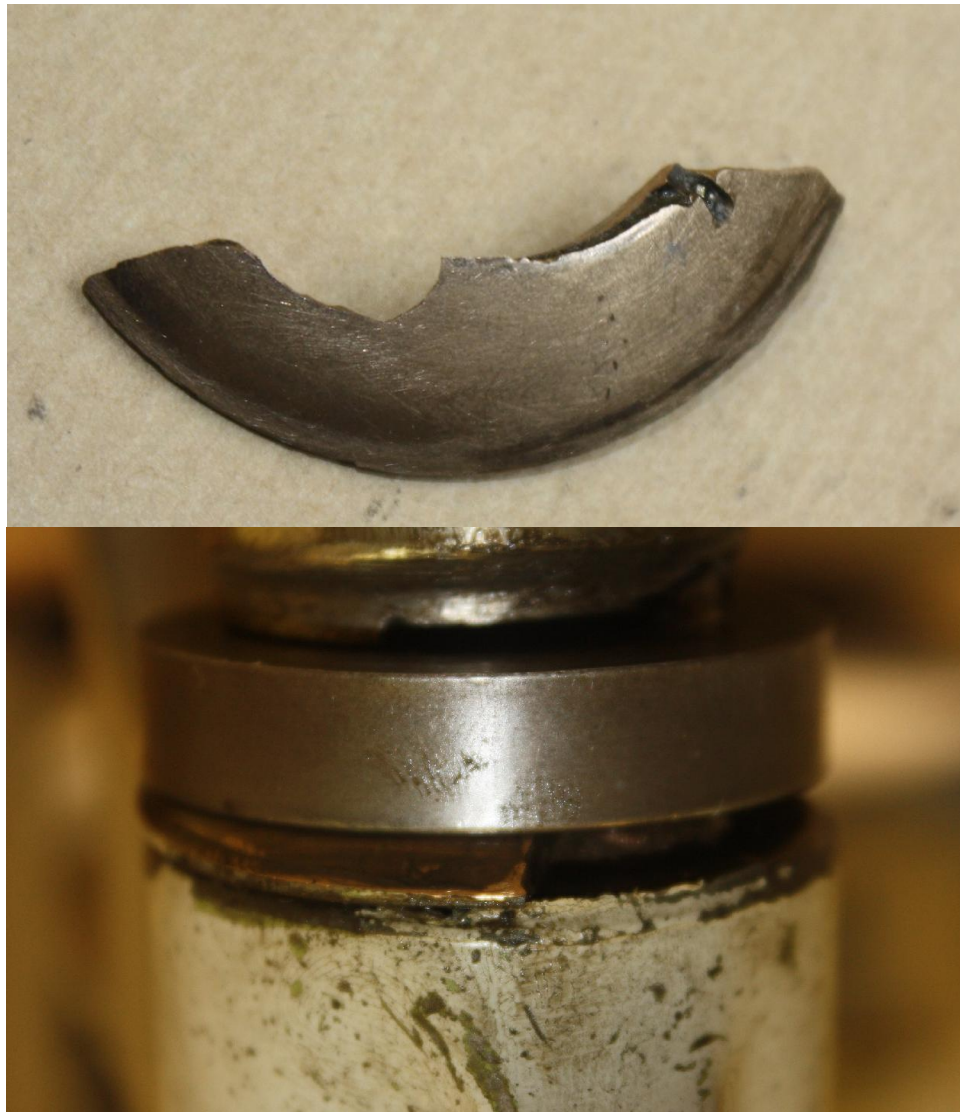
One bushing of the bearing assembly connecting the lower torsion link to the damper piston was found broken.

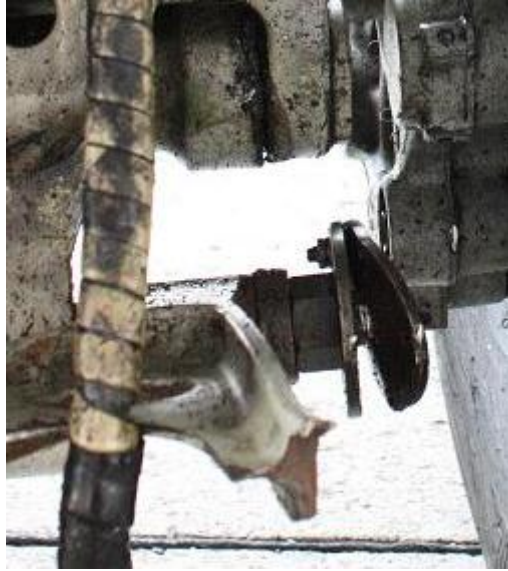
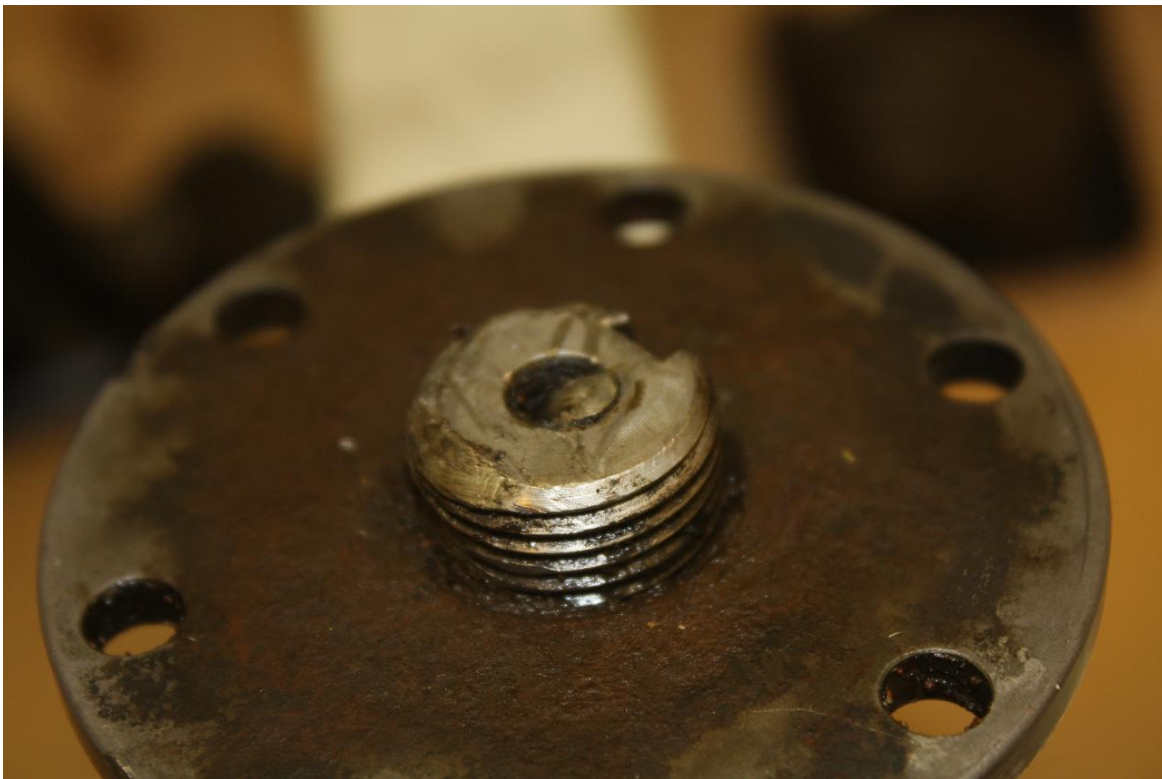
The damper check nut was not found, however, this part of the shimmy damper took a lot of beating from contact with the wheel.

The nut was (most probably) unscrewed in an attempt to open the shimmy damper.

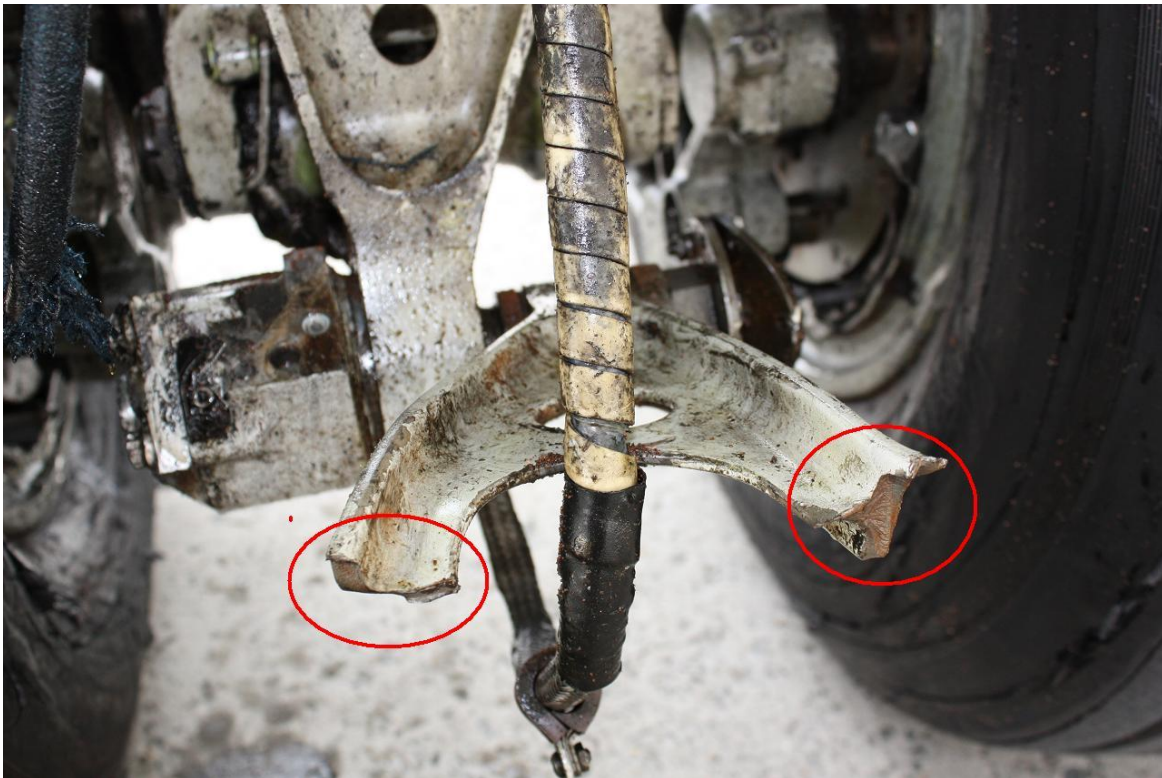
The lower torsion link of the RH MLG was found broken mid-way along its length.

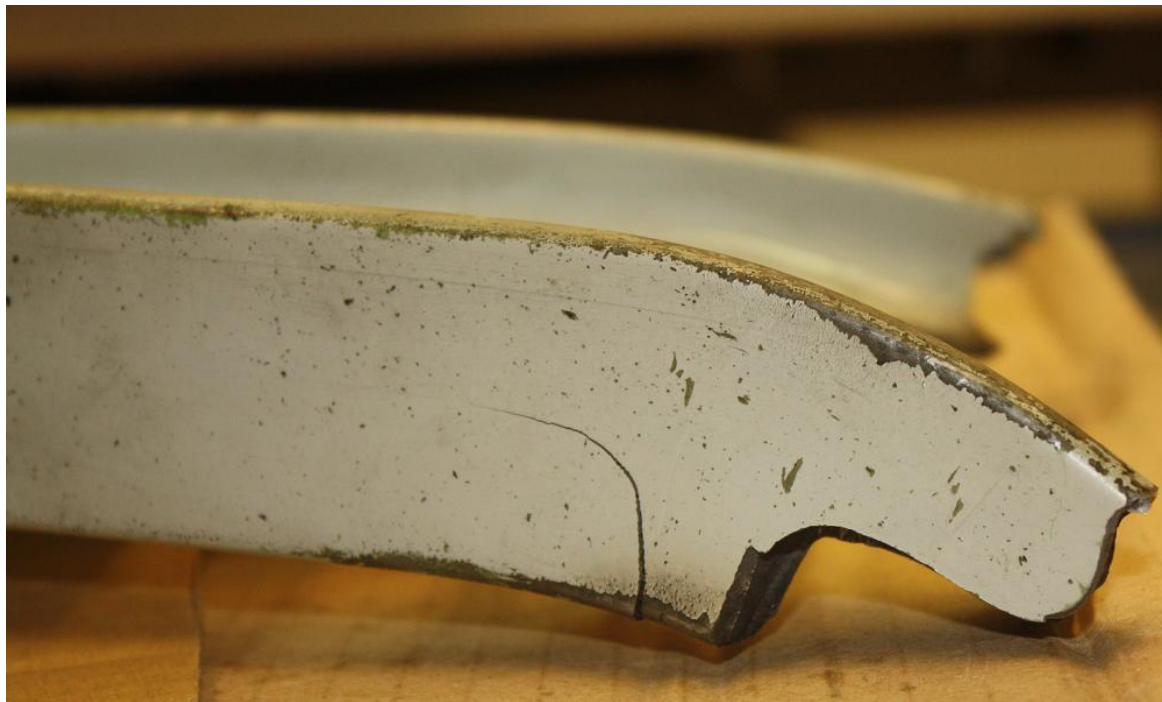
The lower torsion link is bent downward,

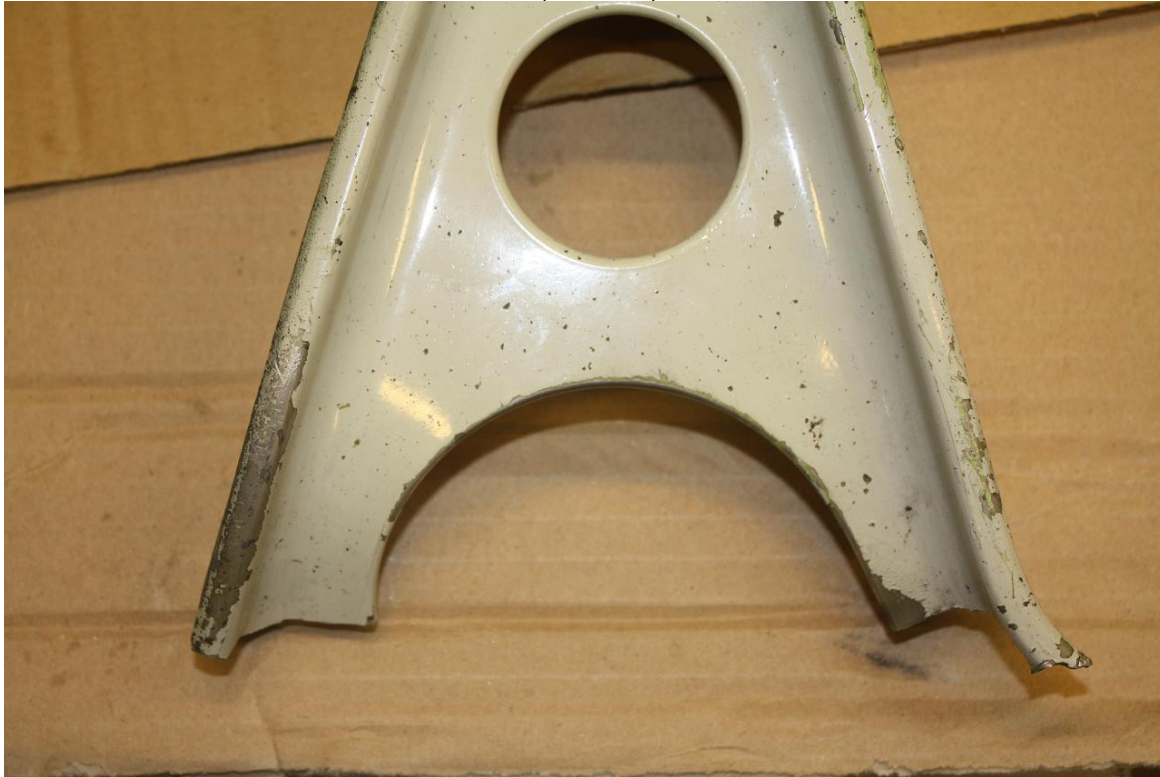
And one branch is bent to the left (outward):

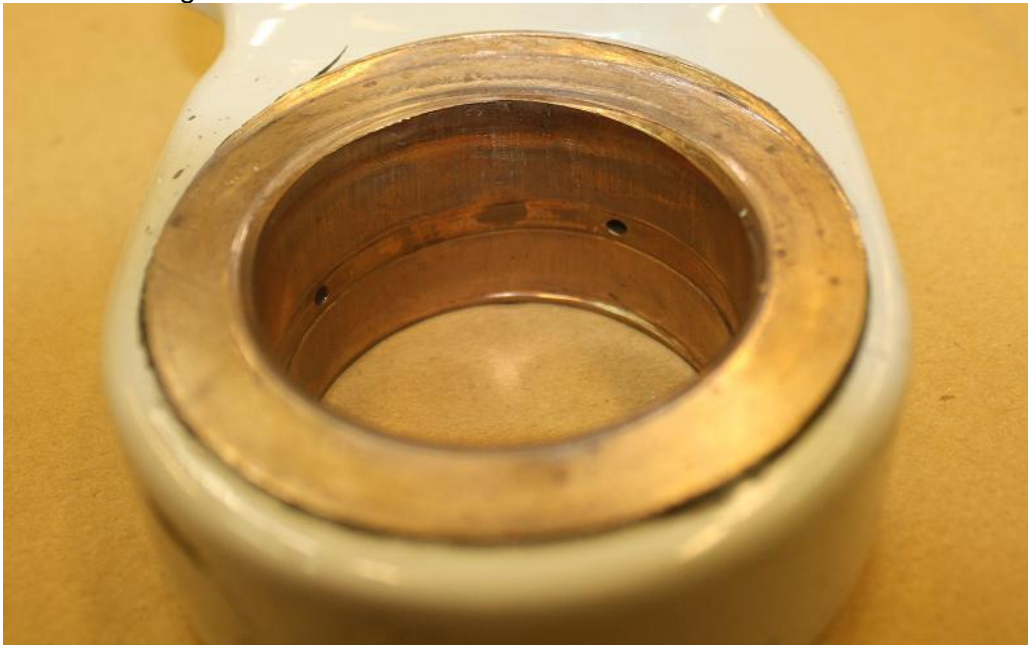
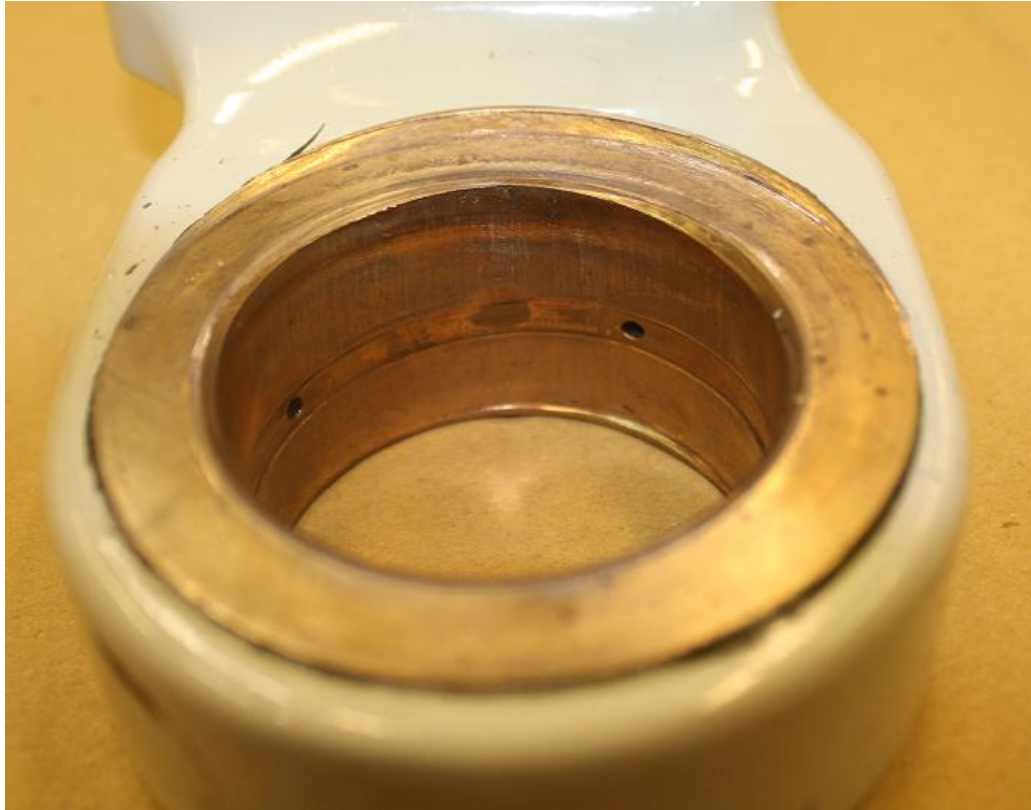
Both bronze lugs of the lower torsion links showed similar deformation:
