## Safety Investigation Report

# ACCIDENT TO THE BEECHCRAFT C24R REGISTERED OO-E\*\* IN EBZW ON 21 APRIL 2011

Ref. AAIU-2011-8-EBZW  
Issue date: 14 August 2012  
Status: Final

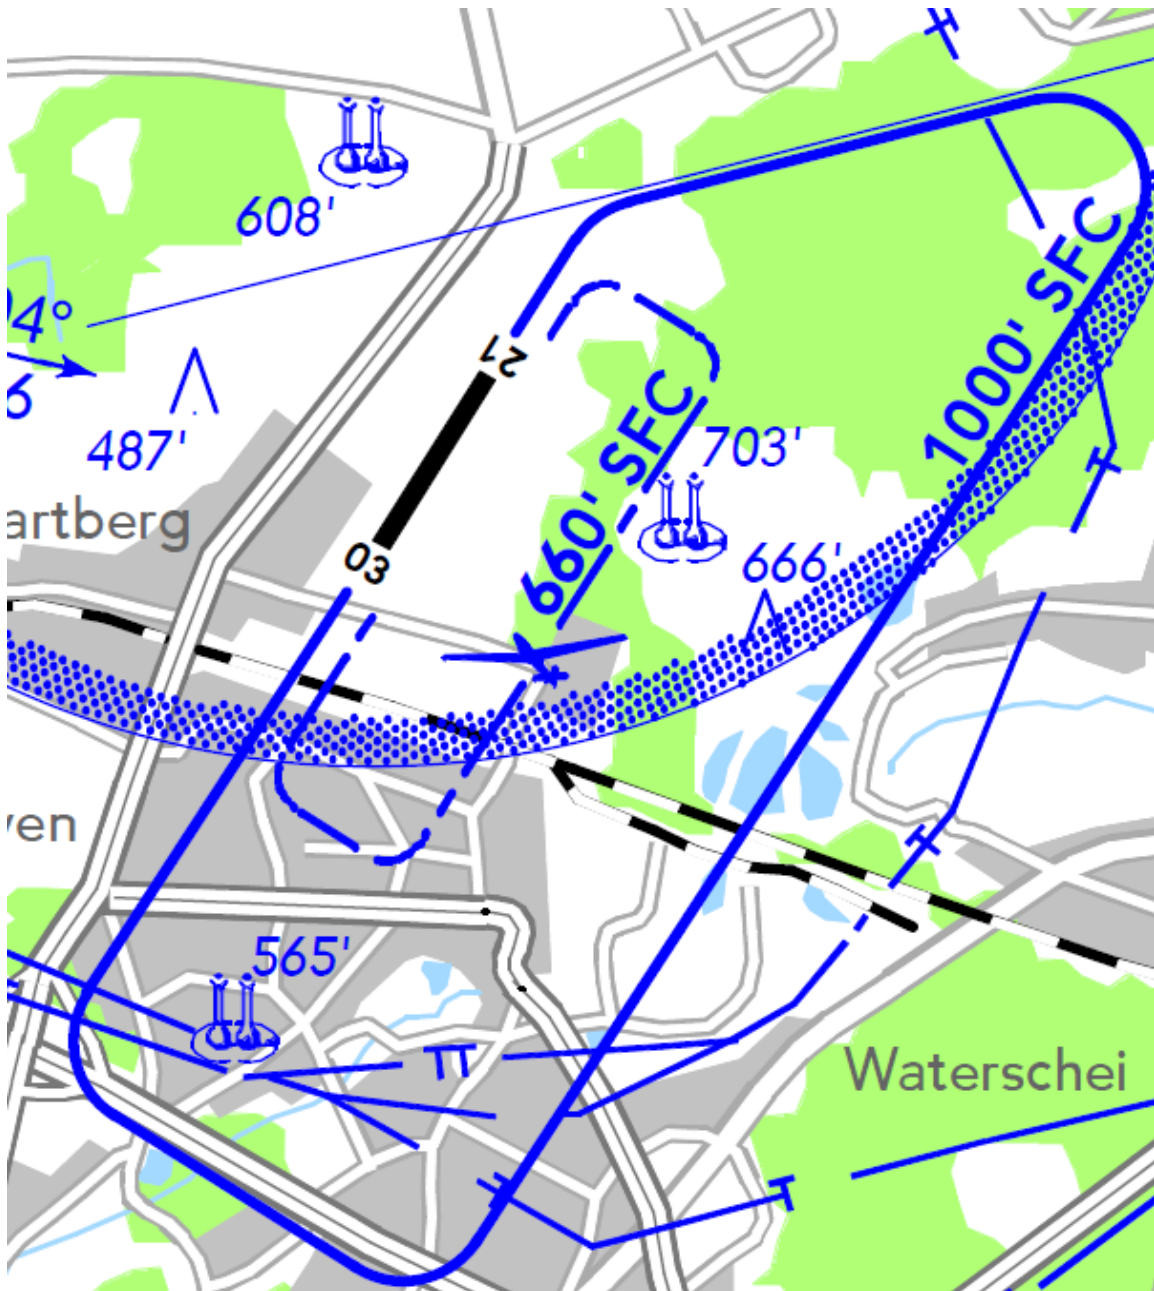
Fig.2: EBZW airfield pattern

The pattern of the airfield is as depicted in Fig.2, and features limitations due to the proximity of a military zone to the North, and noise abatement rules.

- The presence of the coal mine spoil tip in the pattern path,
- The presence of a tree line crossing the final approach path (though clear of the approach path),
- The lay-out of the pattern itself,
- The inexperience of the pilot in landing on short(er) airfield (than those he was used to).

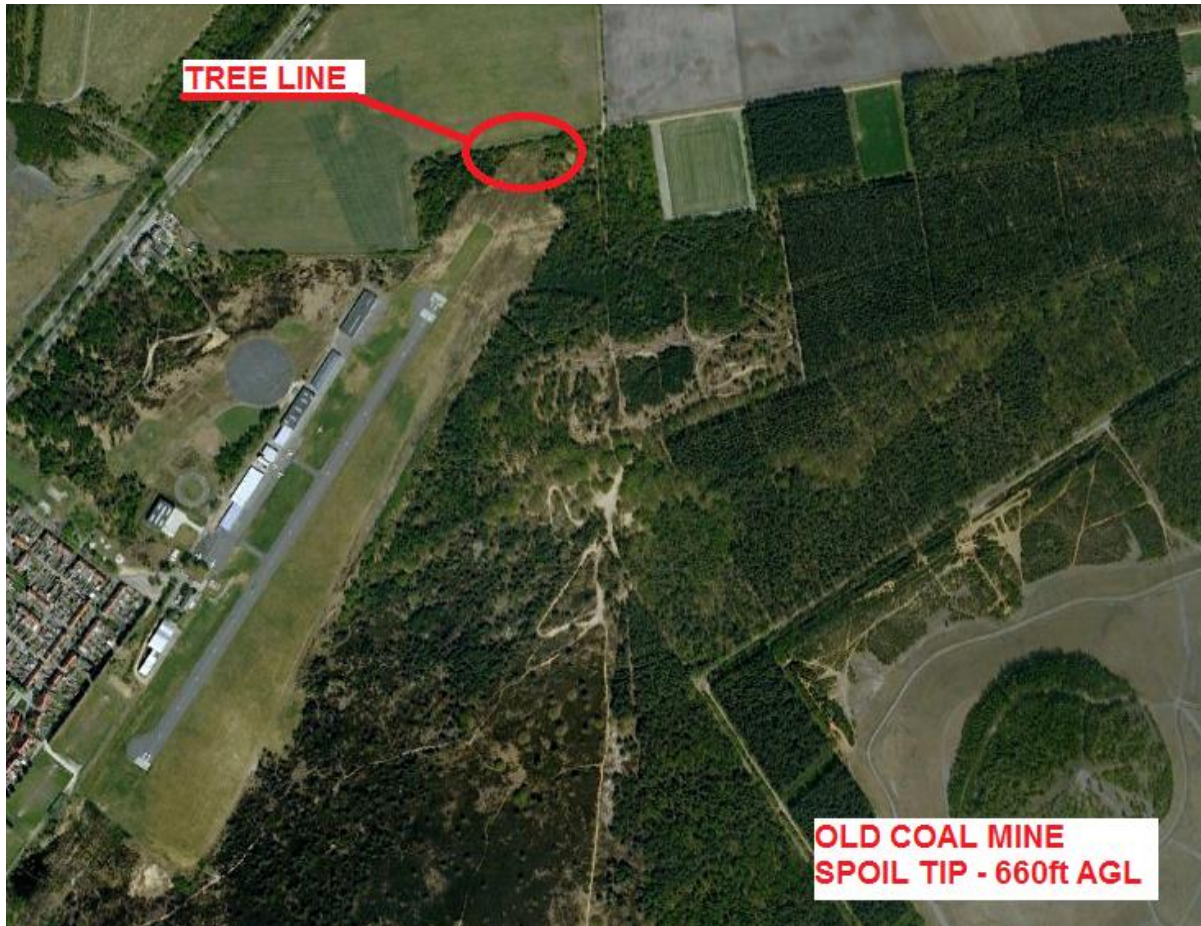
Fig.3 Geography around EBZW Airfield

Genk is a former coal mining region, and there is a coal mine spoil tip remaining from these times, located East of the airfield at 1.15km from the runway, close to the pattern. The spoil tip culminates at 666 ft AGL.

The runway is bordered by trees, and there is a thin line of trees in the axis of Runway 21, at 300 m from the threshold (see fig. 3).

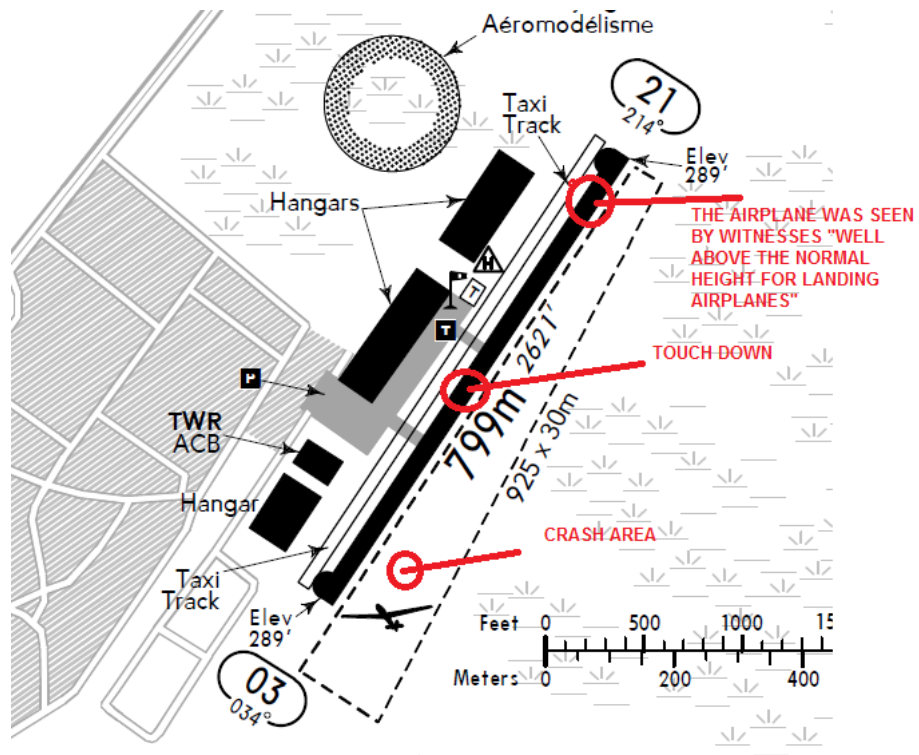
Fig.5 Crash area

The left wing touched the ground first, then the nose in a cartwheel movement. The airplane came to a stop 41 m from the border of the runway. The wreckage general direction was 240°.

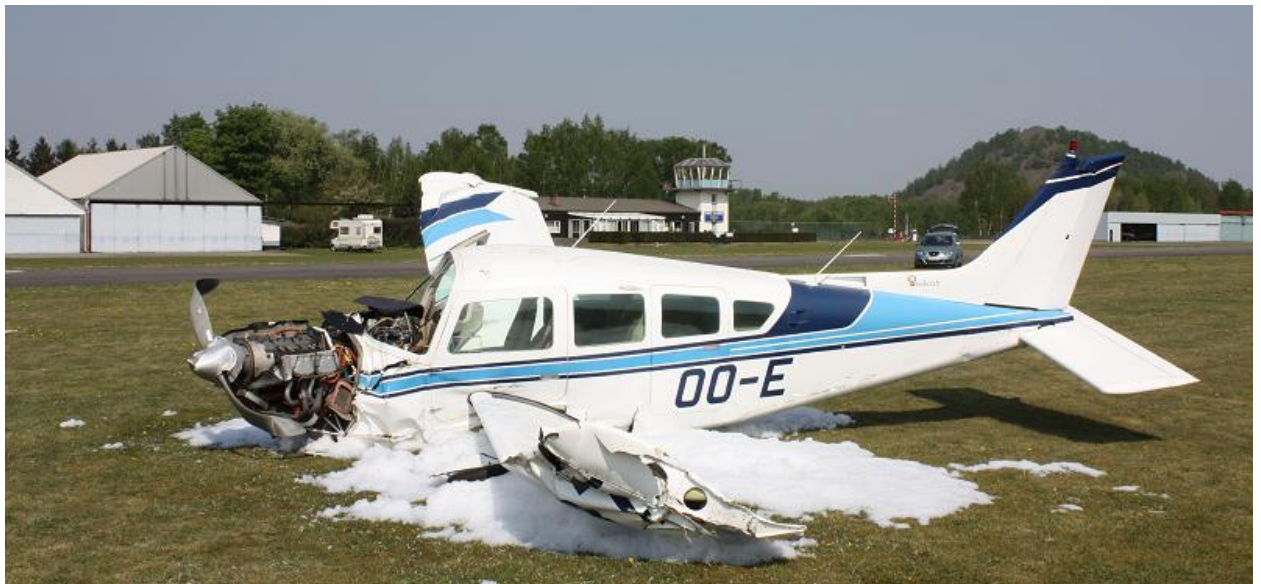
Fig.6 : The wreckage

The airplane sustained heavy damage to both wings and the fuselage.

The left wing stalled and impacted the ground.

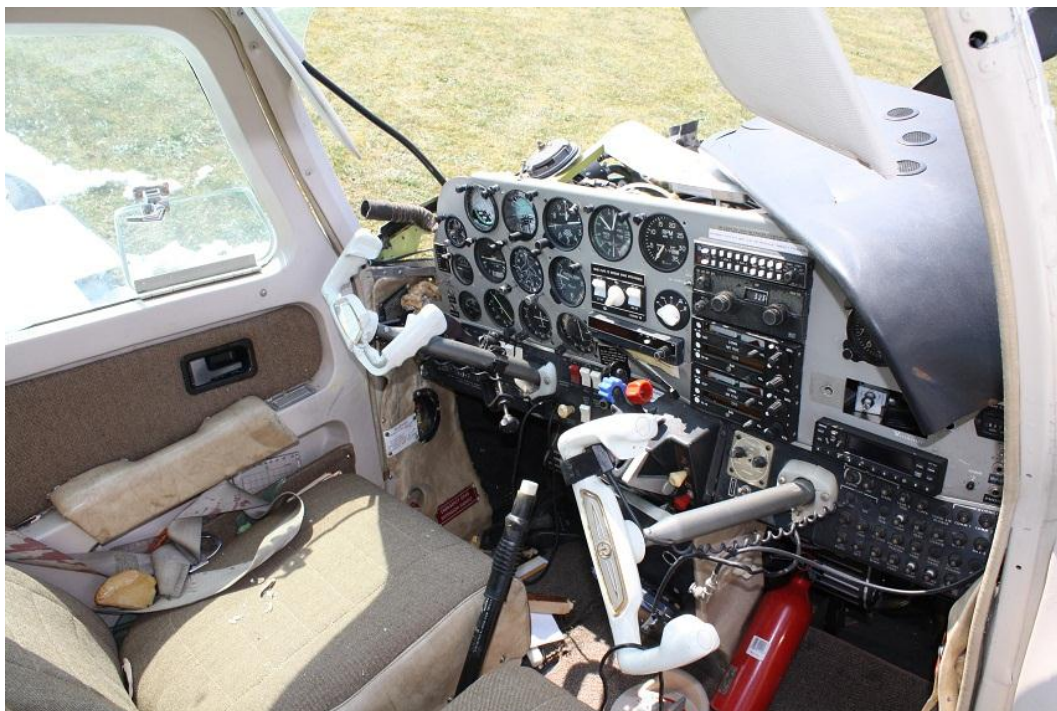
Fig. 8: Controls

- Throttle: full forward
- Mixture: rich
- Propeller: High pitch
- Flaps: fully extended (landing position)
- Landing Gear: extended

The wreckage was found with the flaps in landing configuration (flaps fully extended); the engine controls were fully forward. In this configuration, with a low airspeed, the airplane is indeed very sensitive to the torque of the engine, that would made the aircraft to roll counterclockwise, pushing the left wing down and subject to the important drag generated by the flaps.

In this case, it would require increasing the engine power, applying right rudder to counteract the engine torque and progressively retract the flaps to the Take-off position.
