Safety Investigation Report

Ref. AAIU-2012-25

Classification: Accident
Level of investigation: Standard
Date and hour: 11 November 2012 at 14:00 UTC
Aircraft: Rockwell Commander 112 SN 196. The aircraft was registered in Belgium and held a Certificate of Airworthiness and a valid Airworthiness Review Certificate (ARC)
Total flight time: 3347:57 FH
Accident location: Off EBTN airfield
Type of flight: Cross-country
Persons on board: The pilot was on board alone. **Phase:** Landing
Injuries: None

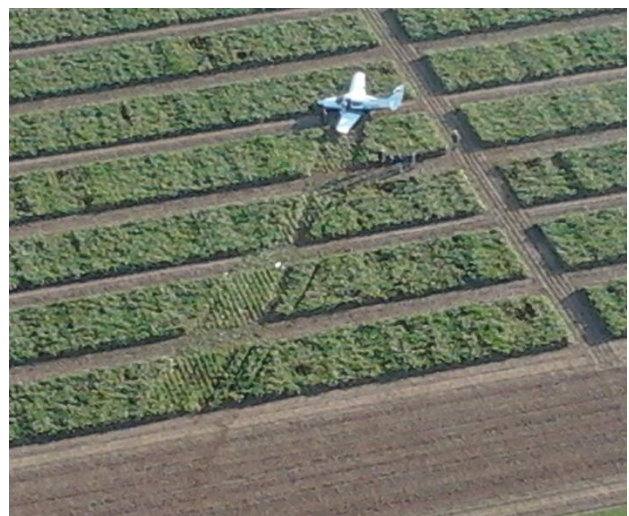
Figure 2: Airplane after the forced landing

The airplane sustained heavy damage to the LH wing, the fuselage and the propeller. The forced landing caused also minor damage to the cultivated field.

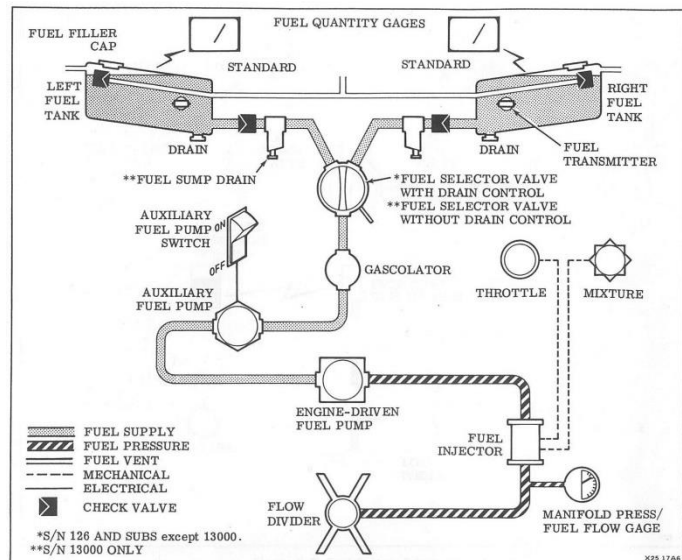
Figure 4: Schematic of the Fuel System

As the schematic illustrates, drains are installed at each fuel tank and a drain system is incorporated in the selector valve.

A/C SN 196 did not incorporate fuel sump drains in the fuel lines between both tanks and the selector valve.

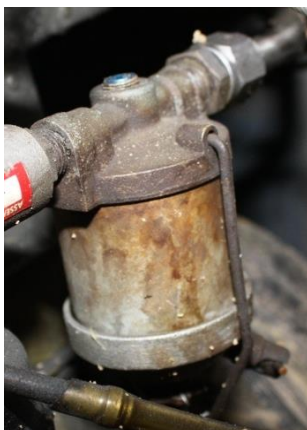
Figure 5: Gascolator

The gascolator was equipped with a drain valve accessible after removal of the engine cowlings. No remote control of this valve was installed.

However, the possibility exists to reach the drain valve without removal of the engine cowlings, but it was very difficult and required the pilot to lie on his back on the floor.

AAIU(BE) recommends the FAA to require the airplane Type Certificate Holder to incorporate a 25 hrs maintenance operation in the “Inspection Intervals Chart” of the Maintenance Manual, reflecting the need of draining the gascolator.

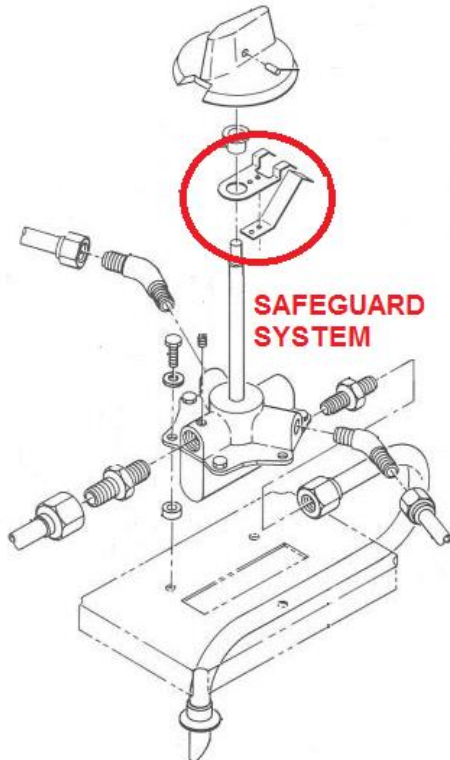
Figure 6: Fuel selector Valve

Further examination was conducted in the usual maintenance organization. As the engine failure occurred immediately after switching the fuel tank, the examination focused on the fuel system. The fuel selector valve handle, found in the "both" position after the crash, was first examined showing that the original placards had disappeared and had been replaced by others "home-made" of pink colour.

The fuel selector valve incorporated a drain valve operated by pulling up vertically the fuel selector valve handle. First attempt to open the drain by gently pulling up the handle showed the drain valve was seized. Further significant force allowed the drain valve to unlock and to move up.

No liquid came out the drain line. Actually, no more fuel was present in the fuel selector valve, likely because a leakage occurred at both connections of the fuel lines coming from the fuel tanks which had been disconnected during the wings disassembly and had not been capped.

After few up and down movements the drain valve control became light and smooth, closing properly when released under an internal spring action.

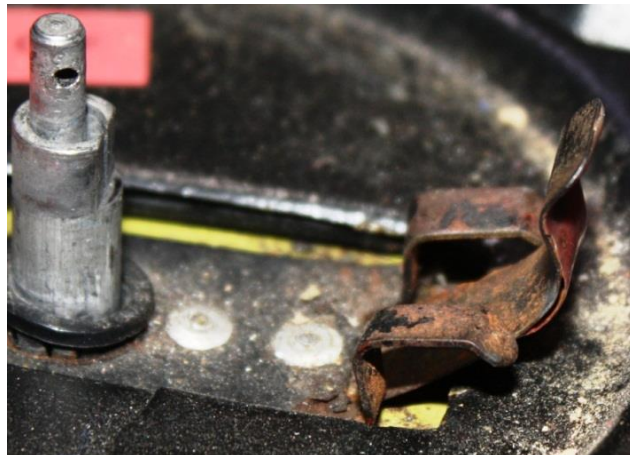
Figure 7: fuel selector Valve safeguard

It was also seen that the safeguard system preventing putting the selector valve inadvertently in the "OFF" position was plastically deformed with the consequence it was no more effective. The safeguard was also rusted.

It is therefore possible that the pilot could have (partially) closed the fuel selector valve when selecting the other fuel tank in downwind.

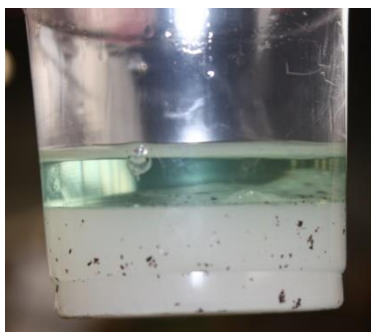
Figure 8: fuel contamination

Thereafter, the engine cowlings were removed and the gascolator installed on the firewall was drained in a clean container.

Obviously, the fuel inside the gascolator was contaminated by a whitish liquid likely to be water. Small black particles were also present.

A layer of green liquid, supposed to be the fuel, was present on the top while the white liquid rapidly settled at the bottom of the container.

Analysis of the liquid found in the gascolator was conducted by a specialized company which confirmed the contamination was mainly due to water. The analysis could not determine why the water had a whitish colour and why the 100LL fuel had a green colour instead of blue.

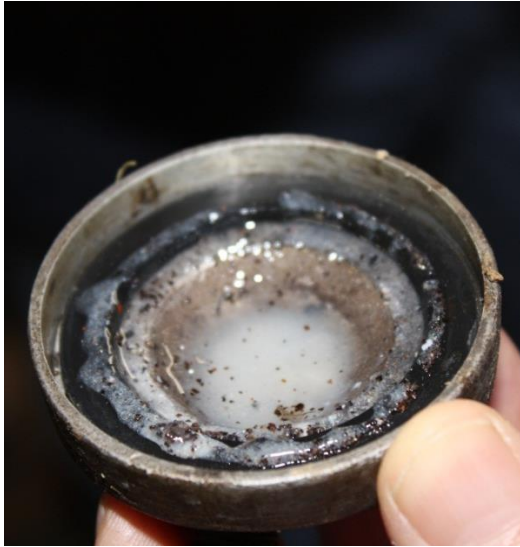
Figure 9: Bottom cover of the gascolator

The fuel gascolator was disassembled showing semi-solid other contaminants looking like a kind of white gelatine. Thereafter, the screen filter located inside the injection system was removed and the inspection confirmed the contamination. Droplets of water were found in the injection system.

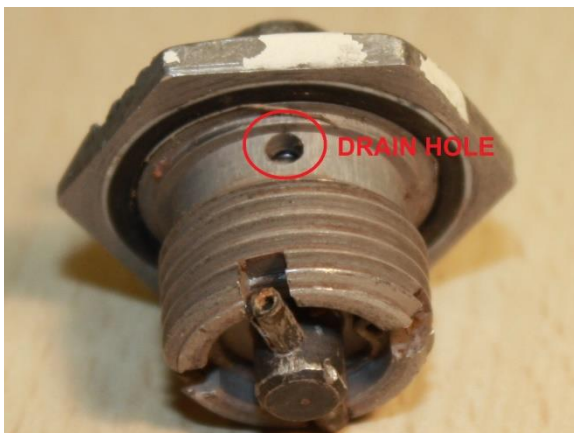
Figure 11: Drain hole in the drain chamber

The fuel tank drains were examined and removed from their respective fuel tanks. The valve drains were held in place in the fuel tanks using an aluminum 1"1/8 castellated nut installed with the non-castellated surface in contact with the lower fuel tank skin i.e. with the castellated surface up. Examination of the valve showed no provision was made on the valve to receive any cotter pin. The drain valves were identified as per the applicable Illustrated Parts Catalog as being PN: 1000B-2A (Valve, drain -13330). They were originally installed on Model 112, serial numbers 126 thru 364.

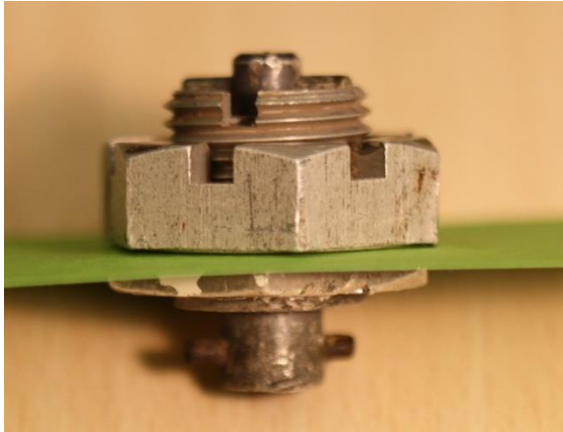
Figure 13: Nut position as found in the A/C.

Drain valve and nut, as found installed in the airplane, shows the drain hole circumferential chamber is hidden by the plain (non-castellated) part of the nut.

Thereafter, the drain valve was installed in a metal can for performing comparative testing of the draining efficiency with the nut installed in both positions. The tests showed that the flow and the pressure were significantly lower when the flat surface of the nut was in contact with the skin. Actually, the limited flow was only possible due to a lack of sealing of the nut along its thread and at the contact surface with the lower tank skin.

AAIU(BE) recommends the FAA to require the airplane Type Certificate Holder to publish adequate information in order to properly verify and install PN 1000B-2A valve drains, per SB, SL or any.

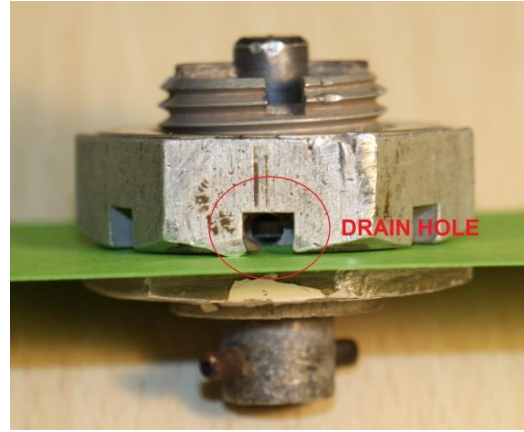
Figure 14: Free passage to the drain hole.

By contrast, there is no flow obstruction when the castellated part of the nut is installed opposite, i.e. in contact with the lower fuel tank skin.

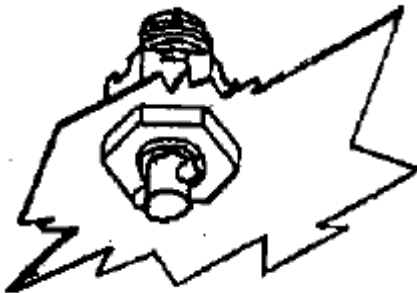
Figure 15: Drawing originating from another PC

No information could be found in the airframe manufacturer applicable documentation to determine the correct orientation of the fuel tank drain nuts.

The only information available is a drawing of the same drain, found in the Parts Catalog applicable to airplane SN: 1 to 125 (thus not applicable to SN: 196). This drawing shows the nut with its flat surface in contact with the lower fuel tank skin.

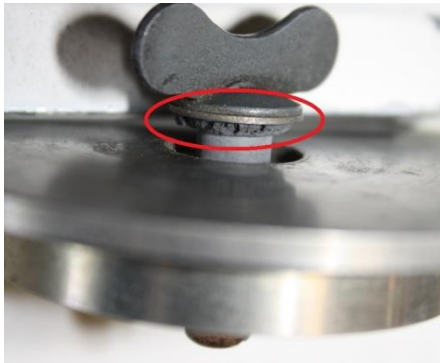
Figure 16: View of a fuel tank cap

Both fuel caps were inspected for proper sealing capabilities showing the small O rings installed on the central locking mechanism was in poor condition.

The fuel caps were thus no longer watertight.

Therefore water could enter the fuel tanks when raining or during the cleaning of the airplane.
