Federal Public Service  
Mobility and Transport  
Air Accident Investigation Unit

## Safety Investigation Report

# ACCIDENT TO HELICOPTER ROBINSON R-22 AT HUY ON 6 APRIL 2012

Ref. AAIU-2012-06-Huy  
Issue date: 30 January 2013  
Status: Final

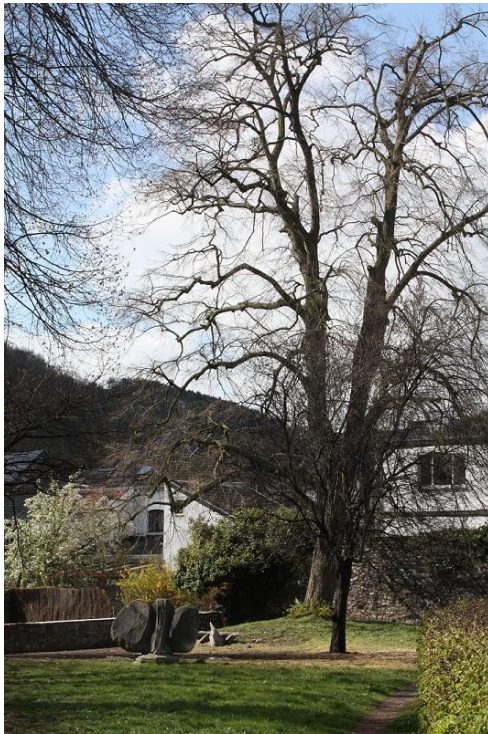
**Figure 3: View of the crash site.**

The helicopter crashed into a small park, bordering the N66 “route du Condroz”, slightly before 16:00.

It fell down between three trees located close together causing a few broken branches.

Upon impact, the helicopter caught fire and was totally destroyed.

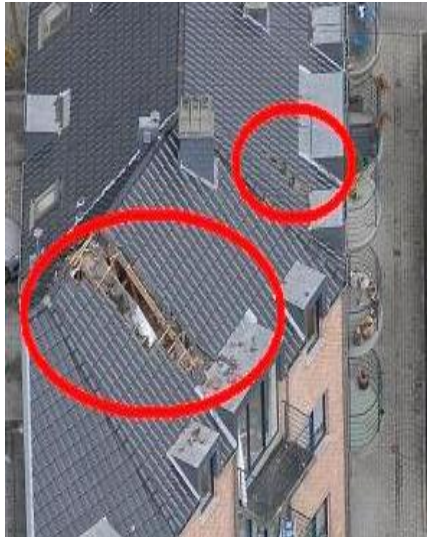
Figure 4: Damage to the roofs.

Upon the rupture, the heavy steel cables (40 mm diameter) fell into the city, causing extensive damages to several houses.

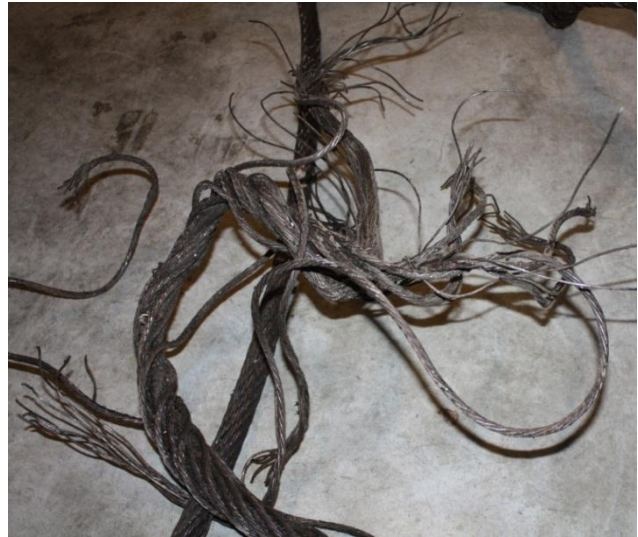
Figure 5: Main and secondary cables.

The accident caused the rupture of a main and a secondary (rescue) cable of the cableway and therefore significant damage to the entire installation.

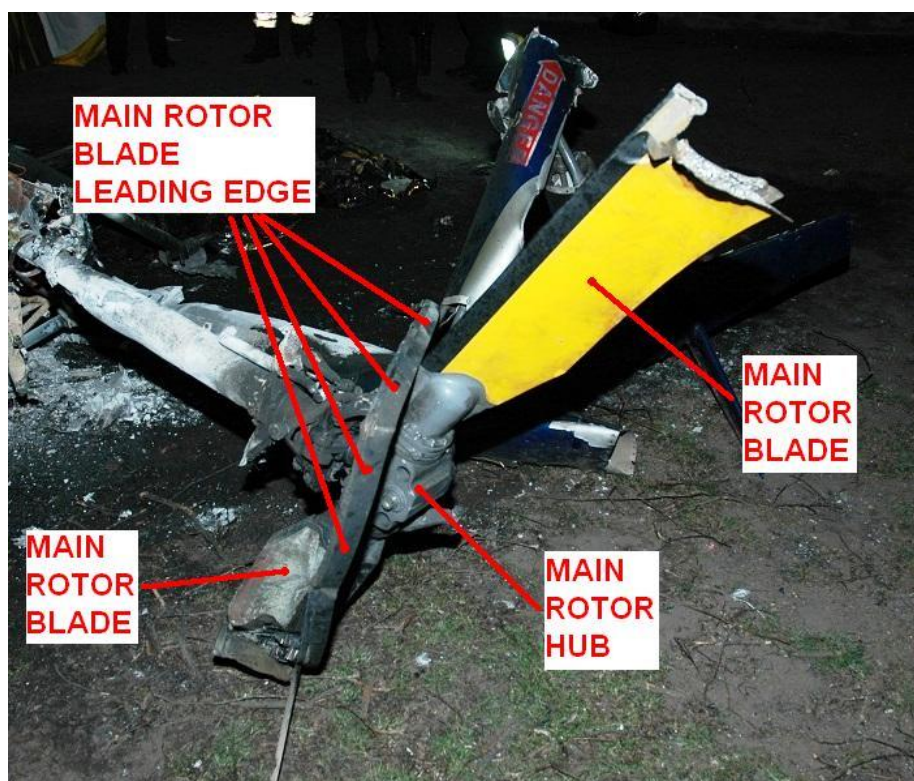
**Figure 8: Main rotor hub and remains of MR blades as found on the crash site.**

A 0,70 meter long remnant of one main rotor blade was still attached to the main rotor hub (The extrados in yellow on the picture).

The second main rotor blade was also attached to the hub, beginning with a damaged (bent) 0,65 m long (grey on the picture) blade extending with a

burned 2,9 m long remnant of the leading edge. Actually, the intrados and extrados sheet metal remains were found in the wreckage, separated from the leading edge by the fire.

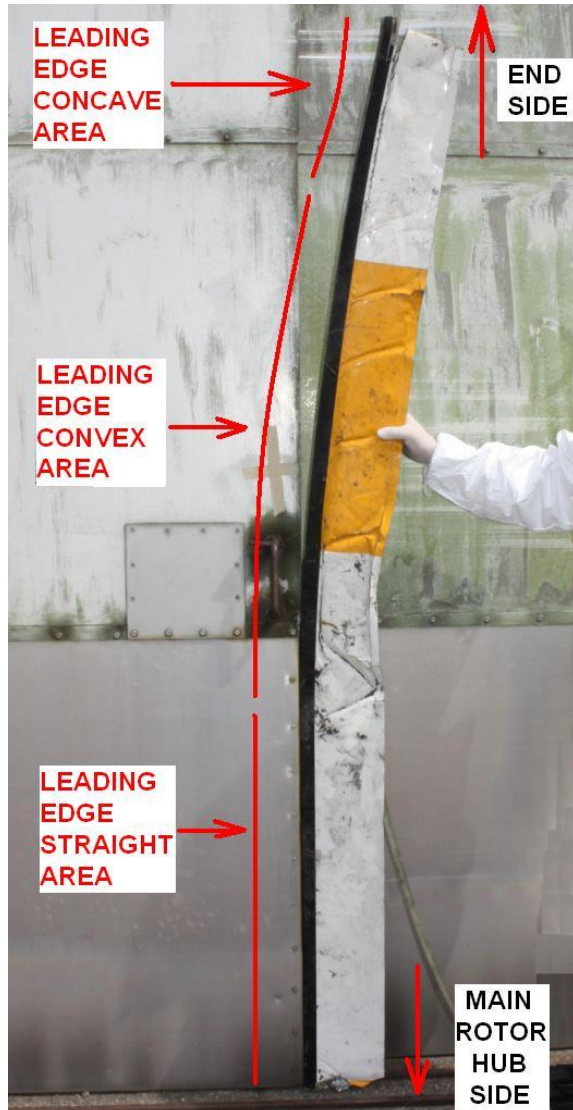
**Figure 9: Separated 2,3m long section of MR blade.**

A 2,3 meters long section of the other main rotor blade (not burned) was found on the ground 5 meters away North East from the wreckage.

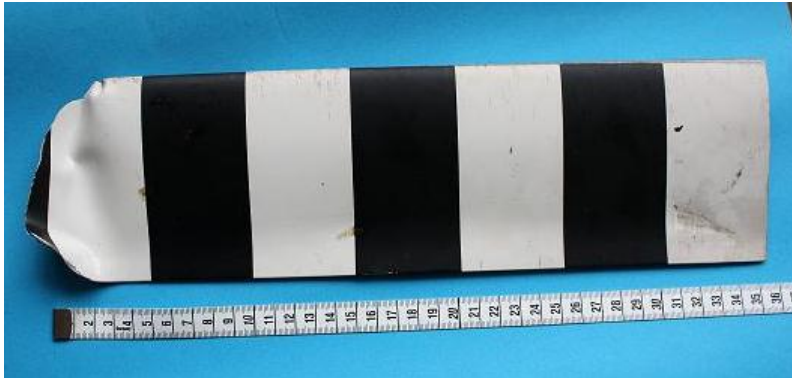
**Figure 10: Separated tail rotor blade.**

One blade of the tail rotor was found damaged by fire and still attached to the hub while the second blade of the tail rotor had been severed at the root and was not present in the main wreckage.

The separated tail rotor blade was retrieved in a swimming pool located in the rear garden of a house located in “rue Haut du Chêne”, 9.

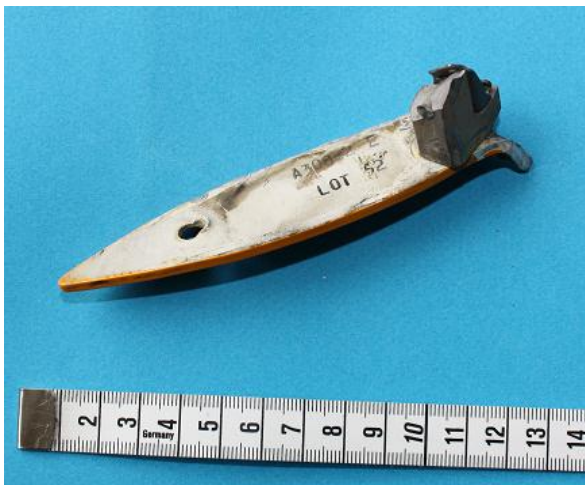
**Figure 11: Separated main rotor tip end.**

A 12 cm-long part of the removable blade tip cover, identified “A300-2” was found at N 50° 30.987' E005° 14.540'. A part of a weight was still attached.

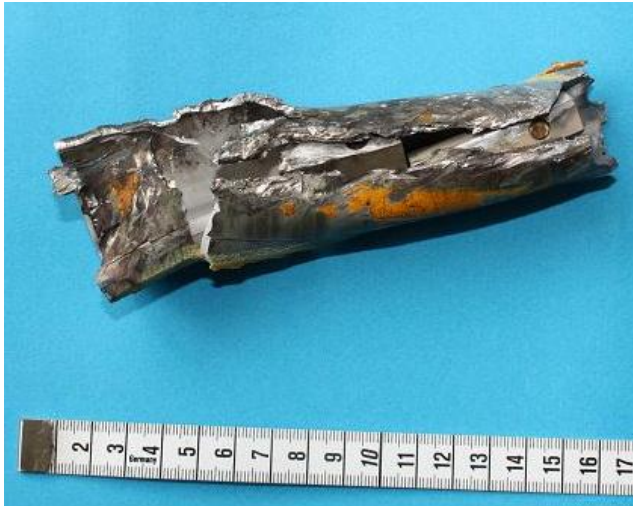
A 15-cm long steel part, weighing 543g, featuring weights was found at N 50° 30.982' E 005° 14.598' (rue des Larrons 4, near a school gate).

This part, showing sharp edges and weights, was determined to be a main rotor blade beam end.

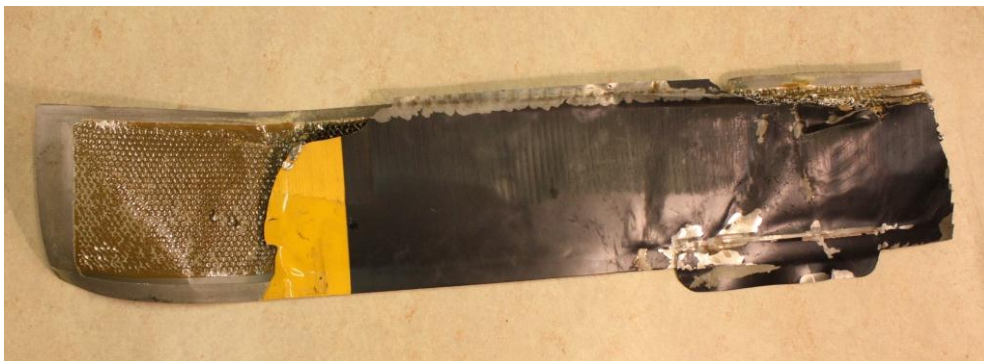
**Figure 13: Separated 0,75m section of MR blade without beam/leading edge.**

A 0,75 m section of the extremity of a main rotor blade trailing edge was found east from the above 15 cm long part, in a playground near the school.

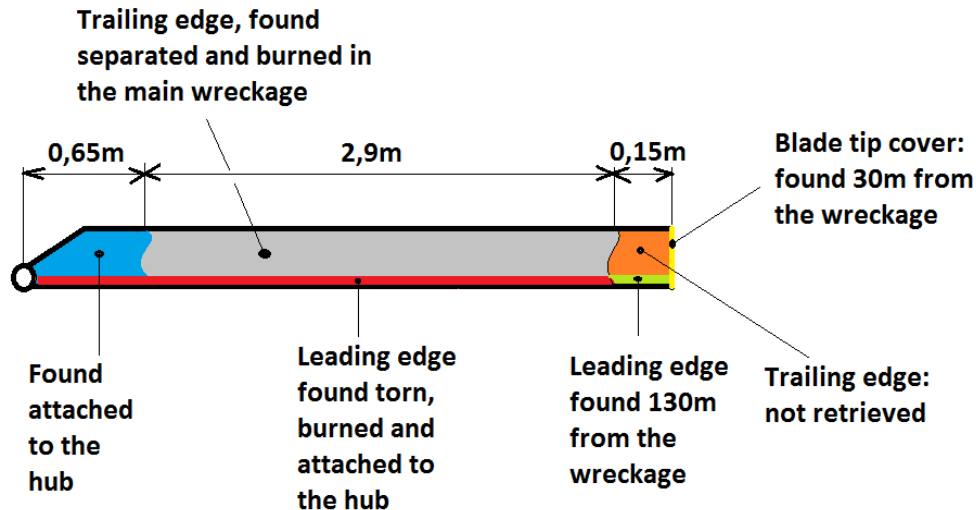
**Figure 15: Sketch of first reconstructed MR blade.**

The first main rotor blade to be examined was featuring a 0,65m bent and burned section attached to the hub. This section was extended by a burned approximate 2,9 m long section of the leading edge where the intrados and extrados sheet metal were missing. Measuring the total length of the remains of this blade demonstrated that around a 15 cm section of the leading edge was missing at the end of the blade.

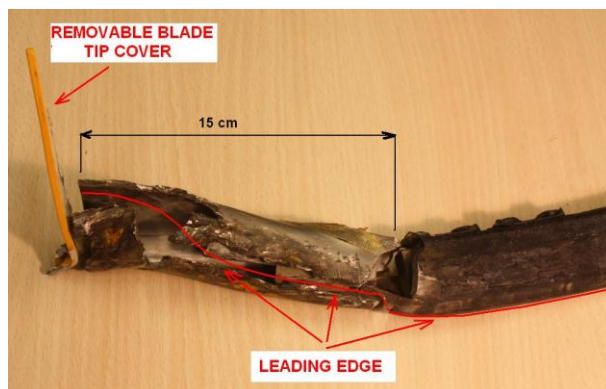
**Figure 16: Reconstructed MR blade beam/leading edge and tip.**

The 15 cm long part found 130 m far from the wreckage was clearly corresponding to the extremity of the burned beam. Additionally, the removable blade tip cover, found 130 m from the main wreckage, fits to the end of the 15 cm long leading edge.

The 15 cm long leading edge was found open, twisted and showed some grooves corresponding to the strands of the cableway main cable. The underside of the leading edge of the removable tip cover was crushed as well as the intrados, but the extrados of the profile was undamaged.

We can conclude that the last 15 cm section of this main rotor blade collided with the cable (likely the main cableway 4 cm diameter cable) with the underside of the leading edge and was severed by the impact forces.

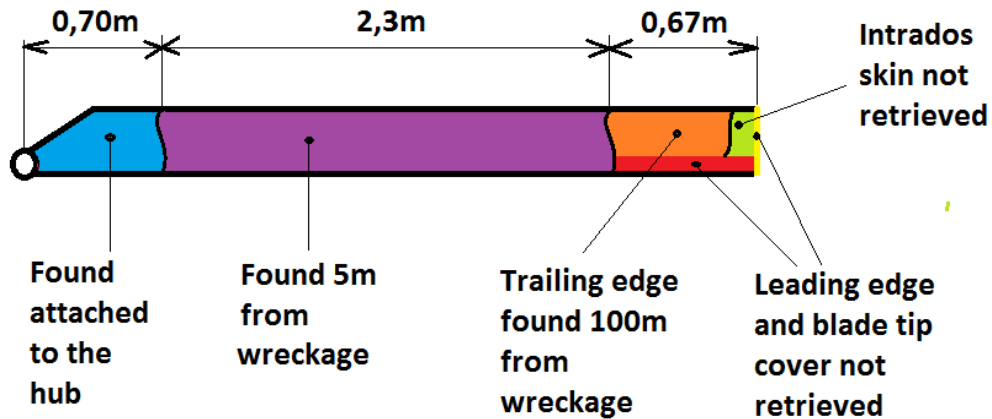
Figure 17: Sketch of second reconstructed MR blade.

The second main rotor blade was also reconstructed as follow:

- the 0,70 meter long remnant found still attached to the main rotor hub,
- another 2,3 meters long section (not burned) found on the ground 5 meters away North East from the wreckage,
- and the 0,67 m section of the trailing edge found in the playground of the school, around 100 m from the main wreckage.

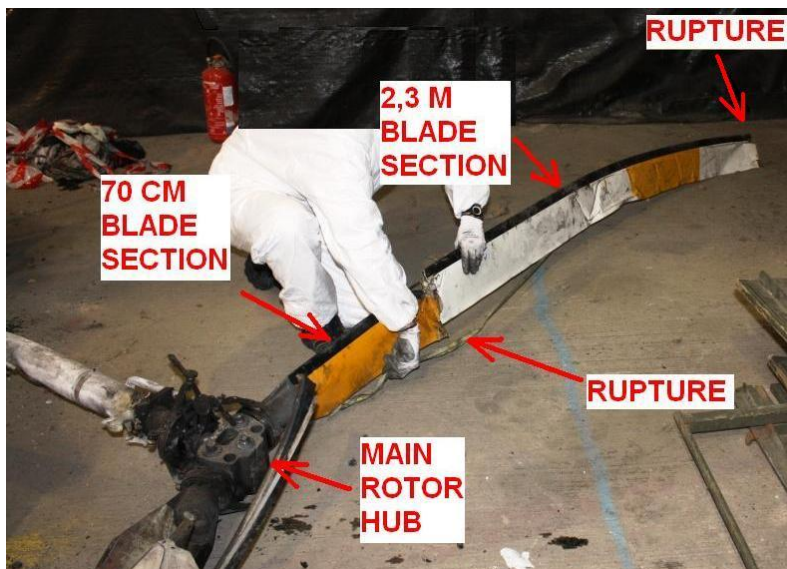
Figure 18: Reconstruction of second MR blade.

As seen on the above picture a 70 cm long section of one main rotor blade remained attached to the rotor hub while the 2,3 m section probably separated with the impact with the ground (found 5 meters away North East from the wreckage).

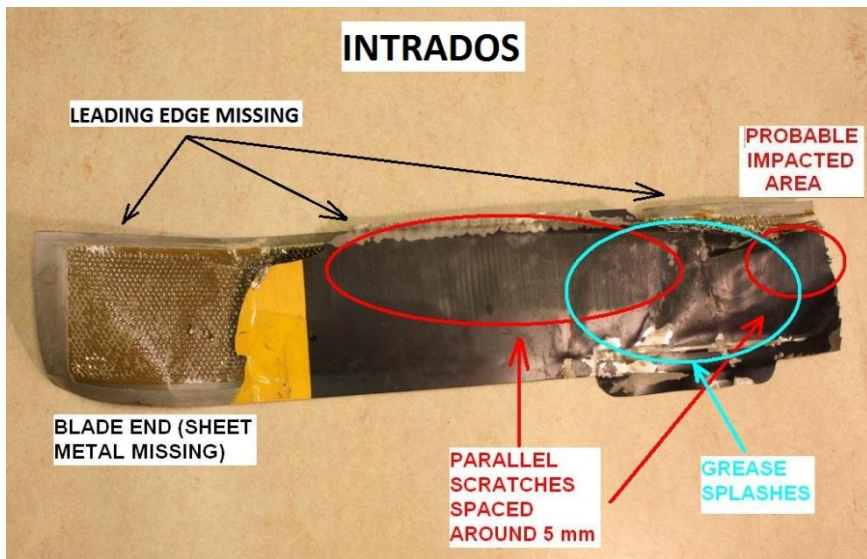
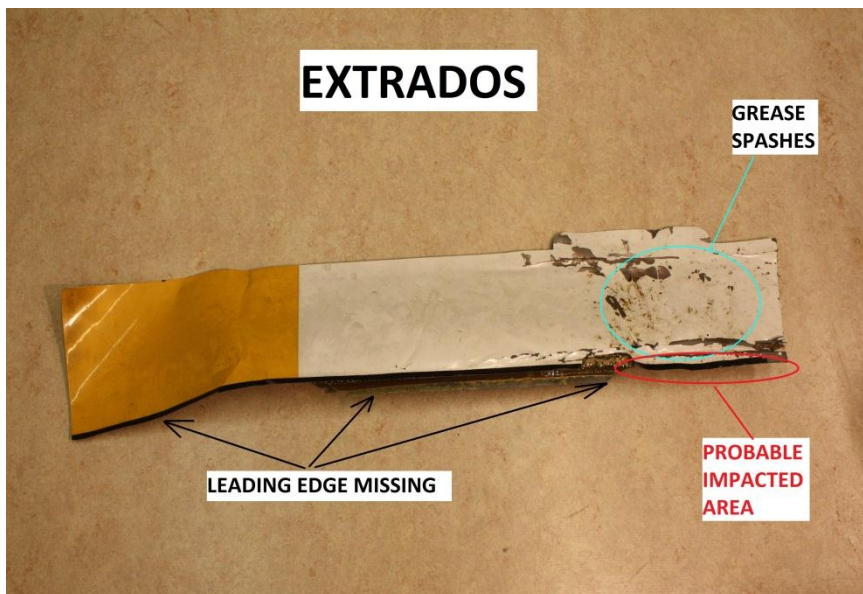
**Figure 19: Intrados of 0,67m long end section of MR blade.**

**Figure 20: Extrados of 0,67m end section.**

The two pictures above show the intrados and the extrados skins of the 0,67 m end section of the blade.

From the above, we can conclude that friction with one or two cable(s) occurred first at the intrados of the blade followed by a violent impact on the leading edge located at around 75 cm from the end of the blade. This impact caused the end of the blade to separate from the main part of the blade. At the same time the leading edge and the skin of this section separated from each other.

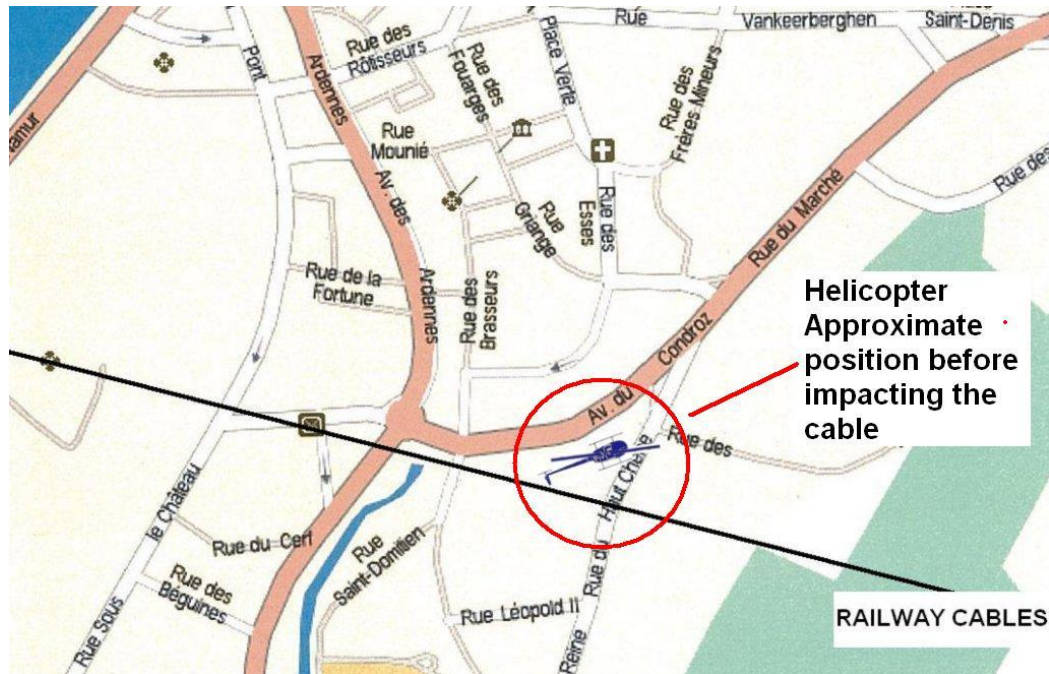
**Figure 22: Approximate helicopter position and direction when impacting cables.**

After a few seconds hovering in that position the witnesses saw the helicopter moving slowly rearwards and hitting the cableway cables with “the rear of the helicopter”.

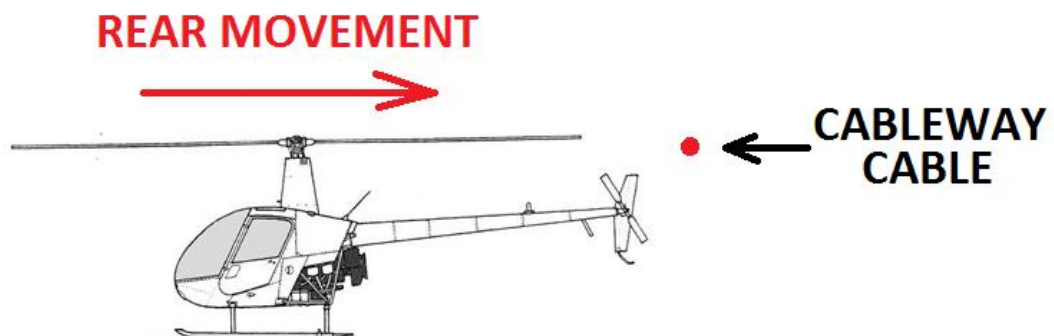
**Figure 23: Relative position of helicopter and cable before impact.**

Actually, as seen in chapter 1.1 above, only the main rotor blades hit the cables.

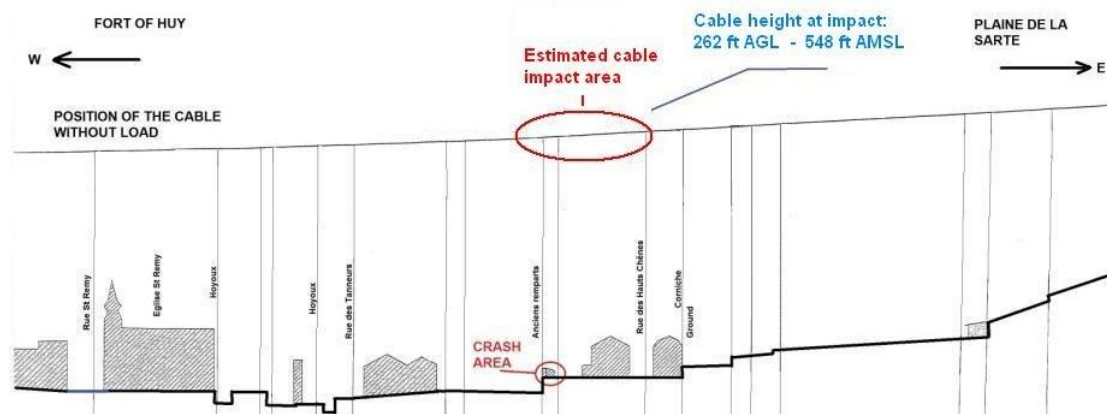
**Figure 24: Cable height at estimated impact area.**

The last radar plot of the helicopter above the “Wilmotte - Dupont” street at 500m from the crash site showed an altitude of 700 ft MSL which corresponds approximately to 450 ft AGL.

The cable height in the impact area was about 262 ft AGL ( $\pm 80$  m). The witnesses didn’t report any visible change in altitude from the time they observed the helicopter coming from the north to the impact with the cables, therefore it is likely that the helicopter trajectory during the last 500 m described a slow estimated  $10^\circ$  descent slope down to the height of the cables.

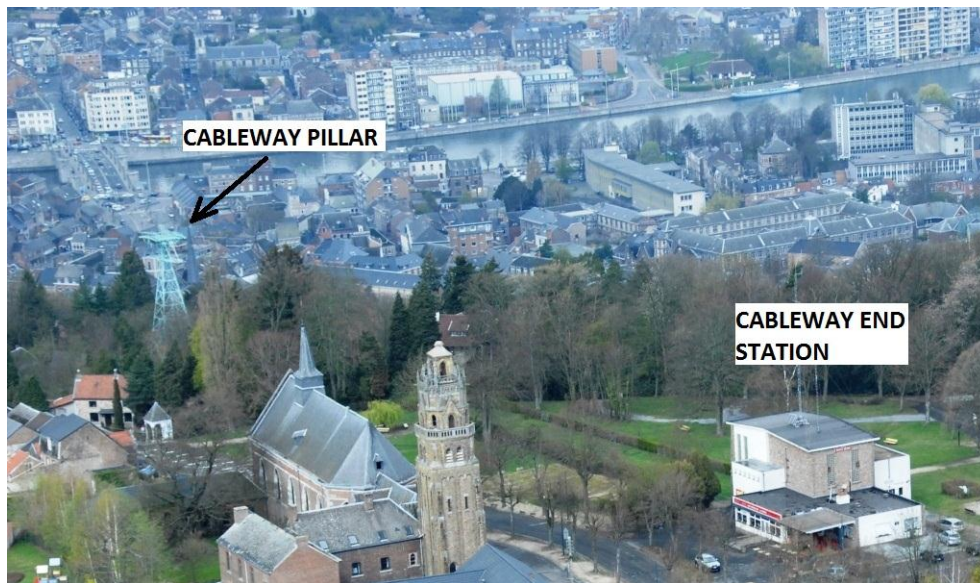
**Figure 26: Example where cables are invisible due to a dark background.**

The possibility exists the pilot didn't see the cables because of the 10° descent slope approach causing the cables to be positioned between the helicopter (and pilot's eyes) and the dark landscape. The cable car season was not yet started causing the cables to be dark and unpolished and therefore less visible. In other words, there was a poor visual contrast between the cables of a dull colour and the dark landscape.

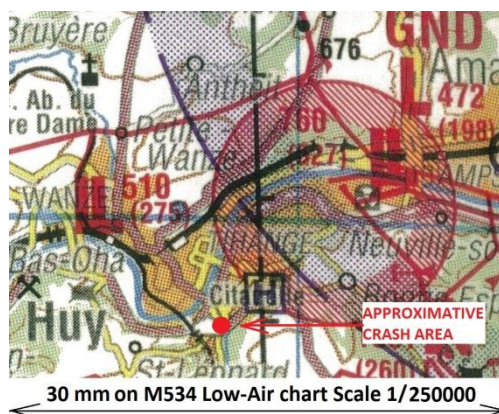
**Figure 27: Zoom of Low-Air aeronautical chart.**

For the purpose of the investigation a zoom of the M534 Low-Air aeronautical chart was made to show the details of the information available for the city of Huy and its neighbourhood. Obviously, this chart is overloaded of details owing to the scale used and some details, as for example the word “Citadelle”, the letter “H” and a red circle, are superimposed on a part of the city.

AAIU(Be) recommends BCAA to provide guidance material to pilots to promote good practices when performing aerial photography. BCAA could inspire oneself from the CAA UK published "General Aviation Safety Sense Leaflet - Aerial Photography".
