# Safety Investigation Report

Ref. AAIU-2013-02-EBNM

**Aircraft:** Robinson R-22 Beta II, msn 3832. The helicopter was registered in Belgium and held a Certificate of Airworthiness and a valid Airworthiness Review Certificate (ARC)

**Accident location:** On EBNM airfield

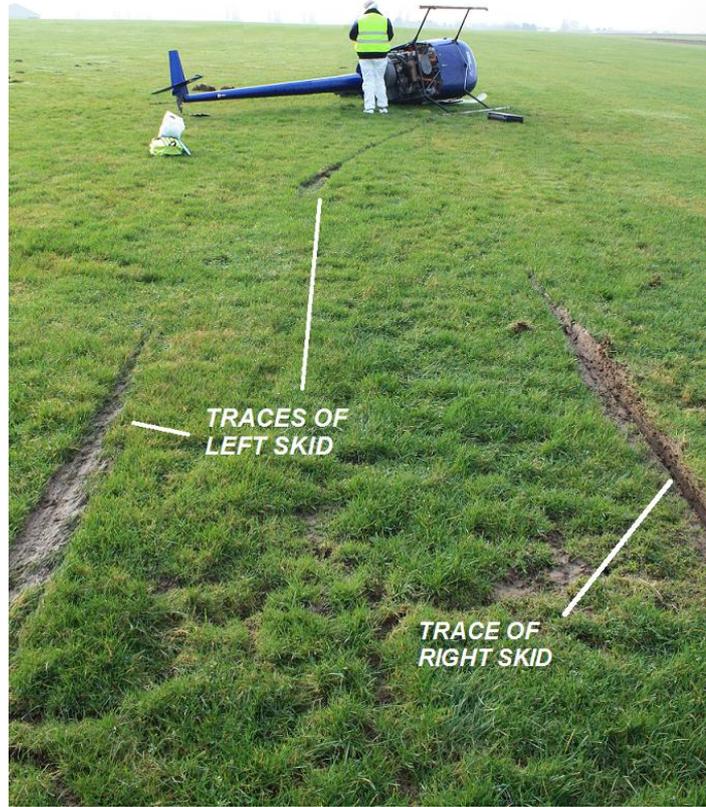
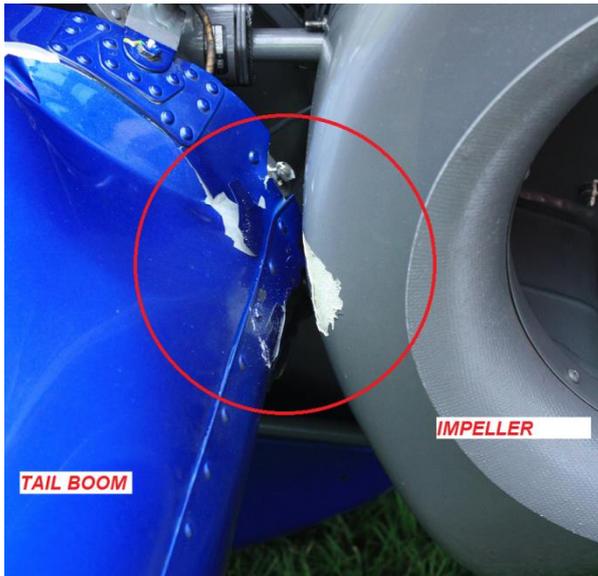
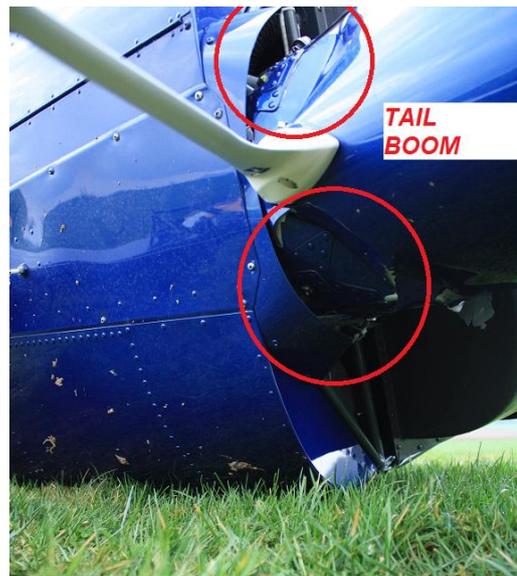
**Skid traces**

The skid traces on the ground indicate the first contact was brutal, the skid made a 10cm deep groove in the ground. The tail boom swung downwards, making a print on the rear fan.

There was a residual forward speed, and the helicopter bounced forward and the nose pointed downwards. .

The left skid touched the ground, and forced the helicopter, losing its balance, to a right turn. The main rotor impacted the ground and the helicopter rolled over its left side.

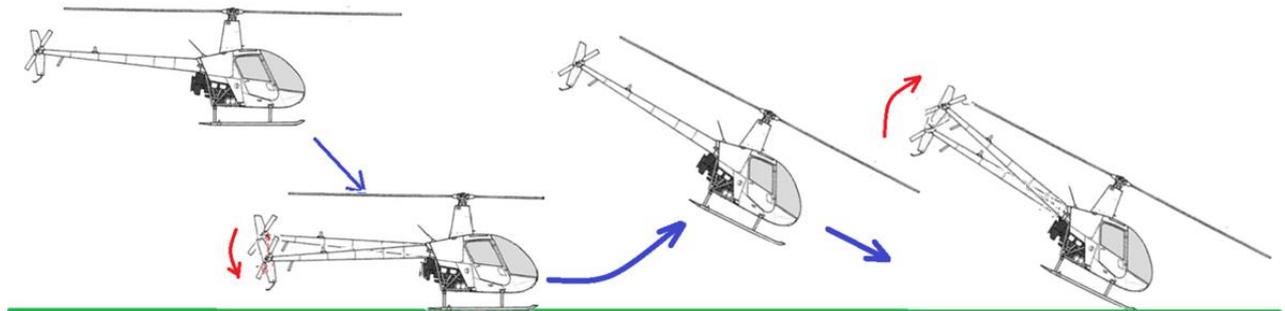
The helicopter after the flare had residual vertical and forward speed in excess.
