# Safety Investigation Report

Ref. AAIU-2014-AII-03  
Issue date: 08 March 2016  
Status: Final

<b>Classification:</b>	Accident
<b>Level of investigation:</b>	Standard
<b>Date and time:</b>	18 April 2014 at 13:50 UTC
<b>Aeroplane:</b>	Manufacturer: Halley Kft. Model: Apollo Fox 912 The aircraft was registered in Belgium since 14 July 2010 and held a valid 'Permit to fly'.
<b>Owner:</b>	The pilot
<b>Total flight time:</b>	About 600 FH
<b>Engine:</b>	One Rotax 912 UL SN: RO-270227
<b>Accident location:</b>	In a field located in Mochamps near the airfield of St Hubert (EBSH) - 50°06'06.0"N 5°24'49.4"E
<b>Type of flight:</b>	General aviation - Cross-country
<b>Phase:</b>	Climbing after the take-off
<b>Persons on board:</b>	The pilot was alone on board.
<b>Injuries:</b>	None

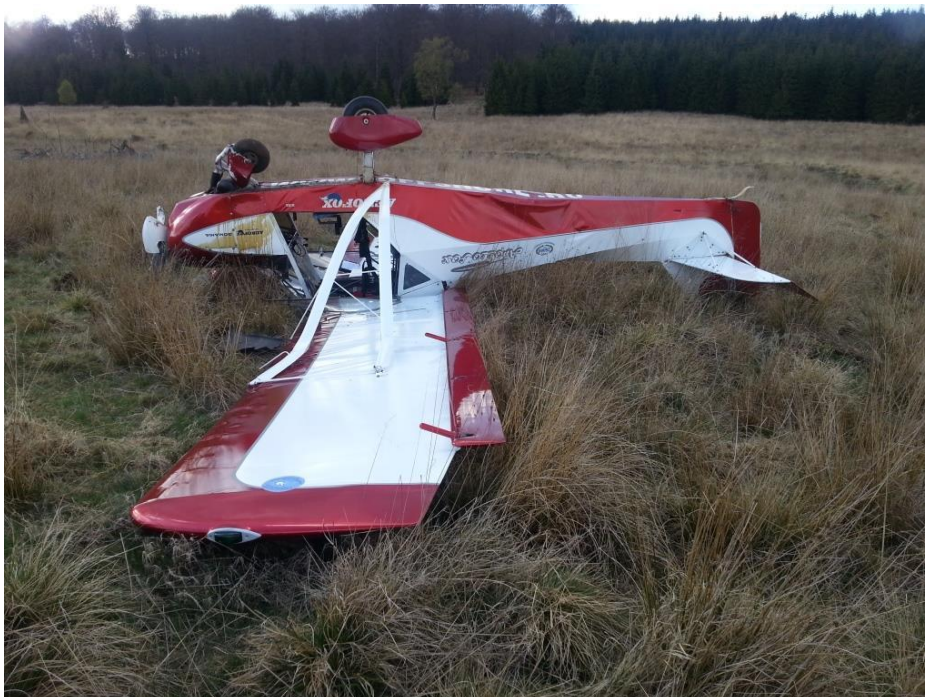
He had no other choice but to make a forced landing on a very uneven terrain causing the nose landing gear to collapse and the aeroplane to flip over. The aeroplane was significantly damaged but did not catch fire. The pilot, properly fastened by his shoulder harness seat belt, exited the aeroplane uninjured.

Figure 1: Aircraft just after the accident

The engine cowling was covered with engine oil. The engine suffered a significant oil leak and subsequent mechanical damage caused by the engine running without oil.

In addition to the damage to the engine, most primary airframe structures were bent or distorted by the flip over during the forced landing.

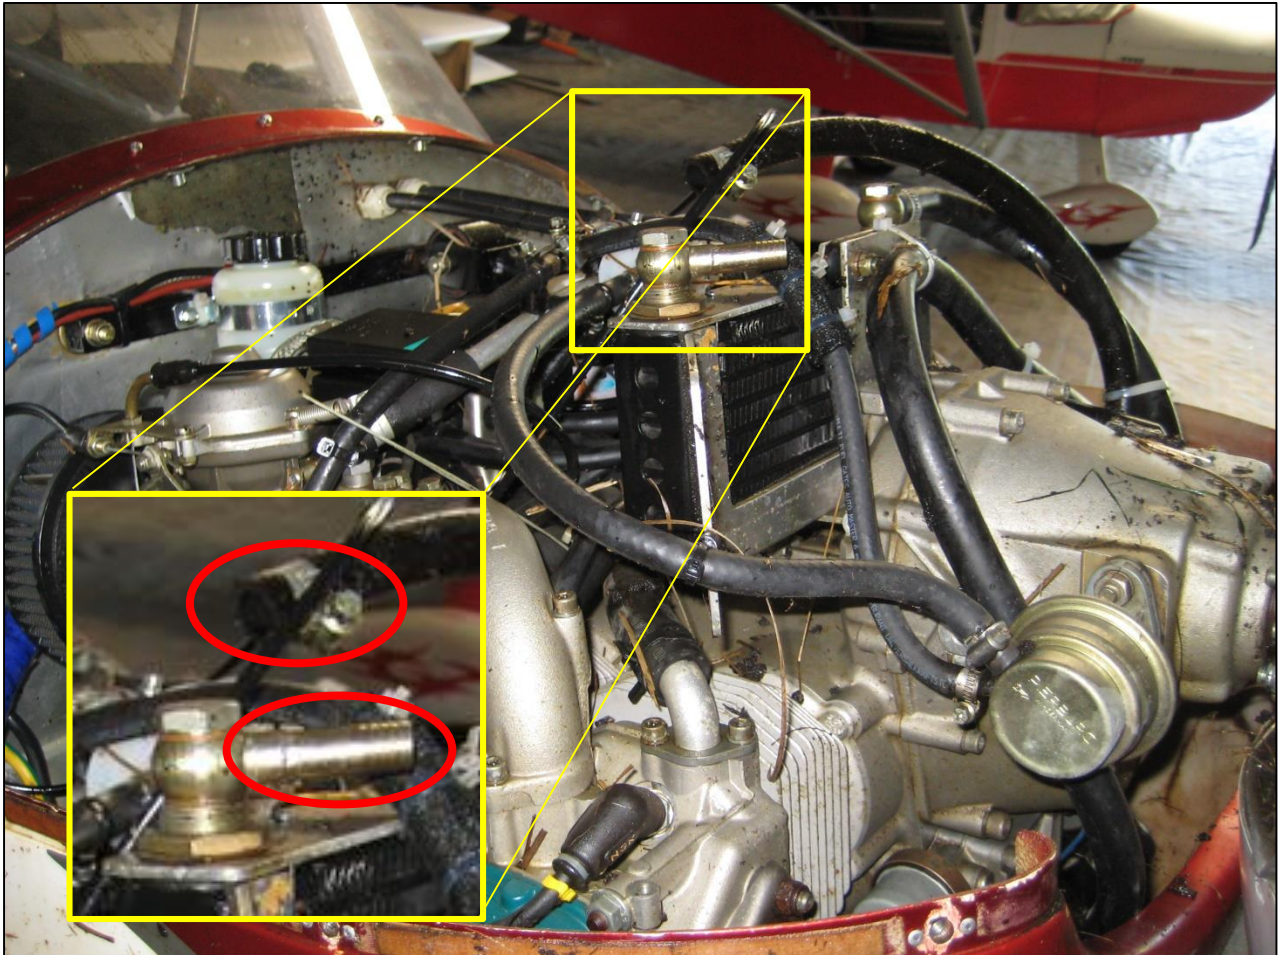
The cause of the engine failure was identified soon after the accident as being a sudden total loss of lubrication due to a flexible pipe disconnection at one oil cooler connector.

Figure 4: Picture of the engine showing the oil pipe disconnected

- An oil cooler hose failed in flight when its flexible pipe had pulled out of the connector.
- The original design of the oil cooler hoses wasn't a problem when, in the original installation, the hoses were submitted to suction. After the oil system modification, the hoses were submitted to oil pressure. The particular and inexplicable design of the connectors made it impossible for the assembly flexible pipe/connector to withstand the pull-out force resulting from the oil pressure.

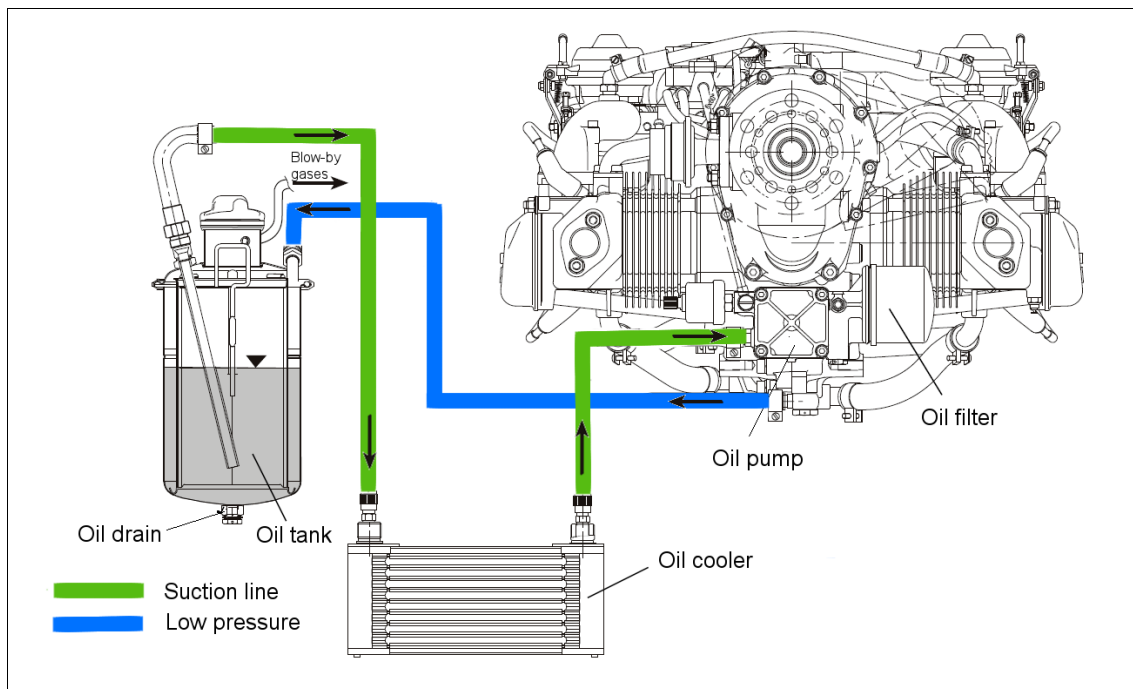
The oil pump is driven by the camshaft. The oil pump sucks the engine oil (green arrow) from the oil tank via the oil cooler and forces it through the oil filter to the individual point of lubrication. The surplus oil emerging from the points of lubrication accumulates on the bottom of the crankcase and is forced back to the oil tank by the crankcase blow-by gases (blue arrow).

Figure 5: Diagram of the original engine manufacturer lubrication system

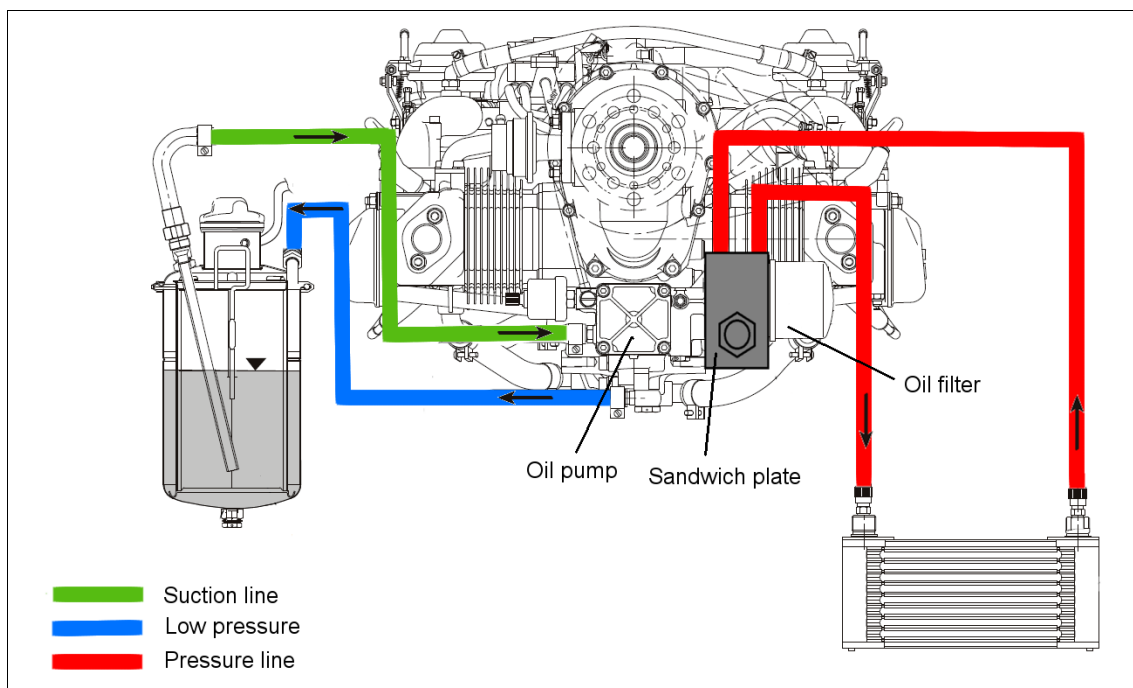
Figure 6: Diagram of the lubrication system after modification

The modification consisted in the installation of a thermostatic valve and the rerouting of the external oil circuit. A sandwich plate incorporating the thermostatic valve was installed between the oil filter and the engine oil pump. The modification resulted in the oil cooler and oil cooler lines being under the engine oil pressure while it was previously submitted to oil suction.

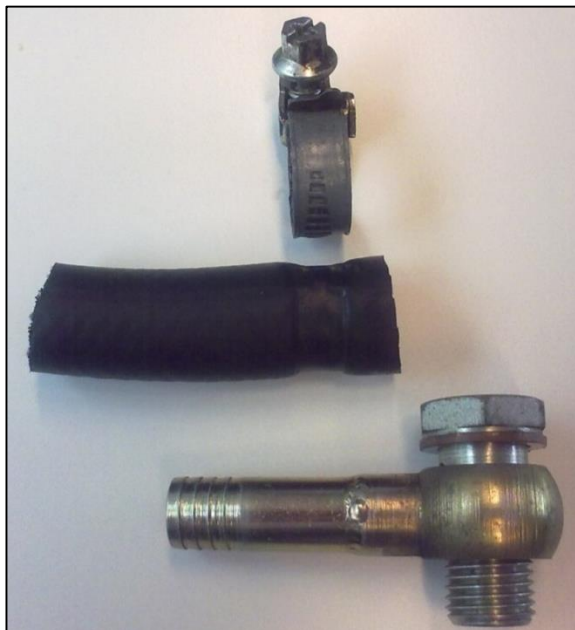
Figure 7: Picture of the failed oil cooler connection

The steel tube of the connector is made of 2 different outer diameter steel tubes welded together ( $\varnothing$  12mm and 13mm).

The end of the tube is barbed by machining 4 small grooves meaning that the external  $\varnothing$  of the barbed portion of the tube shows the same  $\varnothing$  as the tube (12 mm).

The force necessary to put the rubber pipe into place again on the connector was next to nothing, particularly when sliding the flexible rubber pipe on the 12 mm  $\varnothing$  portion.

Further disassembly of both parts (not equipped with a clamping ring) showed that the barbed end could not prevent the hose slipping off the connector tube. It demonstrates that the coupling of the flexible pipes with this type of connector was not designed to withstand oil pressure.

Also, the inadequate design of the oil hose connectors was easily detectable when examined by an experienced mechanic. Moreover, the weak connection of the rubber line/connector should have been detected during a pressure test of the hoses.

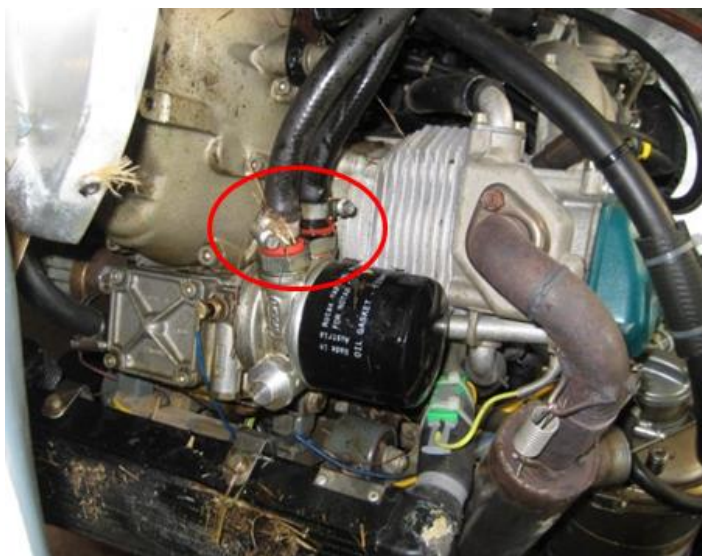
Figure 8: Picture of the rubber pipes as fitted on the connectors on sandwich plate.

The connectors screwed in the sandwich plate are quite different, compared with those installed on the oil cooler. The barbed end has a larger  $\varnothing$  than the tube itself. The assembly of the rubber pipe on the connector requires the pipe to be heated and lubricated in order to allow sliding the pipe onto the connector. When installed, the flexible pipe becomes almost irremovable due to the shape and larger  $\varnothing$  of the barbed end and the tight fit of the rubber pipe on the connector, even when no clamp is installed.

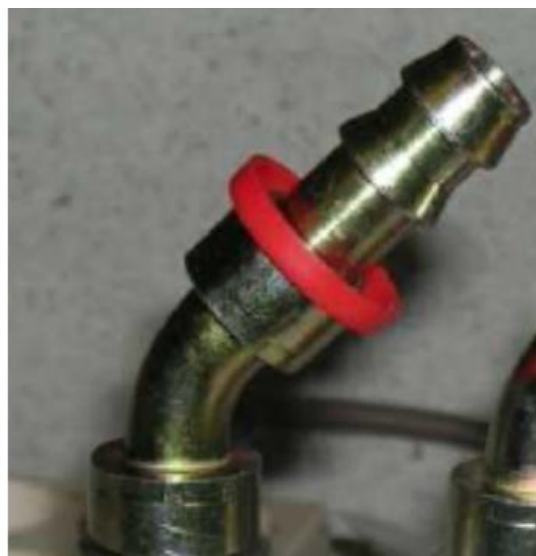
Figure 9: Picture of a connector before installation of the rubber pipe

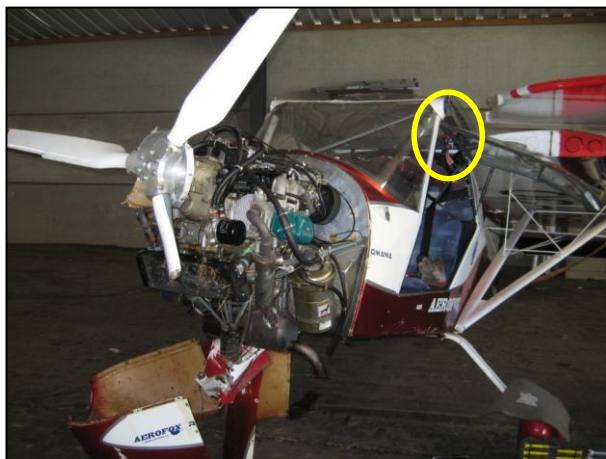
The pilot twice tried to activate the Galaxy GRS emergency parachute system by moving forward the parachute handle with all his strength – but without success. He stated that the handle movement required a significant forward force that he was not able to apply due to the uncomfortable position of the handle. This handle was fixed to, and installed above a structural diagonal tube of the fuselage structure located in the roof of the cabin, approximately above the pilot's left shoulder.

Because of the handle location, the pilot had to raise his arm vertically before reaching the handle with the tip of 2 fingers. When doing that, the structural tube was located in the recess between the fingers.

Figure 10: Location of activation handle

- The general position of the handle requiring the pilot to lift his arm vertically above the shoulder – you have less strength to push on something when your arm is in a vertical position than in an horizontal position between hips and shoulder.
- The direction of the force to be exerted – to have the least friction, the cable should be moved in the same direction as its housing (horizontal and forward in this case). However in this position, it is not easy for the pilot to see (and assess) the right direction, leaving the possibility that he pulls in a too far downward direction, generating extra friction in its support and housing.
- The position of the handle above the diagonal tube causing this tube to be an obstacle for a full hand grip.

Therefore, it is very important, during the installation of an emergency parachute system, to carefully consider the best possible position for the activation handle.

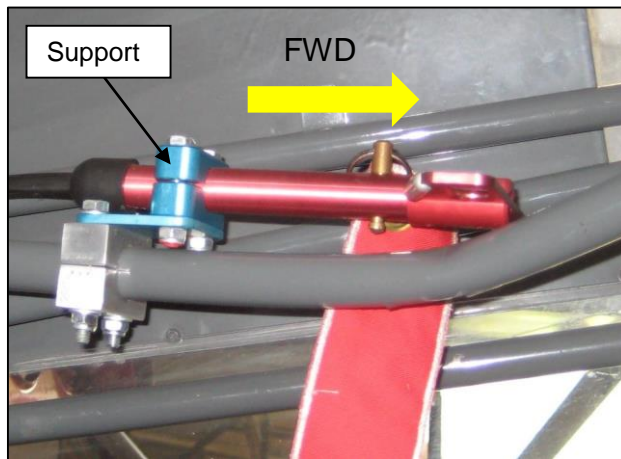
Figure 11: Installation of activation handle

The force required to move the activation handle is 11 kg and the distance for stretching the trigger mechanism is about 7 cm. For information, it takes more force, i.e. 35-40 pounds (17-19 kg) of pulling on the activation handle to fire a rocket of the BRS Aviation type.

- The activation of the emergency parachute handle, located in the ceiling behind a structural tube was very uncomfortable and not functional for the pilot. This caused the pilot to fail activating the emergency parachute system.
