Safety Investigation Report

Ref. AAIU-2015-07
Issue date: 16 October 2017
Status: Final

| Aircraft: | 1) Avions Pierre Robin DR400-180R 2) Burkhart Grob Flugzeugbau GMBH G103 Twin II |

During glider towing operations, a Robin DR-400 towing airplane landed with the towing cable extended. The cable hit a parked sailplane (Grob Twin II) and caused damage to the tail section.

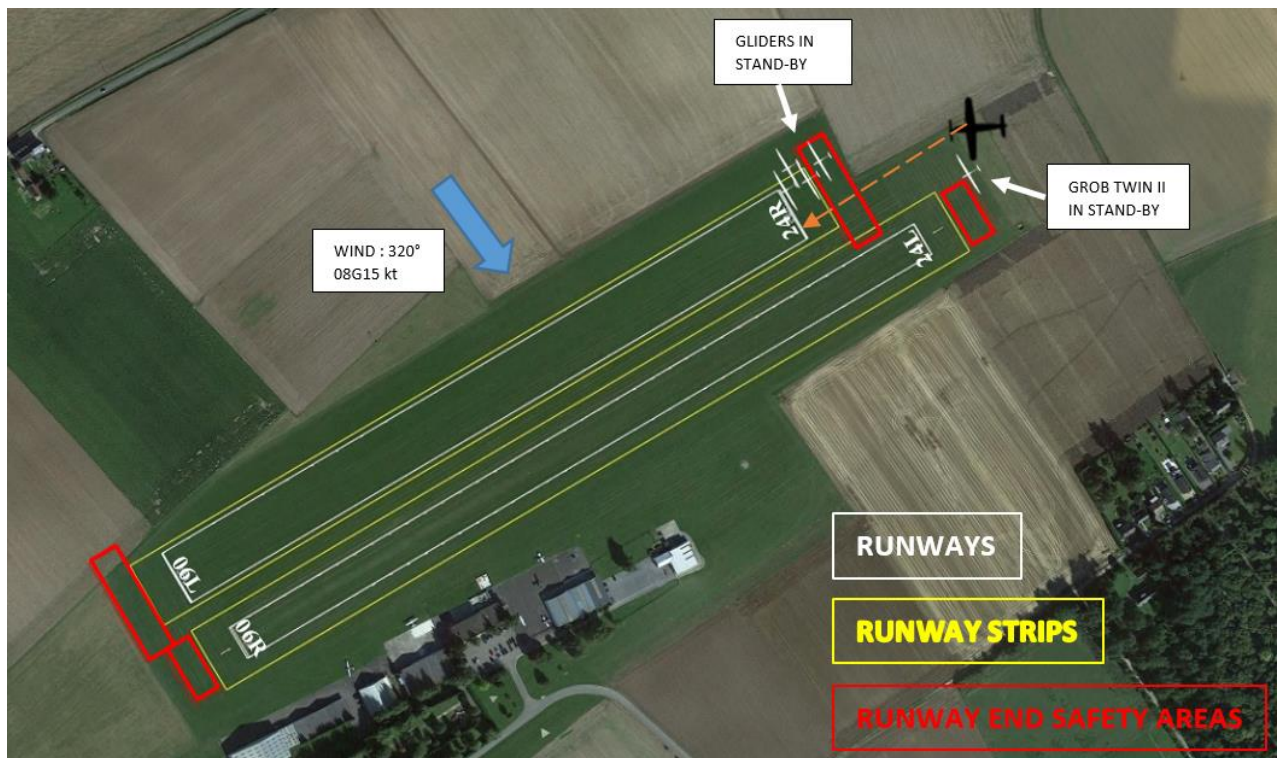
On the airfield, a group of several gliders was standing close to the runway 24R threshold, inside the runway end strip¹ and 'Runway End Safety Area' (RESA)², on the right side of the runway axis. A Grob G103 Twin II was also standing on the left side of the 24R runway axis, at a distance well before the runway threshold and likely outside the RESA of both runways 24R and 24L.

The pilot stated he managed to fly low in final to perform a short landing. He tried to avoid flying above both the Grob G103 Twin II and the other sailplanes waiting to be towed.

Figure 1: Aerial view showing the gliders standing on the ground (in white) and the towing aeroplane (in black) in crabbed approach, slightly left of the centreline.

The runway strip borders (in yellow on figure 1) have an identical width of 60 meters for each runway and the end strips extend 30 meters beyond each runway end.

The Runway End Safety Areas RESAs in red on figure 1 extend 30 meters further to each end strip and its width is, according to BCAA Circular GDF-04, twice the runways' width i.e. 100 meters for 24R/06L and 62 meters for 24L/06R.

During the final approach, he flew above a narrow strip of terrain located to the left of an imaginary extended runway centre line that was, from his point of view, free of obstacles. However, the pilot assumes that the crosswind and the gusts (up to 15 kt) could have made the aeroplane deviating more to the left than the intended path and also that the towing cable hanging rear of the aeroplane was itself also pushed to the left by the crosswind. That combined with the fact that the pilot chose to perform a low final has made it possible that the cable hit the standing sailplane.

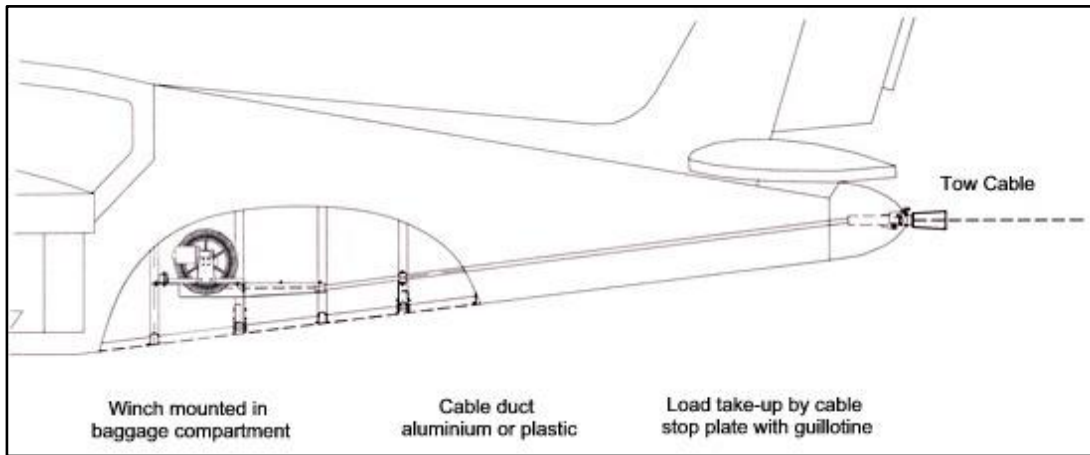
Figure 3: drawing of the setting up of the retractable tow cable winch.

Towing aeroplane: The tow cable winch was found undamaged and in working condition.

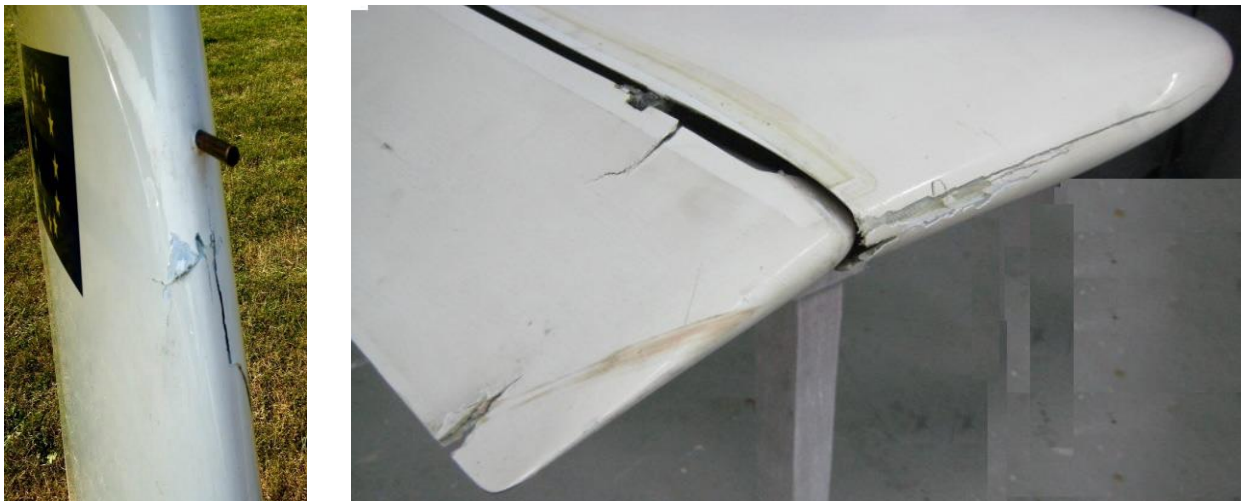
The towing cable hit the Grob Twin II glider, causing structural damage to the tail section.

Sailplane: The tail of the Grob Twin II sailplane showed several impact damages. The right side elevator was cut and the horizontal and vertical stabilizers showed structural damages.

Figure 9: Left: sailplane vertical stabilizer - Right: sailplane stabilizer and elevator

- The towing cable hit the Grob Twin II glider, causing structural damage to the tail section. An evaluation of the position of this sailplane shows it was likely standing on the ground at a place located outside the runway safety areas, while respecting the applicable regulation.
