Safety Investigation Report

SERIOUS INCIDENT POWER OUTAGE AT CANAC 2 AIR TRAFFIC CONTROL CENTER ON 27 MAY 2015

Ref.:
AAIU-2015-05

Issue date:
8 November 2016

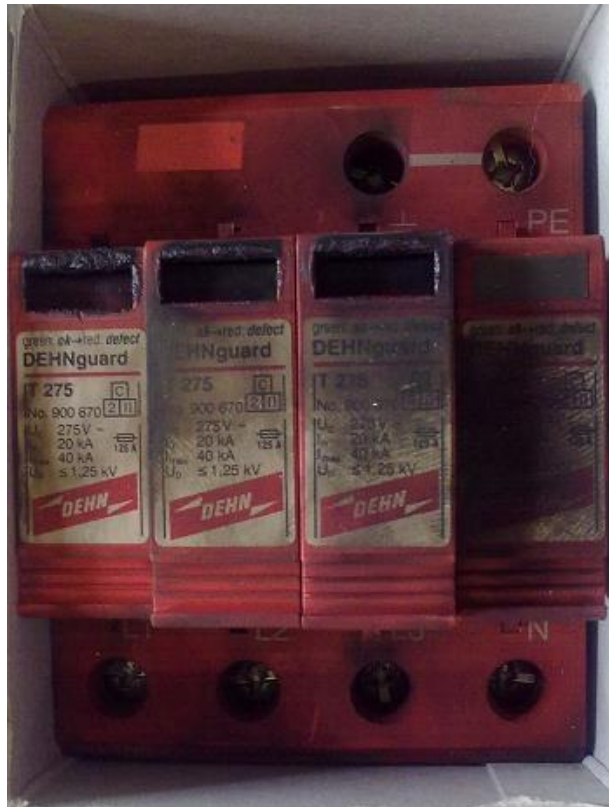
Figure 6: Damaged Circuit-Breaker

The electrical power generation system suffered a major disruption, causing many equipment failures, including all the static switches of the operational room, power supplies, rectifiers, etc.

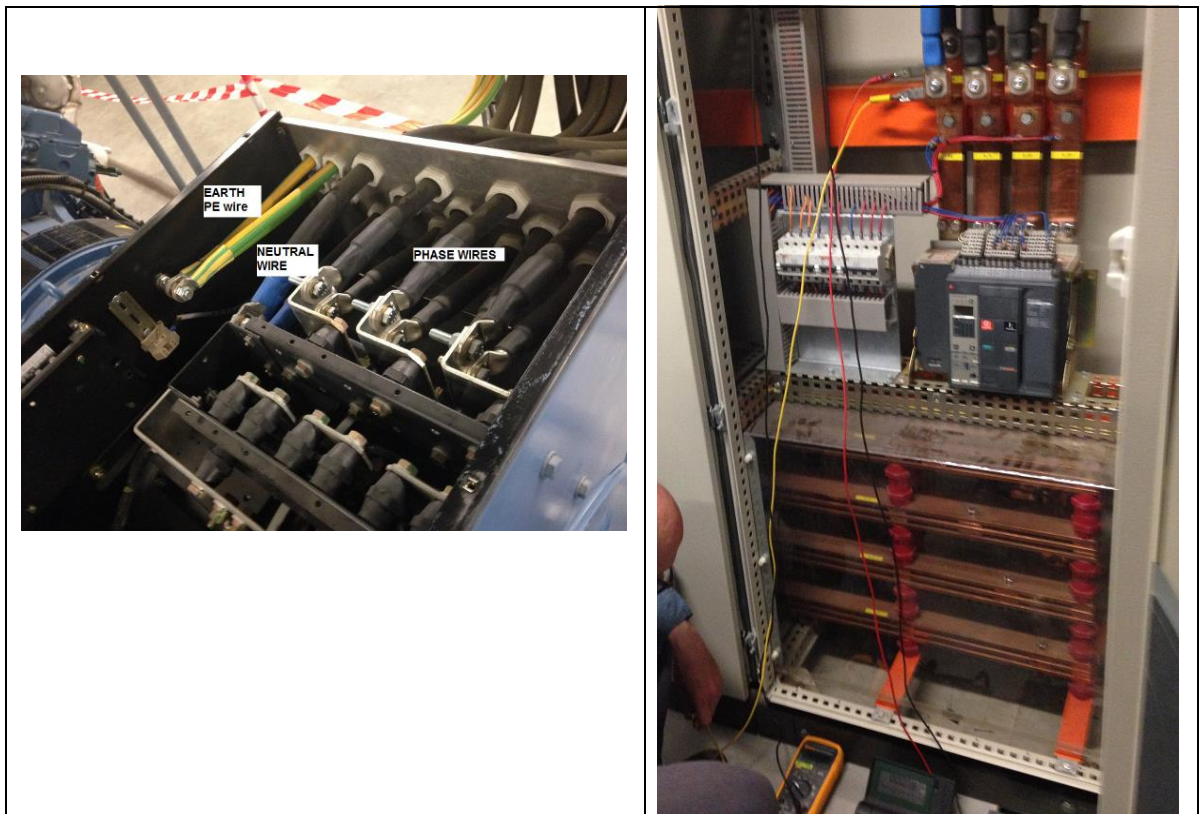
Figure 12: Test of the neutral wire connection

After the incident, an inspection, performed by an independent specialized company demonstrated that the neutral wires of the diesel-powered generators were not connected to the earth.

It is recommended that Belgocontrol would make sure that specific build specifications prepared for future installations and modification to installations involving a main power supply, include a specific requirement to ensure that the Earthing system be verified.

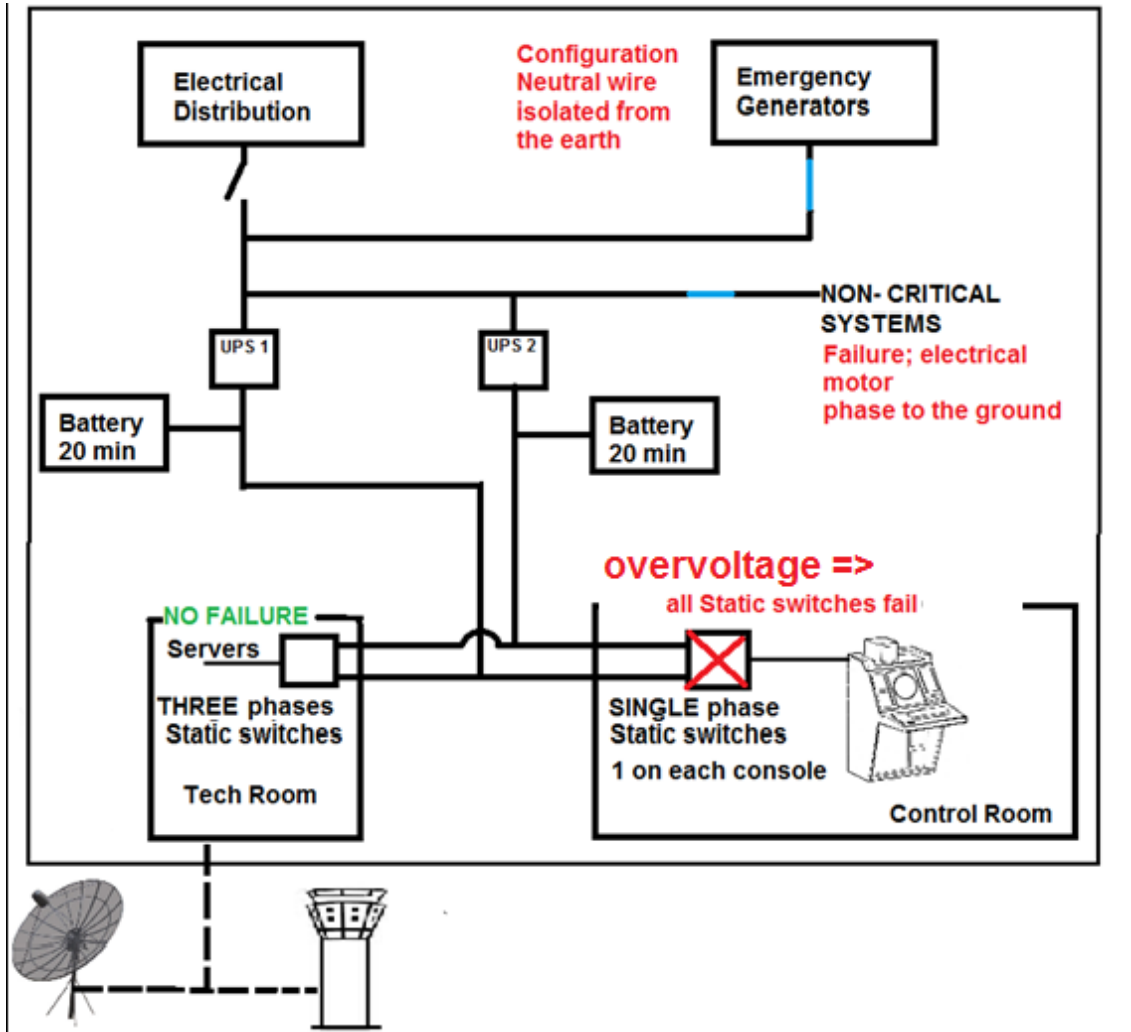
Figure 13: Failure scenario

This failure was caused by a cascade of events, starting by a defect in an electrical motor of an industrial air conditioning unit, causing an important unbalance in the power distribution network due to the absence of earthing of the neutral wire of the diesel-powered generators and resulting in the failure by overvoltage of vital equipment in the ATC control room.

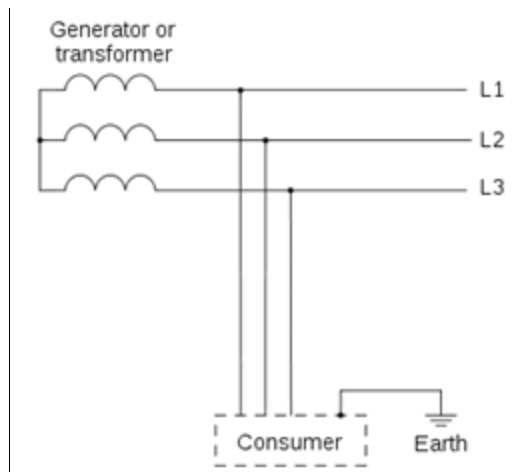
Figure 15: IT Earthing System

The actual wiring connection of the circuit, as found after the event, is similar to an IT earthing system

However, in a IT earthing system, if one of the phase conductors is shortened to earth, it can cause the rising of the voltage of the other phases from 230 V to 400V relative to earth.
