Safety Investigation Report

Ref. AAIU-2016-03r1

SYNOPSIS

Subsequent examination identified the part as a rear latch access door of the Rolls-Royce RB211-535C thrust reverser, released by a Boeing B757-236(SF) aircraft during a flight from EBBR to EDDP on 3 November 2015.

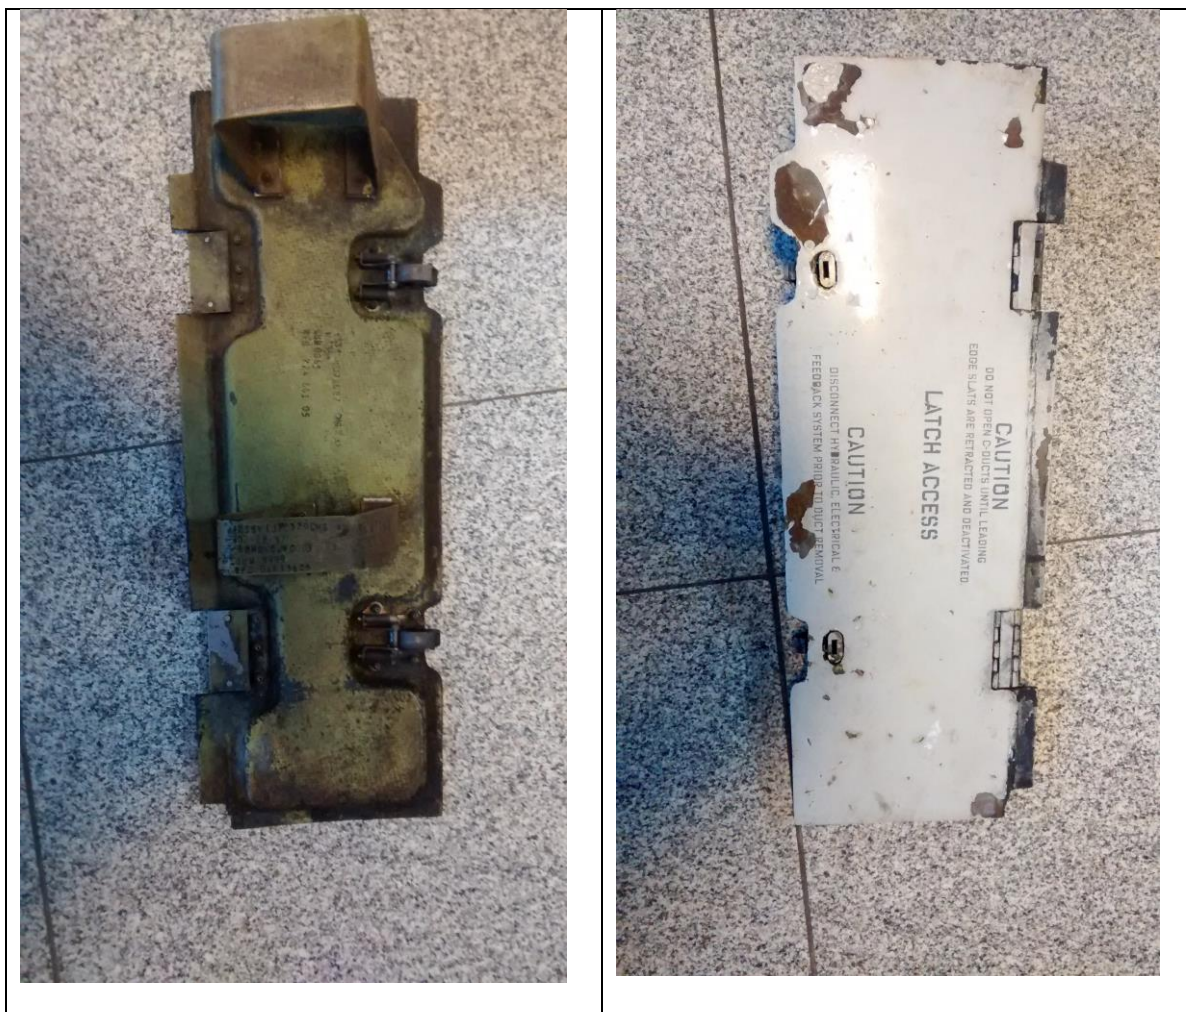
The part bore the part number (P/N) LJ71687, identified as a panel from a reverser door.

The part's dimensions are 57 cm x 21 cm.

Figure 2: the fallen panel (left: interior side, right: exterior side)

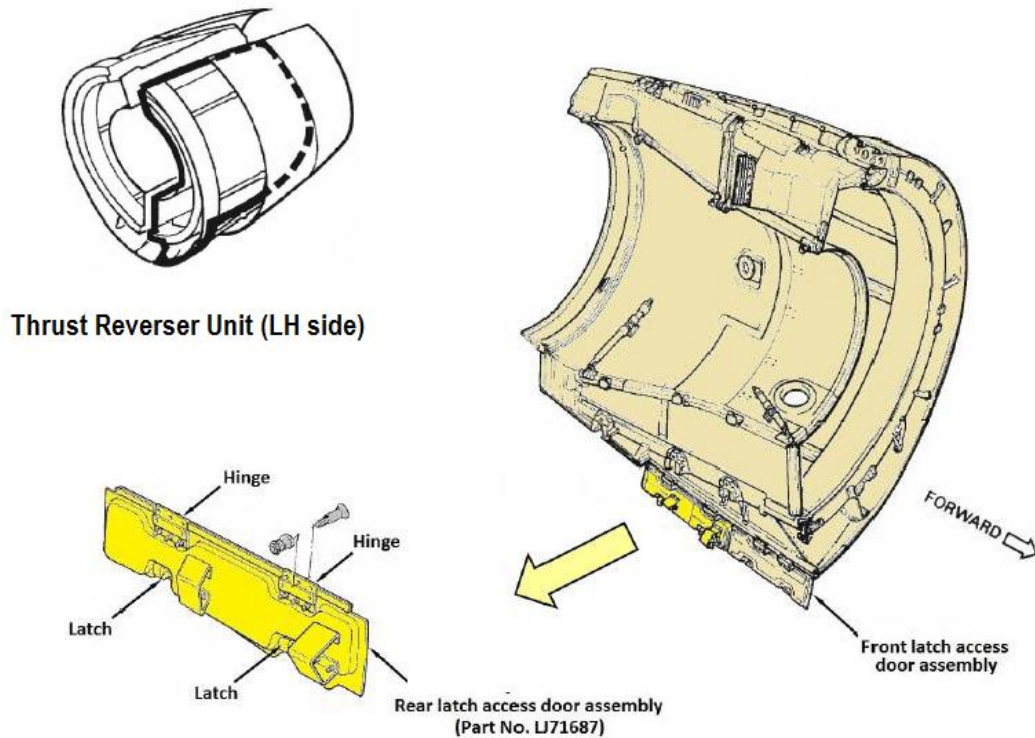
Investigation with Rolls Royce and the concerned operators established that the latch access door was detached from RB211-535C Engine ESN 30083 installed on the N°2 position of a B757-200 aircraft operated by DHL during a flight from EBBR to EDDP on 3 November 2015.

Figure 4 : Location of the latch access door when installed

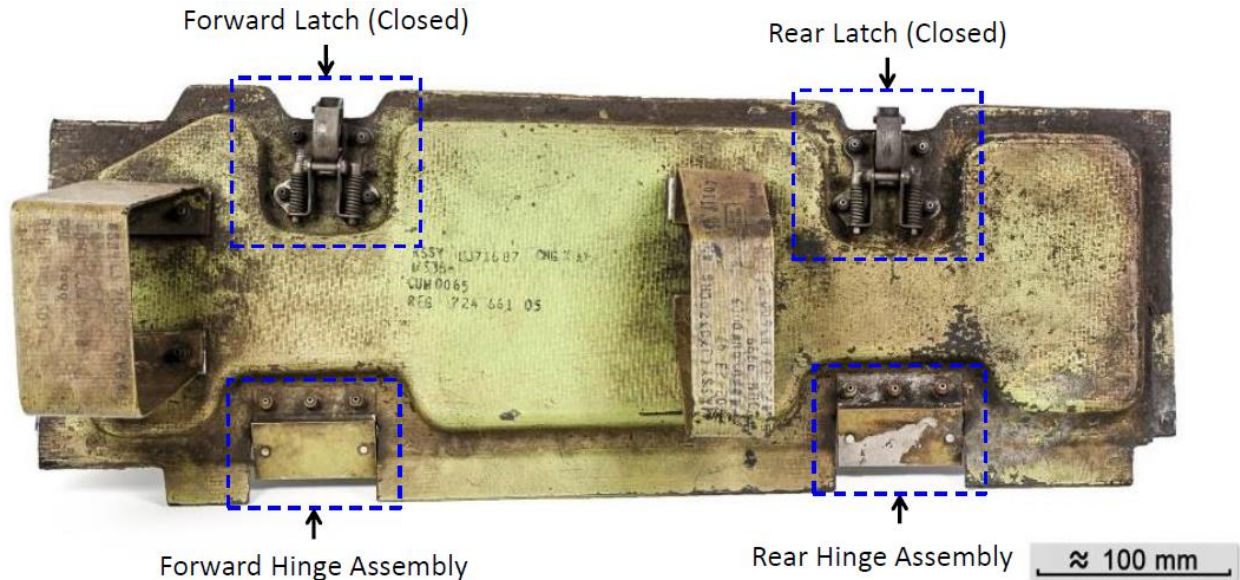
Figure 5

The initial inspection determined that the door had been released due to the break-up of the forward and rear hinges assemblies.

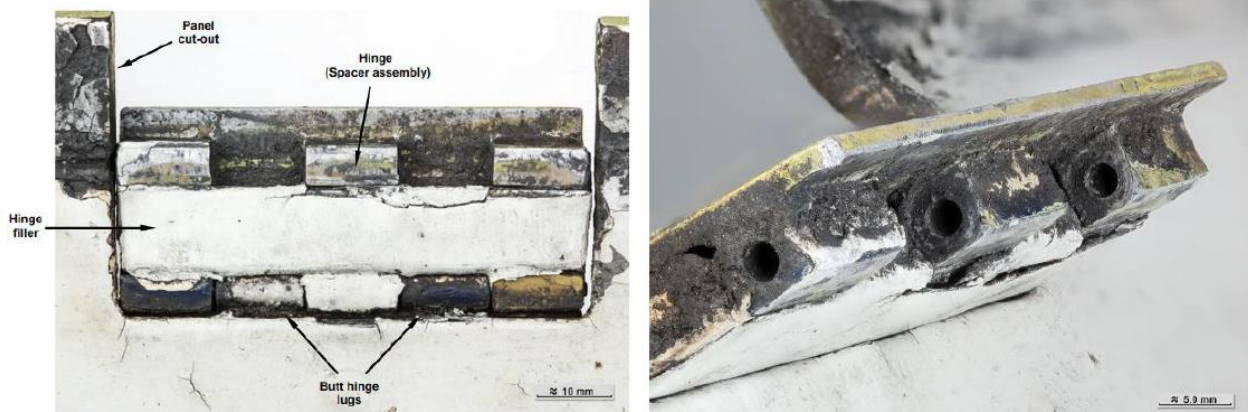
Figure 6 : Forward hinge

The inspection of the forward hinge assembly established the hinge had separated at the butt hinge pivot point on the thrust reverser side of the assembly. The respective hinge pin was completely missing with no remnants of the hinge pin left in the retaining lugs.

General view of forward hinge assembly

Close-up view showing retaining lugs (no evidence of pin remnants).

The release of the subject door assembly was due to separation of the forward hinge which occurred as a result of axial migration of the hinge pin on the TRU side of the hinge assembly. Migration of the hinge pin was due to a combination of in-service wear and insufficient pin retention, allowing the pin to migrate forwards and disengage completely.

- Rolls Royce introduced a Request for Manual Revision (RMR) to introduce a specific wear check of the hinges into the existing AMM Task 78-31-00-210-806-A00 at next publication date (May 2017). All airframes will now be inspected to the new AMM criteria at “C” Check every 18 months or 6000 hours as per MPD task 78-111-00.

DHL is the only operator with RB211-535C powered B757 aircraft in service. They currently operate 17 aircraft. Based on the findings from the investigation, DHL have introduced a special inspection task to check the TRU latch access doors for hinge pin wear and migration at aircraft “A” Check. Inspection of the entire DHL operational fleet has now been completed.

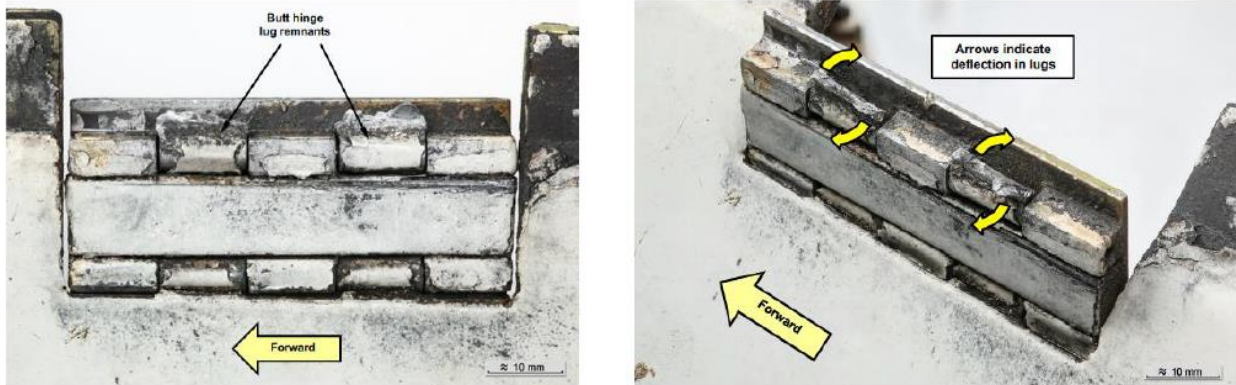
Figure 7 : Rear hinge

The inspection of the rear hinge assembly found that the hinge had separated due to complete fracture of the 2 butt hinge lugs on the thrust reverser side of the assembly.

The deformation in the fractured lugs was consistent with the access door being released at the forward hinge first and then being rotated downwards under aerodynamic loading, fracturing the lugs in overload.

Binocular examination of the fracture surfaces confirmed the lugs had fractured in overload with no evidence of propagated fracture.

Separation of the forward hinge allowed the door to dislodge into the airstream, with subsequent aerodynamic loading causing the rear hinge lugs to fracture in overload, releasing the door assembly.

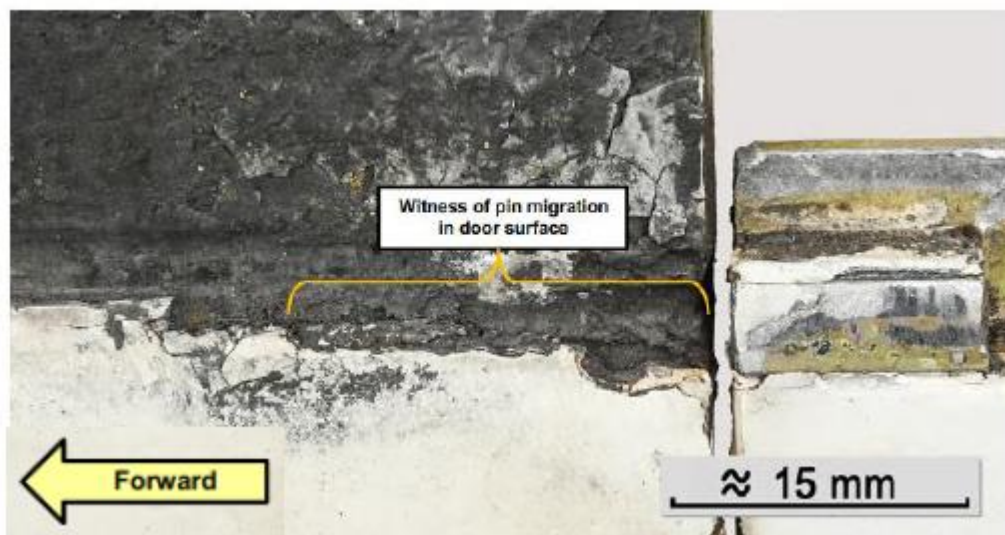
A closer examination of the forward door cut-out adjacent to the missing hinge pin identified evidence that the pin had migrated forwards.

Figure 8 : Marks of migration of the forward hinge pin

This was most likely due to a combination of in-service wear and insufficient pin retention, allowing the pin to migrate forwards and disengage completely resulting in separation of the door at the forward hinge.

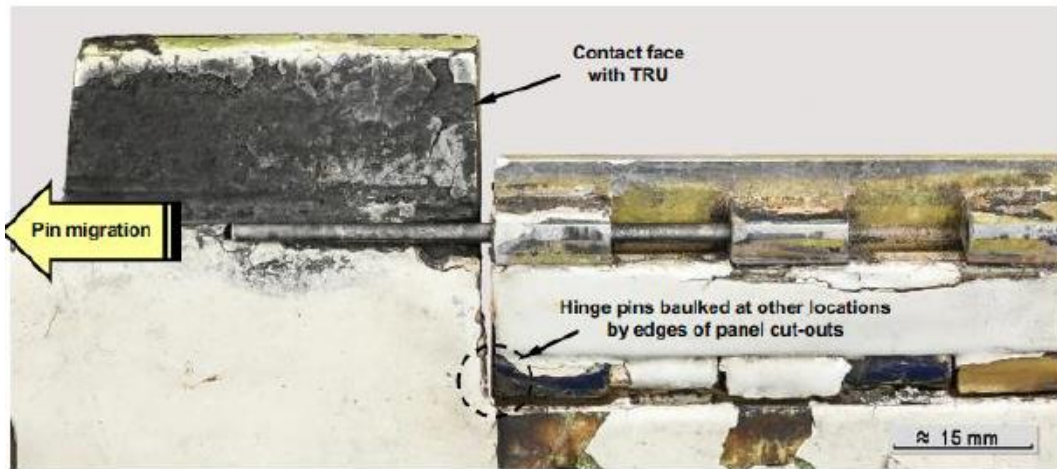
Figure 9

At all the other hinge pin locations the pins were baulked by the edges of the door cut-outs.
