Safety Investigation Report

Ref. AAIU-2015-AII-8
Issue date: 14 August 2016
Status: Final

Classification:	Accident
Level of investigation:	Standard
Date and time:	14 August 2015 – 12:52 UTC
Aircraft:	Homebuilt helicopter, Rotorway A600 Talon, S/N 8040
Operator:	Private
Incident location:	Stasegemsesteenweg, Kortrijk 50°49'51.23"N, 3°17'24.84"E
Type of flight:	Cross-country
Phase:	During take-off from a private terrain
Destination:	EHSE (Breda International Airport)
Persons on board:	Two
Injuries:	None

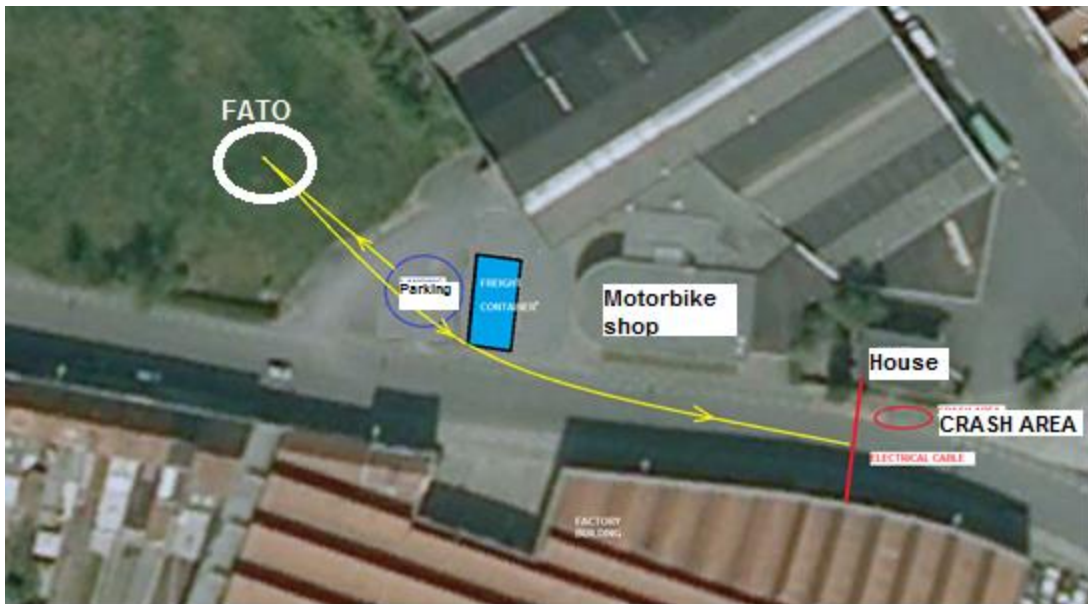
Figure 1: Crash area

During take-off from the side of a street at the verge of the urban area of Kortrijk, the helicopter pilot made an avoiding manoeuvre when the path of the helicopter crossed a telephone line running across the street. The helicopter fell from a height of 4m and hit the pavement, bending the skids. Both occupants exited the helicopter uninjured.

The helicopter jumped upwards, cut the electrical line with the aft rotor. The pilot heard the "low rotor rpm" warning, and lowered the collective. The pilot tried to decrease the rate of descend by pulling the collective just before impact, but could not avoid a hard contact with the pavement at 12.52.

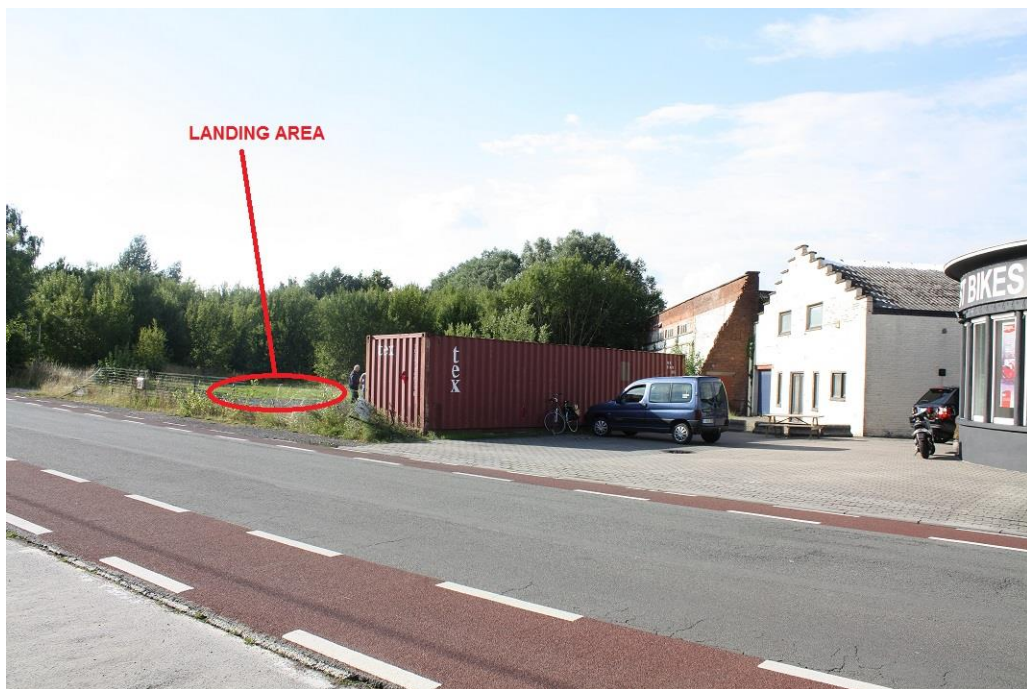
Figure 2: Landing and take-off area

The landing area is a confined space, limited on the East side by a freight container, on the North side by a hangar, on the West by trees and vegetation.

- The freight container (see fig.2), the car parking area (it was not secured) and street lighting poles constitute obstacles protruding through the take-off surface.
- The 50m area around the FATO englobes houses whose occupants have not been notified.
- The vehicles running on the street could be considered as obstacles (assuming a lorry with a height of 4m), as the circulation was not interrupted during the take-off.

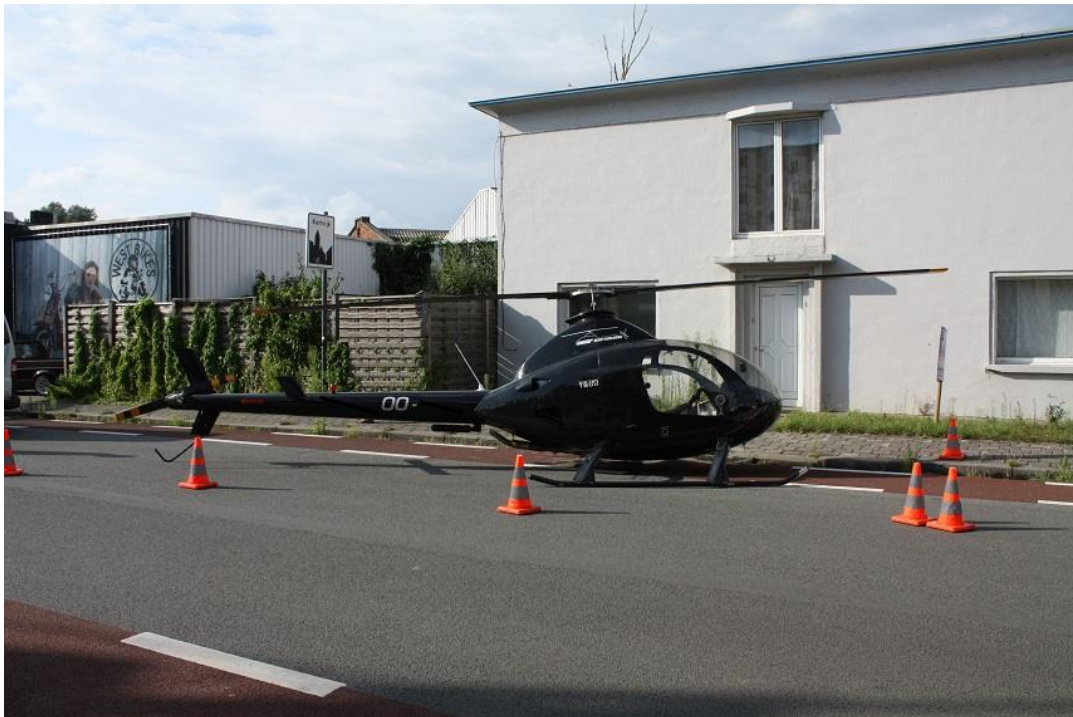
Figure 4: Crash area

The landing area is located within the urban area of Kortrijk (actually, the helicopter landed next to the “urban area” sign – see Fig.4). The pilot stated the FATO was located in an industrial zone, and indeed the area is mostly covered by industrial buildings. However it is itself embedded in an urban zone.

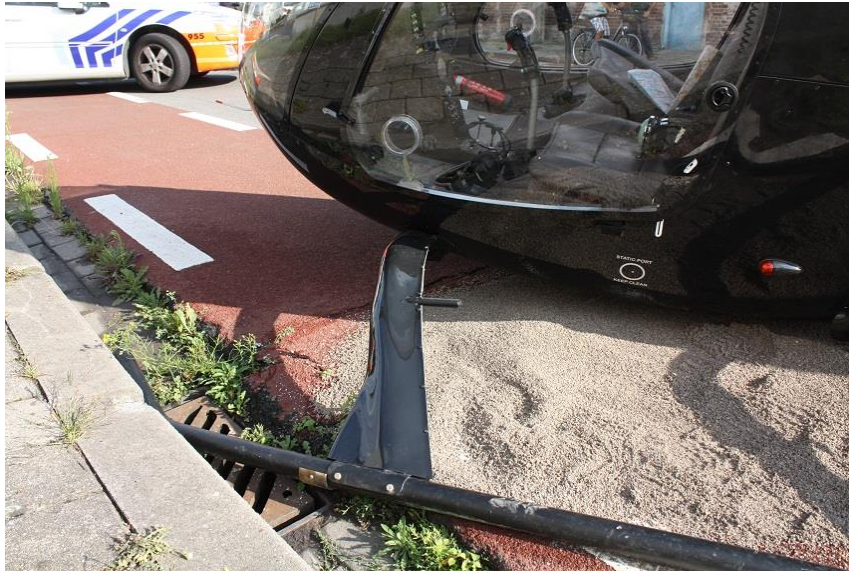
Figure 5: Bent skid

The helicopter skids were bent as a result of the hard landing.

Obvious damage on the skids support. No visible damage on the cabin, boom, rotors.

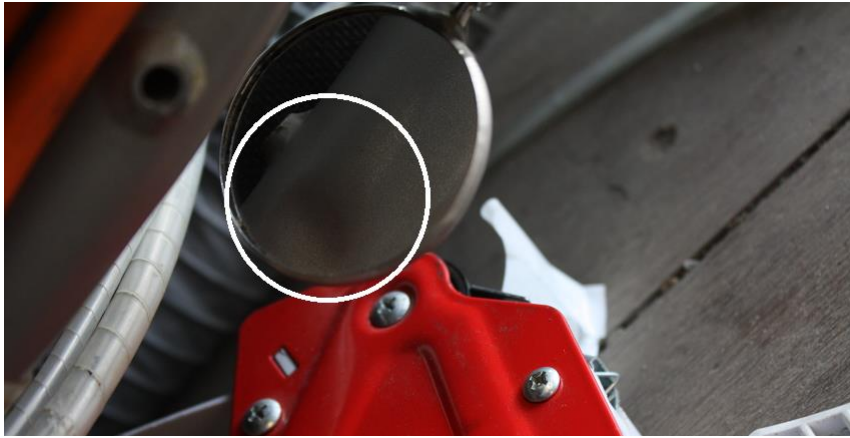
Figure 7: Damage to structure tube

The lower tube structure of the helicopter shows two dents, at the skid attachment.

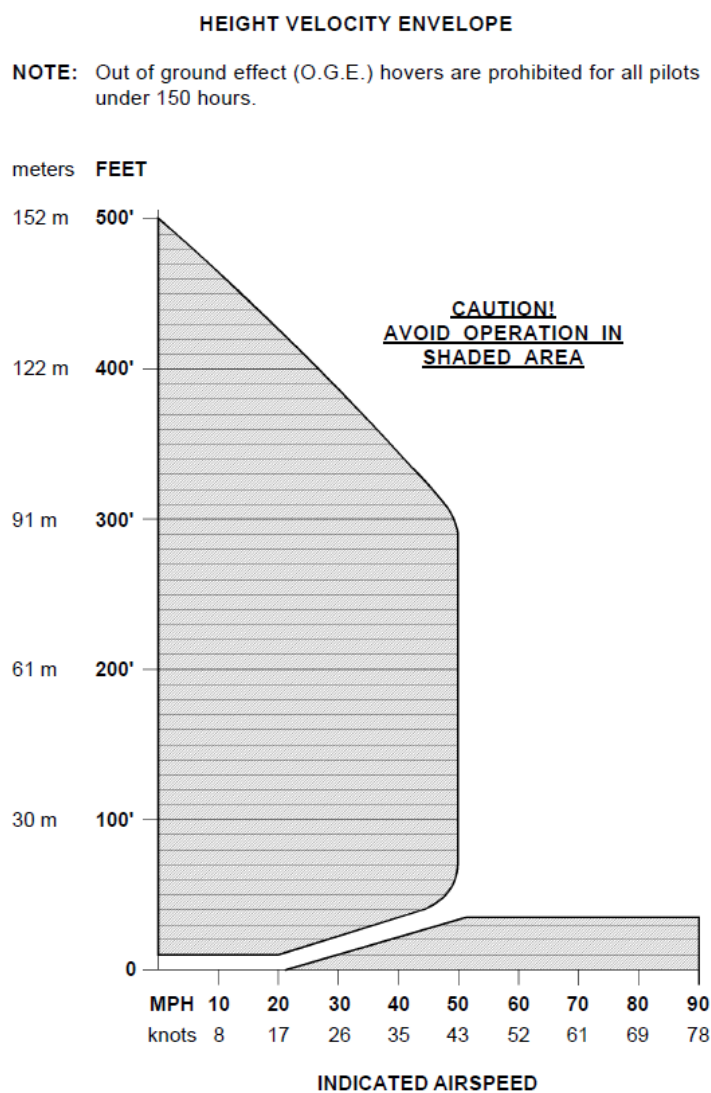
Figure 10: Height Velocity envelope

Obviously, a take-off complying with the height – velocity graph of the helicopter would have taken him at low height, above the road.

The pilot stated also that, owing to the configuration of the take-off area, he could not avoid to fly the helicopter inside the height-velocity diagram.

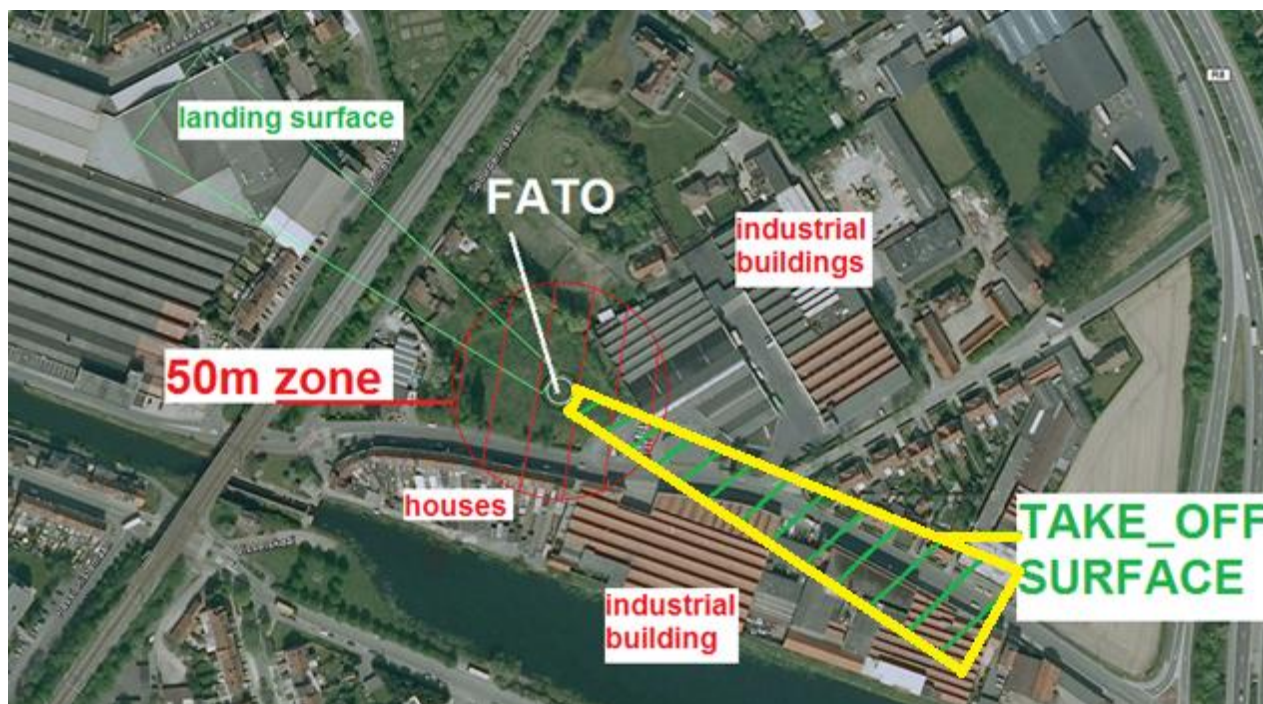
Figure 12: Take-off zone

The flight preparation failed to identify the potential dangers, such as lighting poles and the electrical wire.
