Safety Investigation Report

Ref.:
AAIU-2017-11-19-01

Issue date:
22 January 2021

**ACCIDENT
ULTRALIGHT ESQUAL VM 1C
AT LANDEGEM
ON 19 NOVEMBER 2017**

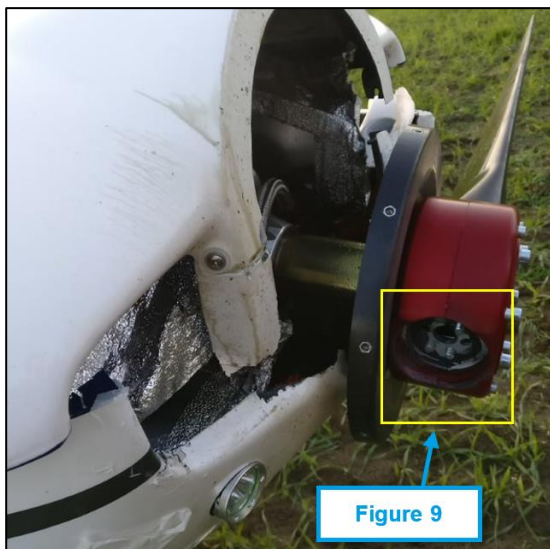
In addition to the propeller failure, the engine rear plate and the engine mount suffered significant damage causing the engine remaining attached to the airframe structure at only one location instead of four. The oil cooler and its flexible lines were ruptured causing an oil leak. The engine cowlings were damaged by the movement of the engine inside the engine compartment.

The dashboard attachments were also found broken. It is expected that the structure of the aeroplane, the accessories and the instruments also could have suffered from the heavy shocks caused by the unbalance of the separated blade of the propeller.

The nose landing gear fairings were damaged by the severe shocks sustained when the propeller separated or during the forced landing roll on a soft ground field during.

Figure 8 : overview of the damage at the nose of the A/C

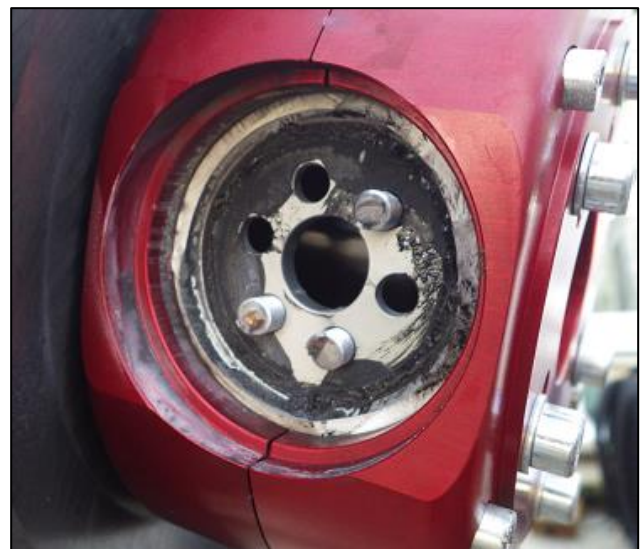
Figure 9 : zoom on the damage of the hub

The measured torque of the 2 bolts located along the separated root blade was determined to be about 6 Nm. This insufficient torque can be explained by the partially missing blade root that released partially the originally applied torque.

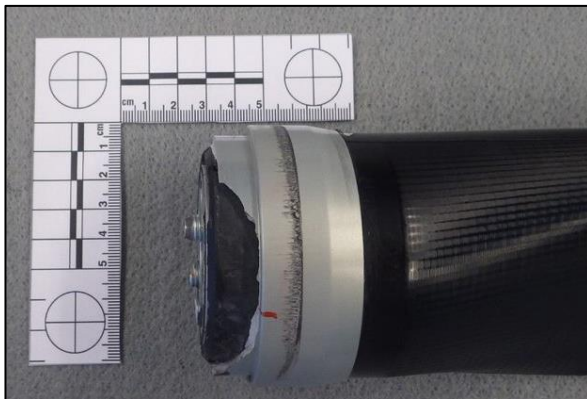
Figure 10 : root of the lost propeller blade

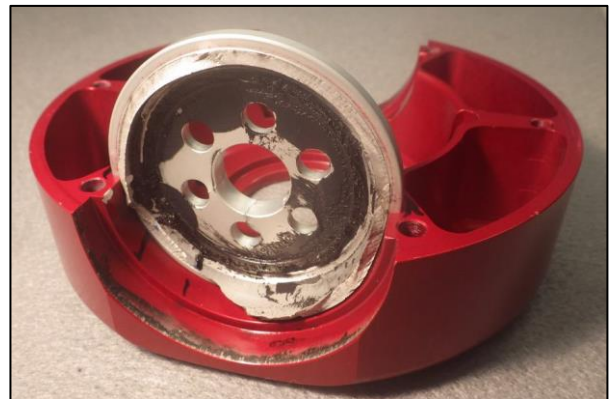
Figure 11 : broken part of the blade root left in the hub

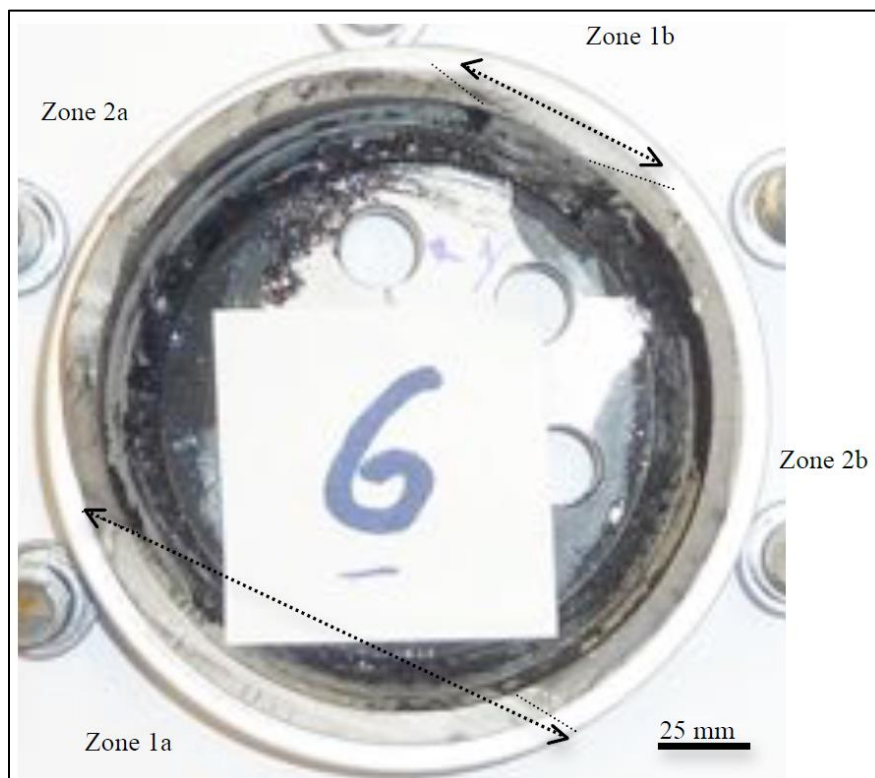
The examination concluded that the propeller blade failed due to fatigue, causing the fracture of the aluminium root fitting. The fatigue crack started in the shouldering of the ring, where a stress concentration is present. The bolt fractures and the grooves on the hub halves are consequential damage. The full report of the laboratory is in appendix.

Figure 12 shows the part at higher magnification. 4 zones have been identified:

- zone 1a (indicated by the larger double arrow): exhibits a very smooth aspect with very clear beach marks; these beach marks indicate presence of a fatigue phenomenon;
- zone 1b (indicated by the smaller double arrow): has an aspect similar to that of zone 1a but is smaller; this zone also shows beach marks indicating presence of fatigue;
- zone 2a and 2b: these zones make up the rest of the fracture surface between the zones 1a and 1b. They correspond to the overload fracture.

Figure 12 : fracture surface of the fixation ring of propeller blade 2; indication of particular zones (the number 6 is an identification tag used by the lab)

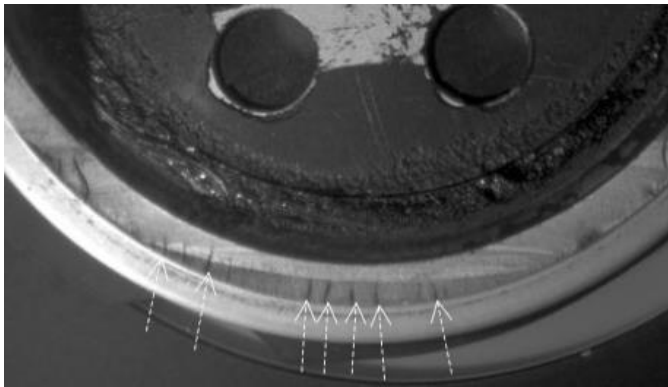
Figure 13 : detail of zone 1a with presence of beach marks; white arrows indicate multiple initiation points of the fatigue crack

As indicated on Figure 13, zone 1a shows small terraces, which indicate multiple initiation points of the fatigue phenomenon; therefore it is very likely that the stress loading to the crack was rather high. This is also in agreement with the location of the crack in the shouldering of the ring. At this location there is presence of a large stress concentration, which is very probably the cause of the crack initiation. Because of the high stress level, the fatigue phenomenon can be classified as low cycle fatigue, leading to the inevitable overload failure.

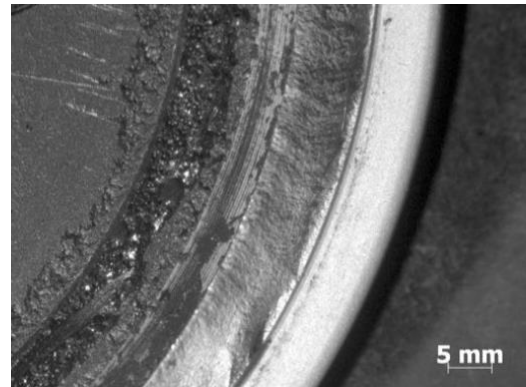
Figure 14 : detail of overload zone 2b

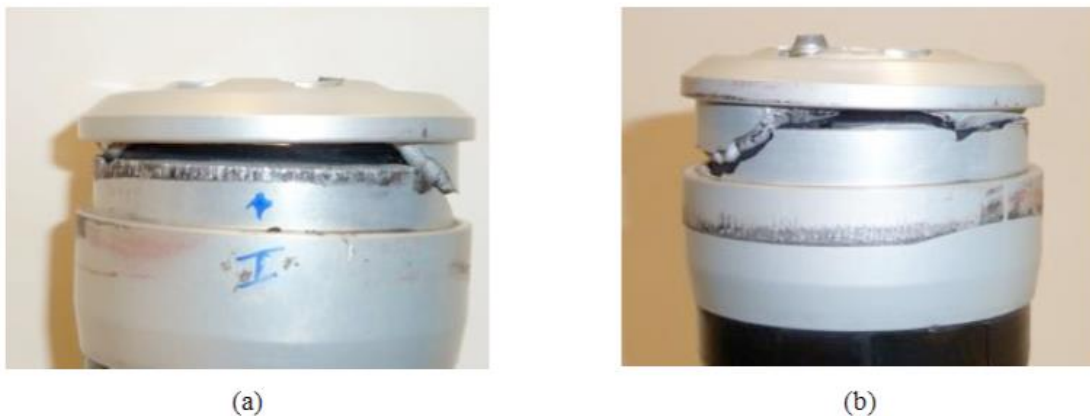
Figure 3 (a) and (b) give a global view on the two complementary fractured parts of the failed propeller fixation ring. On both pictures one clearly sees surface grooves parallel to the propeller axis. As will become clear from the rest of current analysis, these grooves were created after the primary fracture of the fixation ring by centrifugal projection of the propeller blade from its position between the hub halves. The observed grooves indeed correspond to those observed on the interior surface of both hub halves (see figures 15 and 16).

Figure 3: both complementary parts of the fractured fixation ring have been put together; they exhibit perfectly axial surface grooves caused by centrifugal projection of the blade after primary failure of the fixation ring

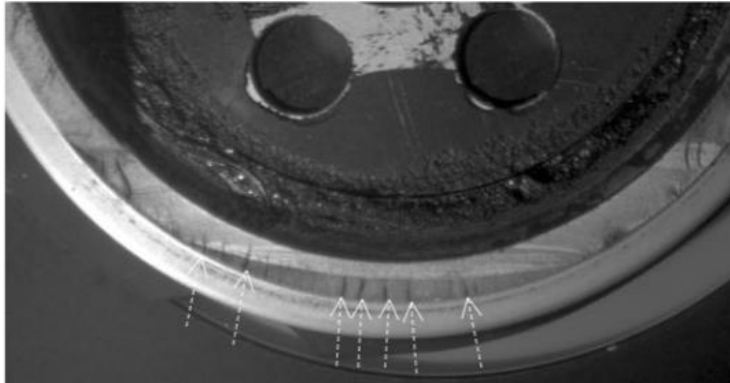
Figure 7: detail of zone 1a with presence of beach marks; white arrows indicate multiple initiation points of the fatigue crack

As indicated on figure 7, zone 1a shows small terraces, which indicate multiple initiation points of the fatigue phenomenon; therefore it is very likely that the stress loading to the crack was rather high. This is also in agreement with the location of the crack in the shouldering of the ring, as can be clearly seen on figure 3a. At this location there is presence of a large stress concentration, which is very probably the cause of the crack initiation. Because of the high stress level, the fatigue phenomenon can be classified as low cycle fatigue, leading to the inevitable overload failure. It is noted that the overload failure doesn't follow the shouldering. Finally, the presence of a second fatigue zone, zone 1b, indicates the presence of a reversed bending component on the propeller blade.

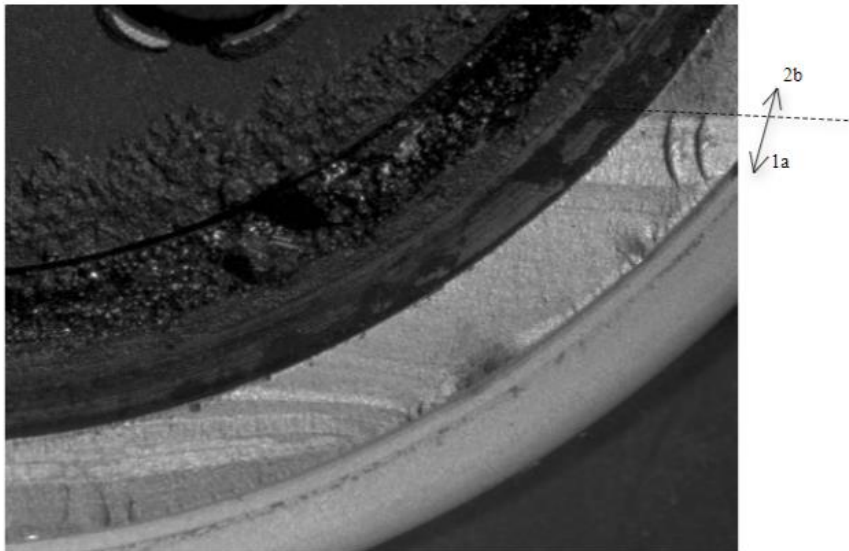
Figure 8: detail of zone 1a with indication of the transition of the fatigue zone towards the overload zone 2b

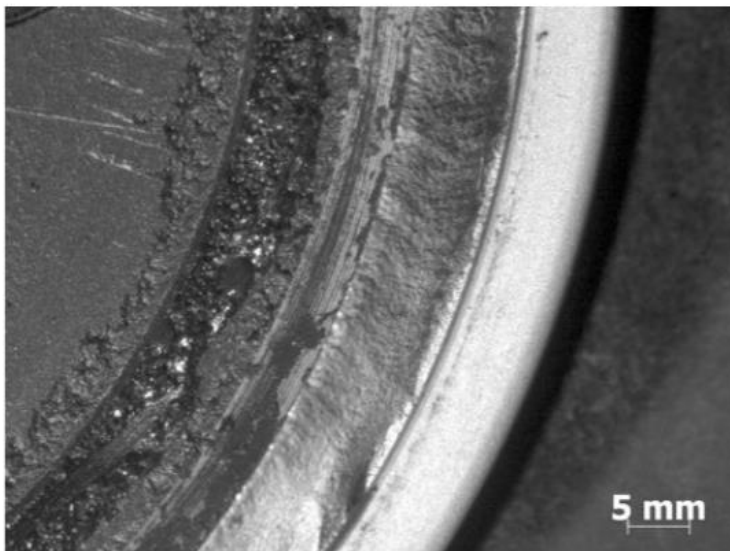
Figure 9: detail of overload zone 2b

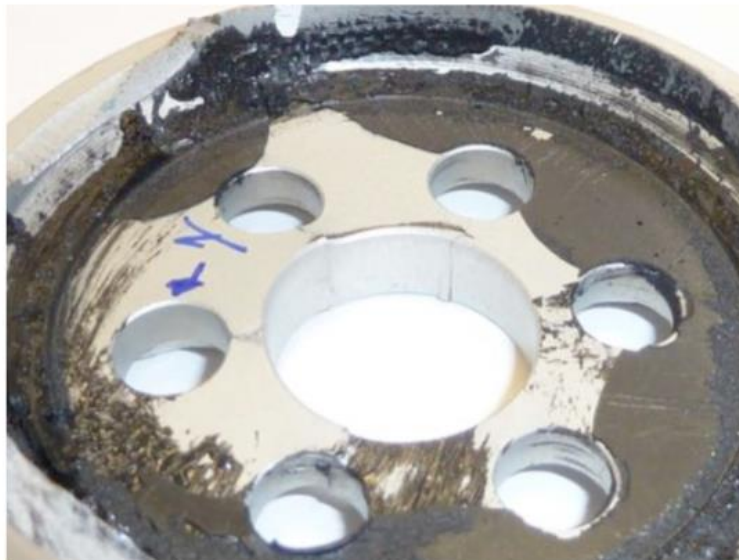
To conclude the fractographic analysis, secondary cracks have been observed in the fixation ring (see figure 10). They are located near the boreholes at the weakest section; all 6 holes exhibit a crack. They are the result of compressive stresses applied by the bolt heads on the fixation ring. Figure 11 shows a detail of hole No. 1 indicated on figure 10.

Figure 10: view on the fixation ring and the cracks in the weakest section near each hole;

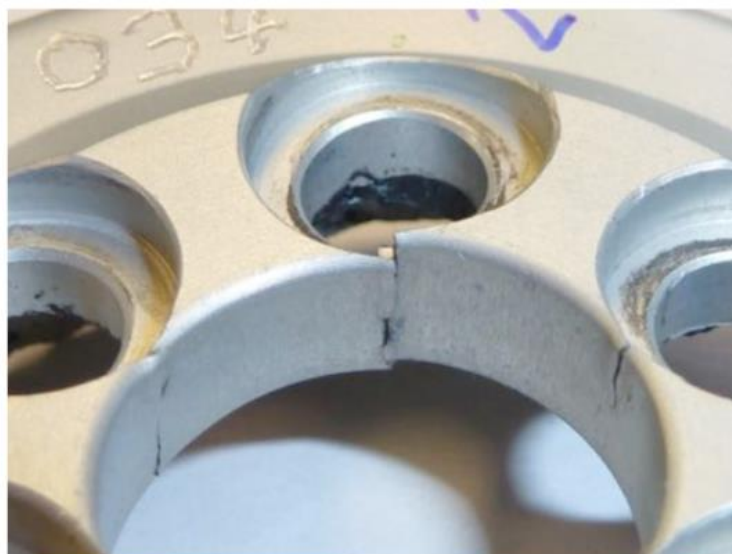
Figure 11: detail of the crack near hole No. 1, as indicated on figure 10

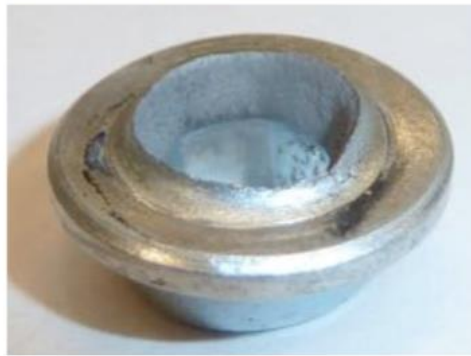
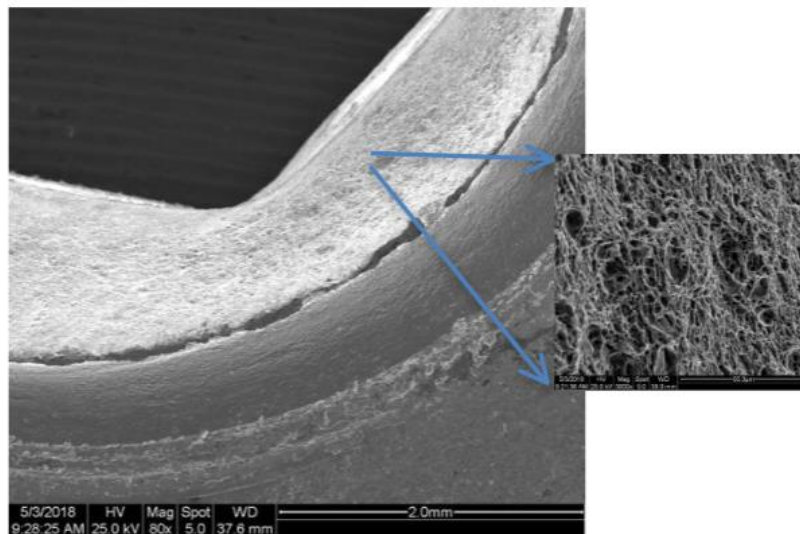
Bolt No.1 has failed in its head by shearing off; this is a typical failure mode for this type of bolts with hexagonal Allen key socket. Figure 12 and 13 show the overload fracture surface of bolt No. 1.

Figure 12: overload of bolt No. 1; ductile shearing off of the head

Figure 13: SEM picture of fracture surface of bolt No. 1; insert showing dimples indicating a ductile overload

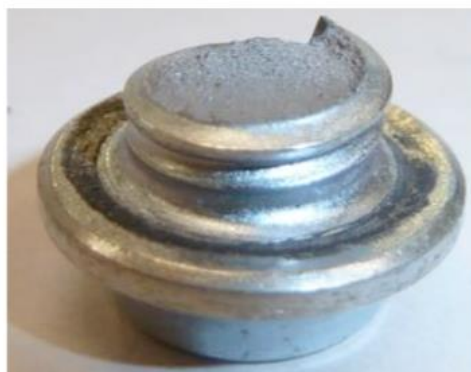
The 5 remaining bolts have all failed in the shank in a ductile way typical for overload. As an illustration, figure 14 shows the fracture surface of bolt No. 3

Figure 14: ductile fracture surface of bolt No.3

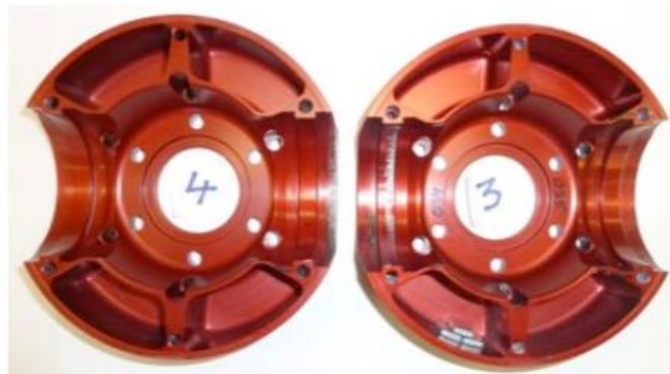
Both hub halves are intact, except for axial grooves (in the direction of the propeller blade) as can be noticed on figure 15 and 16. This indicates that the grooves were created during the axial movement during and immediately after breaking of the fixation ring of the propeller blade 2.

Figure 16: view on both hub halves, showing sliding grooves created by failure of propeller blade 2; no significant traces have been observed on the location for undamaged propeller blade 1

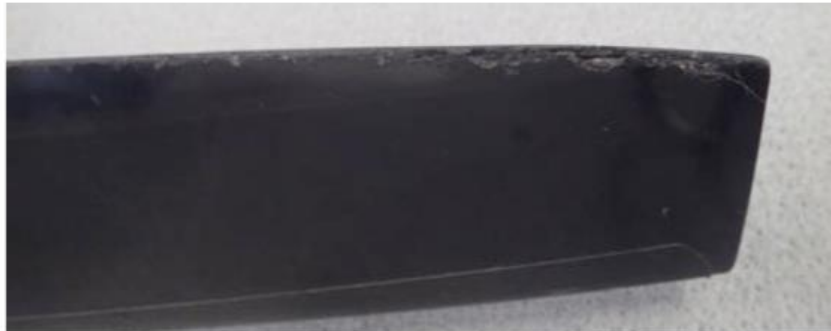
Figure 17 shows the trailing edge of the extremity of blade 2; two particles have been found (see figure 18(a) and (b)). Both particles have a brownish colour and a fibrous texture. The EDX spectrum of particle 1 (see figure 19) reveals carbon and oxygen (hydrogen is not visible using EDX) and a variety of elements between Na and Cu. Particle 2 has a similar spectrum. Both particles are organic, probably wood, with small contaminations of other elements.

Figure 17: extremity of blade with damage on the trailing edge

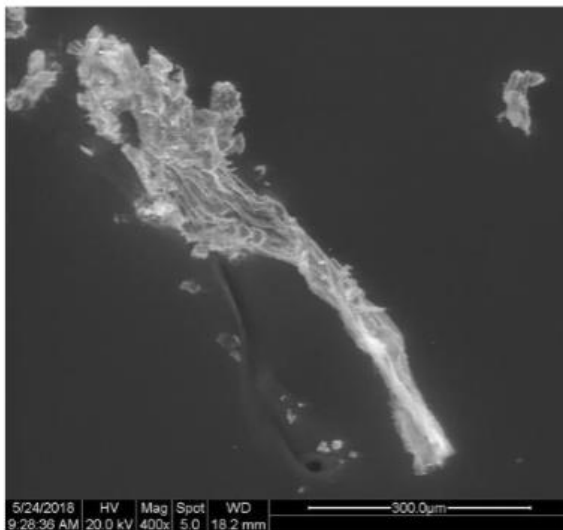
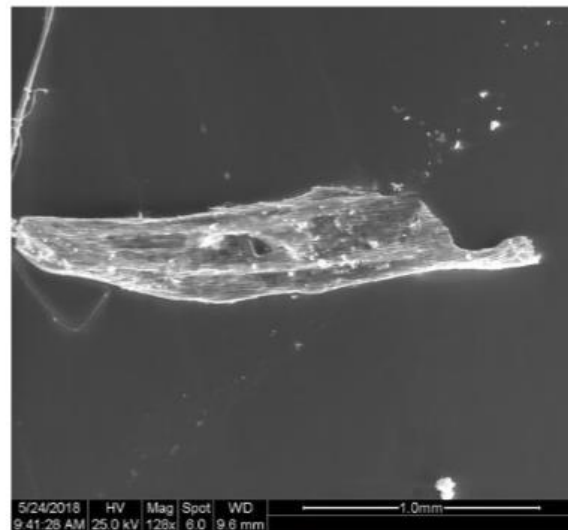
Two organic particles have been found on the damaged trailing edge of propeller blade. These particles are very probably small chunks of wood with contaminants. There are no indications that these particles and the damage of the blade are at the origin of an accidental load having caused initiation of the fatigue crack.

Figure 18: two particles with fibrous texture found in the damaged zone of the blade extremity
