Safety Investigation Report

Ref.:
AAIU-2017-55

**SERIOUS INCIDENT
CESSNA 152
AT TEMPLoux
ON 31 OCTOBER 2017**

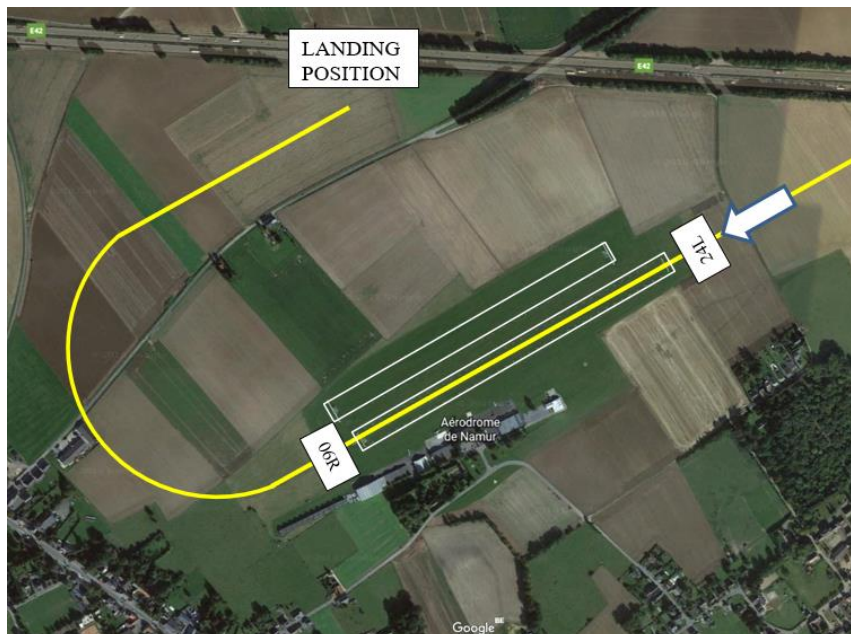
Already descended to 300 ft AGL, and still in the downwind leg, the pilot took the decision to make an emergency landing in a field. The airplane landed on an open field, rolled for 150 m and came to stop in an adjacent beet field without any damage. The occupants could evacuate the aeroplane uninjured.

Figure 1: Approximate flight path and final position after the forced landing

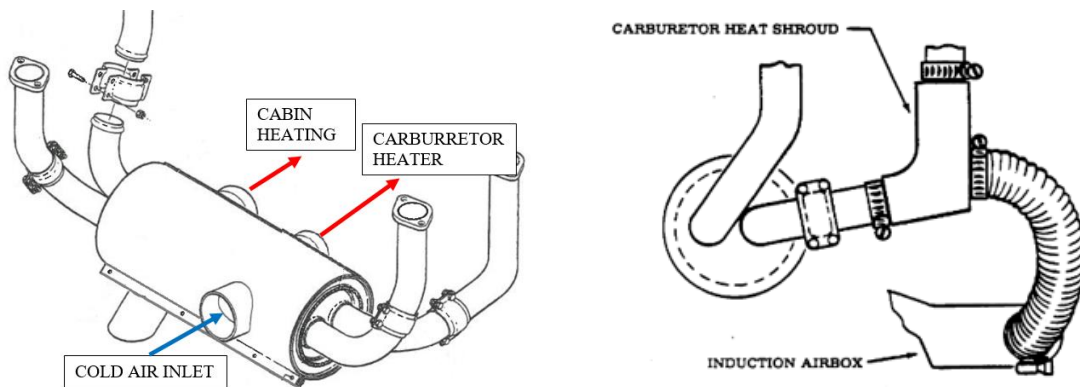
- A chamber located between the shroud and the exhaust muffler. In this configuration, there is no filtering system installed, or
- A shroud located close to the exhaust pipe of cylinder 4. This shroud is equipped with a screen filter featuring a square-mesh size of about 3 mm.

The affected aircraft was equipped with the first type (a chamber between the shroud and the exhaust muffler).

Figure 2: exchanger using the heat of the muffler. Figure 3: exchanger using the heat of an exhaust pipe.

It is recommended that Cessna - Textron Aviation installs an adequate screen filter in the heater air induction system of Cessna 152 aeroplanes, to avoid the penetration of contaminants in the carburettor float chamber which have the potential to reduce the fuel flow at the carburettor main nozzle and cause an engine loss of power or stoppage.

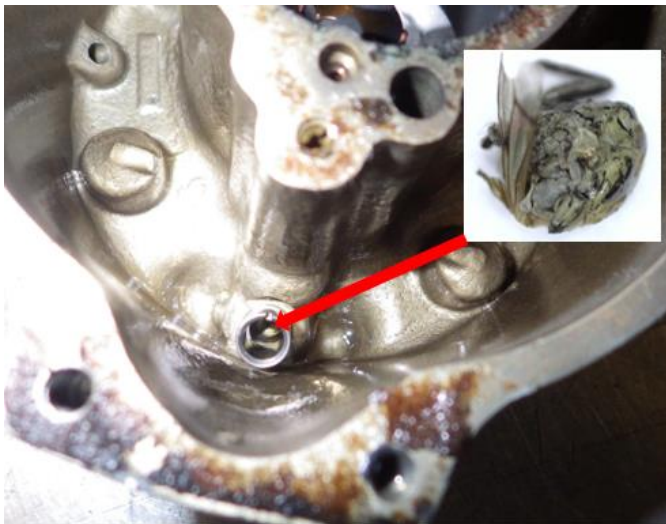
The carburettor was removed from the engine sump and disassembled. After disassembly of the bowl and throttle body, it became possible to access the float chamber where a small dead insect was found inside the carburettor's mixture metering sleeve, at its bottom, leading to the fuel nozzle. The dead bug (about 2,7 mm diameter) was blocking the fuel flow to the fuel nozzle.

Figure 4 Location of the fly in the sleeve of the metering valve.

The cause of the engine malfunction and the subsequent forced landing is the contamination of the carburettor float chamber by a small insect (fly) that obstructed the fuel feed to the main nozzle. The insect entered inside the float chamber of the carburettor via the vent of the float chamber of the carburettor.

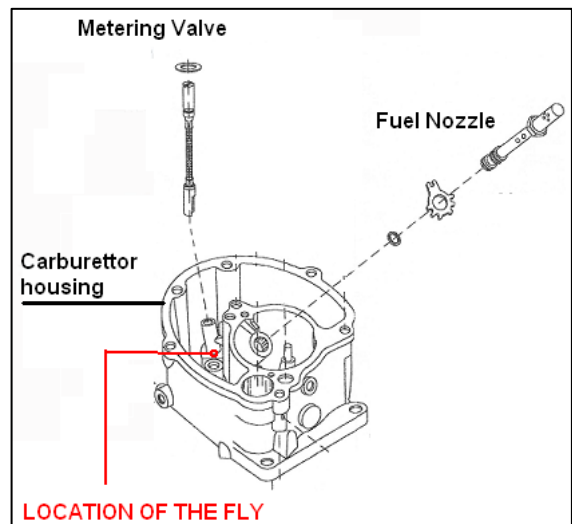
Figure 5/ View of the carburettor bowl

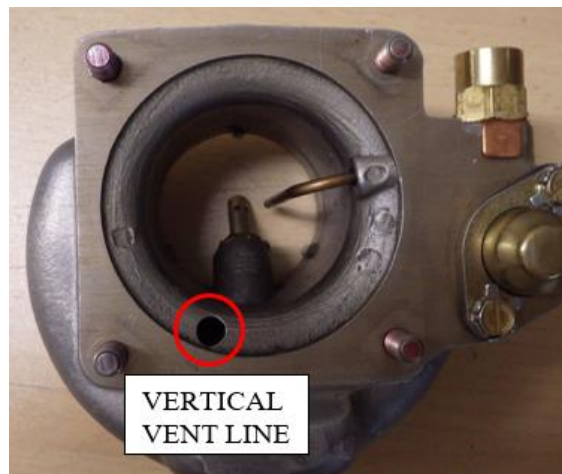
Figure 6: Bowl assembly (Picture taken upside down)

Although the vent line of the main fuel nozzle and idle is protected against the penetration of possible contaminants by a 6 mm diameter fine screen filter, there is no protection in the venting of the float chamber.

The screen filter of the vent line of the main fuel nozzle and idle is installed at the joint surface of the bowl and throttle body. The rationale for the installation of a filter at that place and not at the common vent passage of the float chamber and the main fuel nozzle and idle could not be determined.

AAIU(Be) is of the opinion that the installation of an adequate filtering system in the vent line of the carburettor is the best way to prevent the contamination of the float chamber. It has to be noted that in the Marvel Schebler MA-3PA model carburettors, the common vent passage to the float chamber and the main fuel nozzle is not equipped with a filter but the main fuel nozzle has its own fine screen filter located further in the vent circuit. The justification for the installation of a filter at that place and not somewhere else in the common vent passage, which would have the advantage to protect both the float chamber and the main nozzle, could not be determined during the investigation.

It is recommended that Lycoming Engines identifies the different Lycoming engine models using a carburettor featuring a design similar to that of the Marvel Schebler MA-3PA carburettor where the vent of the float chamber is directly exposed to the penetration of contaminants, and installs a filter in the vent line of these carburettors to prevent the risk of contamination of the fuel chamber.

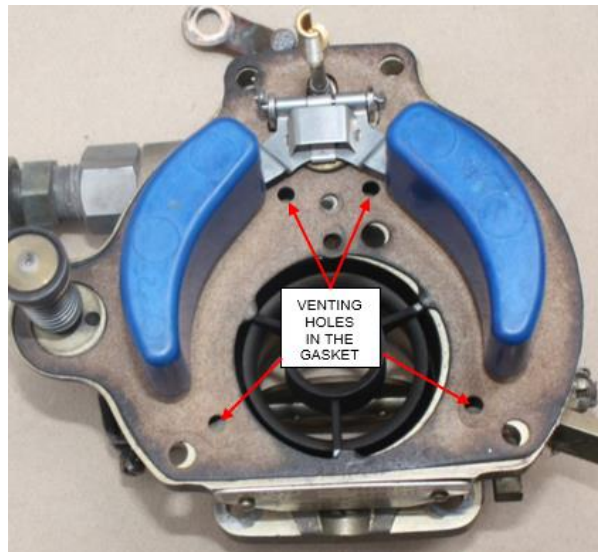
After entering inside the carburettor through the vertical vent line, the contaminants will first fall on the gasket installed between the bowl and the throttle body before falling in the float chamber through the gasket's venting holes. If such a contamination of the fuel occurs, the contaminant will either float in the fuel or sink at the bottom of the float chamber depending on its density. Thereafter, it will be carried away by the fuel flow towards the carburettor's mixture control sleeve. This could obstruct the nozzle, causing an engine failure.

Figure 7: throttle body shown upside down before removal of the float and the gasket

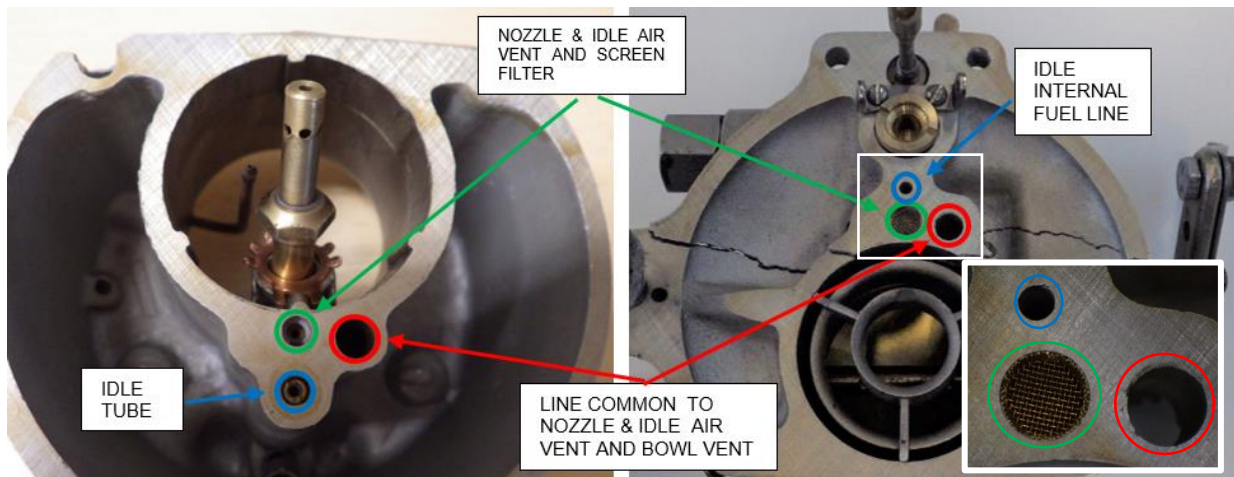
Figure 8: Bowl assembly

Figure 9: Throttle body, installed upside down

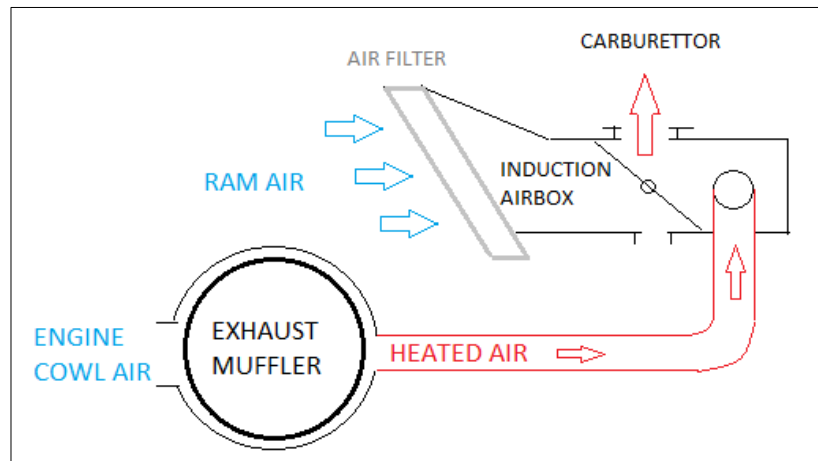
When the carburettor heater is selected by the pilot, the flap inside the heater box rotates anti clockwise (as shown in Figure 10) causing the interruption of the ram filtered airflow and the intake of non-filtered heated air coming from the heat exchanger. From that time, the airflow entering in the carburettor inlet can transport contaminants towards the carburettor inlet, presenting a serious risk of contamination of the float chamber.

Figure 10: Sketch of the air induction system

It has to be noted that the last manufactured C152s incorporating a coarse square-mesh screen filter at the carburettor heat shroud will not be able to retain small bugs like the one that penetrated inside the carburettor bowl (the approximate largest dimension of the bug was 2,7 mm).

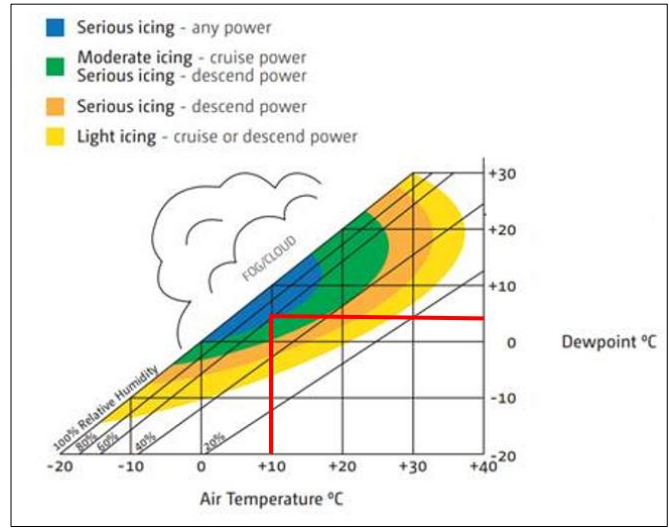
The meteorological conditions (Temperature: 10°C - Dew point: 4°C) at the time of landing were conducive to carburettor icing. The figure below shows that “Serious icing at descent power” prevailed when the incident occurred.

Figure 12: Figure showing that a risk of serious icing was present at descent power.

The use of carburettor heater, recommended as a standard procedure in the Flight Manual, was therefore justified and adequate during the descend.

However, applying the carburetor heater during the final approach, as recommended by the Flight Manual, implies a risk to ingest dust or insects at low altitude through the carburetor heat system. This can lead, as in this case, to the engine stoppage.

It is recommended that Cessna – Textron Aviation modifies the Flight Manual of Cessna 152, Section 4 – Normal procedures to move the item requiring to put carburettor heat on cold from the ‘After landing’ paragraph to the ‘Landing’ paragraph. This in order to leave the option to the pilots to put the carburettor heat on cold in the final phase before touchdown. Additionally, the flight manual should contain a warning on the dangers (like contamination) of the use of the carburettor heat on and close to the ground, especially at grass and other soft fields.

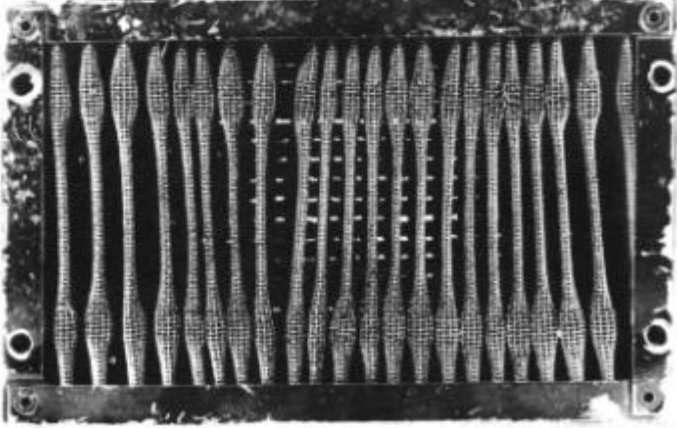
The purpose of the carburetor air filter is to remove dirt and abrasive particles from the air before it enters the carburetor. When the carburetor air filter has not been properly maintained, the result is the same as operating without a filter. The most common result of dirt entering the engine is worn piston rings and excessive ring groove wear. As ring groove wear progresses, ring breakage will eventually result.

Figure 1. Example of Deteriorated Carburetor Air Filter

a. The filter must be cleaned daily when operating in dusty conditions. When operating in other than dusty conditions, inspect the filter daily and clean when required. If any holes or tears are noticed, the filter must be replaced immediately. The required maximum time for servicing these filters is 25 hours.
