Federal Public Service  
Mobility and Transport  
Air Accident Investigation Unit

# Safety Investigation Report

## ACCIDENT YAKOVLEV 52 AT COUVIN ON 14 FEBRUARY 2017

Ref.:  
AAIU-2017-AII-02

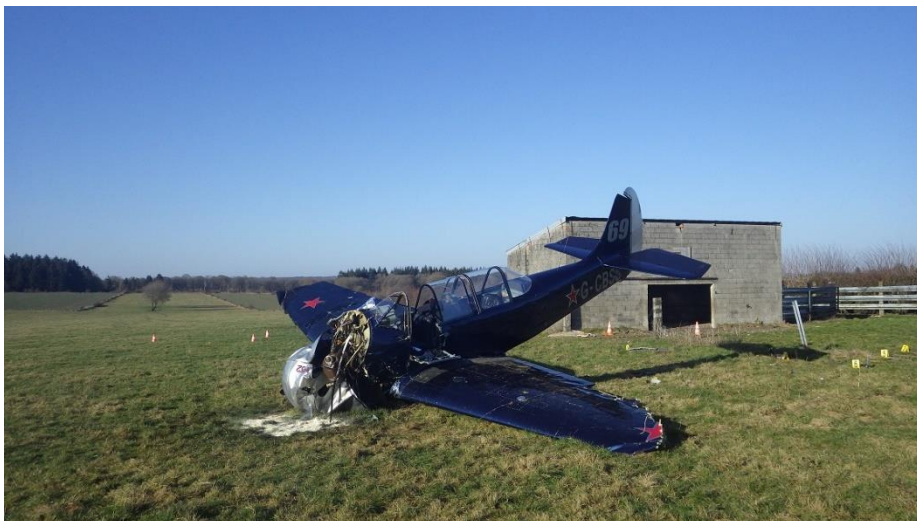
Figure 8: Final rest of the wreckage

Both wooden propeller blades disintegrated on impact with the ground and their remains were found at different places. The blade roots were still connected to the propeller hub. The front underside of the engine impacted the ground. The engine separated from the fuselage with the crankshaft pointing towards the R/H with respect to the direction of the fuselage. Despite this, some engine control cables and fluid lines were still connected to the airframe. At impact, the nose landing gear partially detached rearwards and impacted the underside of the fuselage. The front underside of the fuselage structure moved upwards towards the inside of the cabin to such an extent that there was very little space available for the pilot's legs. The pilot's foot rests are displaced at the same level as the seat base. The left wing aileron and a part of the trailing edge of the wing were severed and rested near the pole of a fence located between the initial impact location and the wreckage.

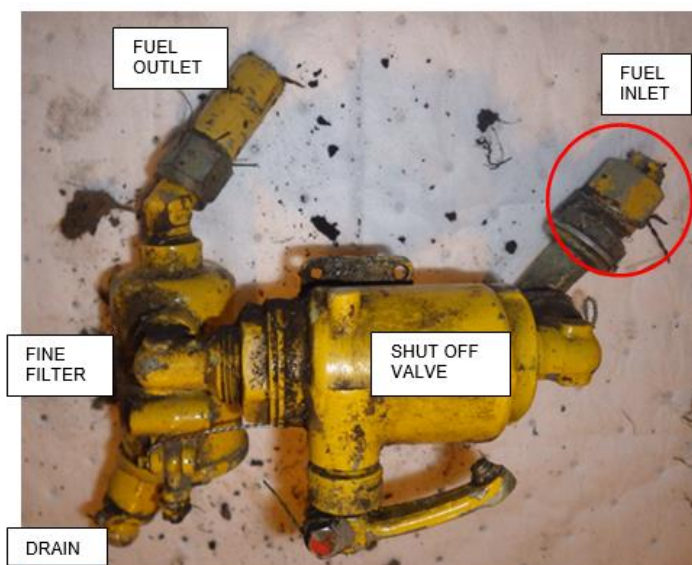
The fuel shut off valve and the coarse filter, both yellow painted, were found still attached on the remains of the fire wall but they had moved from their original location on the left side of the firewall to the right side. The fuel line connecting the collector tank to the inlet of the fuel shut off valve was severed at the elbow of the shut off valve. The inside of the elbow was found filled with a plug made of black debris that were analysed by the Royal Military School laboratory (RMA) and determined as being a mixture of plastic polyethylene, plastic polypropylene and plastic polycarbonate particles. The origin of these particles looked strange because no similar contamination was found somewhere upstream in the fuel circuit. In particular, the collector tank that is the closer upstream component was thoroughly examined and was determined to be perfectly clean. Finally, a close examination of the ruptured line found that the contamination was greasy and the same kind of contaminant was found not only inside the line but also outside. This could conclude that this contamination occurred during or after the impact.

Figure 9: Shut off valve and fine filter fitted together

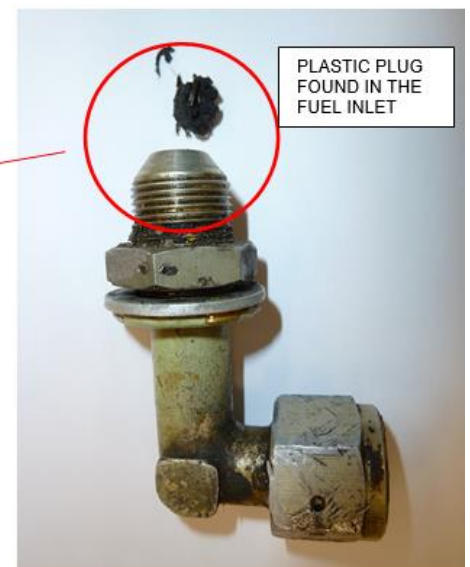
Figure 10: Fuel inlet elbow of the fuel shut off valve

The outlet flexible line of the coarse filter was found severed close to its end fitting and was obviously contaminated by brown soil and particles of grass, demonstrating that the contamination occurred during the accident or after, possibly when moving the wreckage for its transportation. The cover of the coarse fuel filter was removed for internal inspection. The filter casing and the filter element were found in good condition and without visible contamination, with the filter element properly installed. There was no more fuel and no trace of water inside the casing. The shut off valve assembly was disassembled showing that the

- RMA found that the black plug of dirt at the inlet elbow of the shut off valve was made of plastic polyethylene, plastic polypropylene and plastic polycarbonate particles. The initial assumption that the plug was made of a mixture of soil and engine oil was wrong.

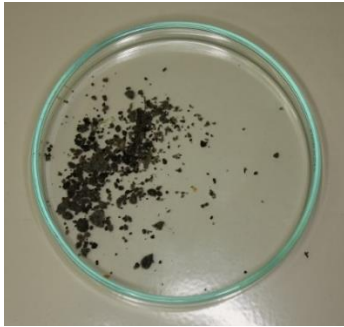
Figure 11: Particles found inside the shut off valve

- The particles found inside the shut off valve were made of plastic polycarbonate.
- Beside the contamination by dirt, the inside of the Al alloy casing of the fine filter was corroded.

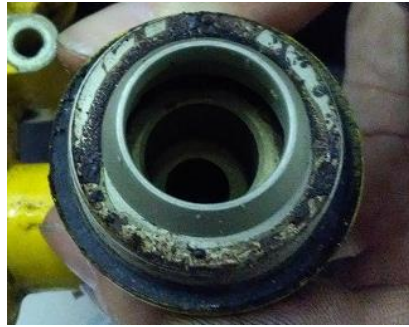
Figure 12: Contamination along the shut off valve seat

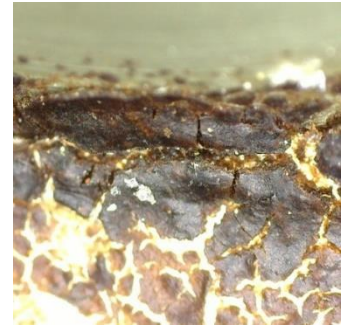
Figure 13: Magnification of the shut off valve seat contaminants

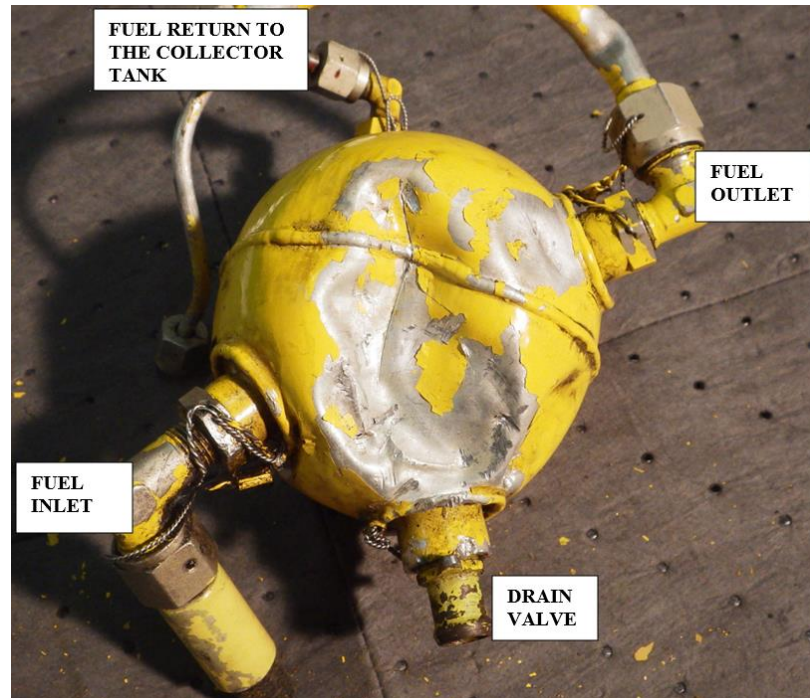
Figure 14: Compensation tank before removal of its connections

The compensation tank still contained a small quantity of liquid that could only be extracted after the removal of the drain valve assembly and shaking the tank. The recovered liquid was identified as being dirty water (about 2,5 centilitres) without any trace of fuel. The inner surface of the drain valve which is in contact with the inside of the compensation tank was

found rusted, however there was no contamination particles found inside the compensation tank.

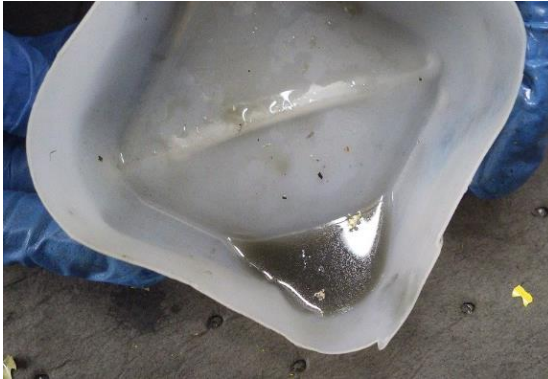
Figure 15: Dirty water from the compensation tank.

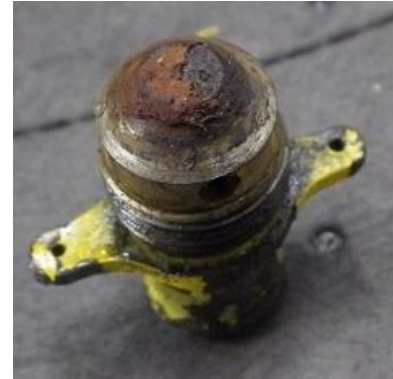
Figure 16: Drain valve of the compensation tank

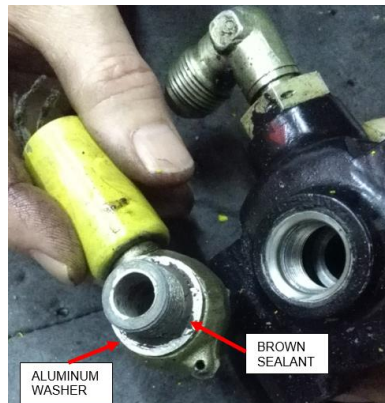
The flexible line at the outlet of the fine filter was disassembled showing that the connection was sealed by an aluminium washer and the addition of a normally not required brown coloured sealant. However, no trace of fuel leak was noticed around this connection which operates under pressure.

Figure 17: Fine fuel filter after the outlet fuel line removal.

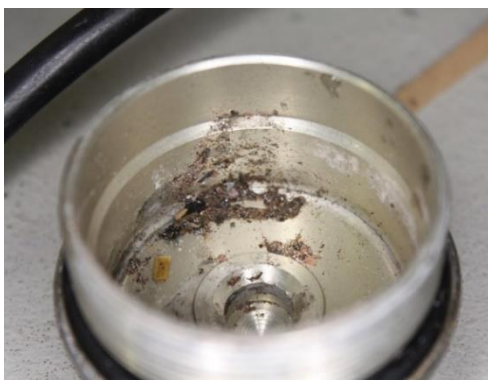
The cover of the fine filter was unscrewed, showing evidence of dirt in the cover and on the underside of the filter element. Additionally, the inner side of the cover showed white products being traces of aluminium corrosion.

Figure 25: Contaminants inside of the fine filter cover

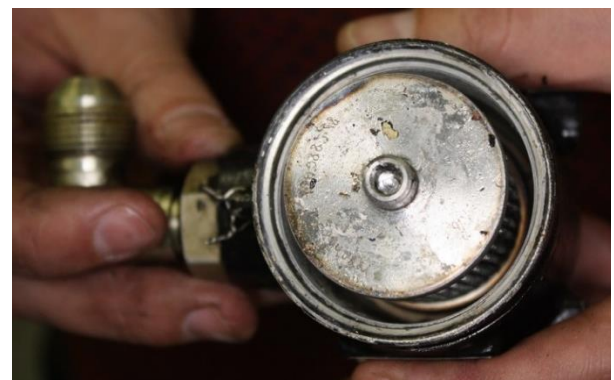
Figure 26: Fine filter underside, as seen just after removal of the cover

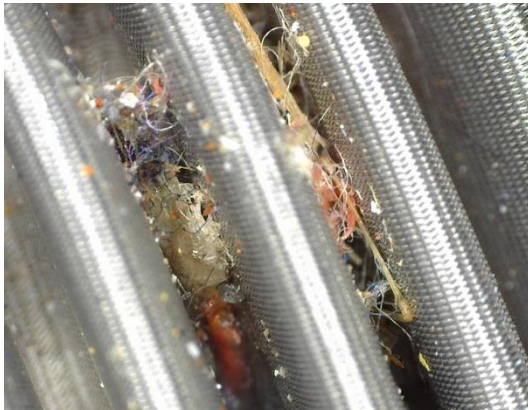
The filter element made of a metallic very fine mesh fan folded, was found contaminated. The biggest contaminants were of various colour and were visible to the naked eye. Moreover, close examination of the filter element using a digital microscope determined that the fine mesh was also contaminated with small particles, mostly yellow coloured looking like the paint used to paint most components of the fuel system, partially clogging the narrow interstices of the mesh.

Figure 18: Contamination visible to the naked eye.

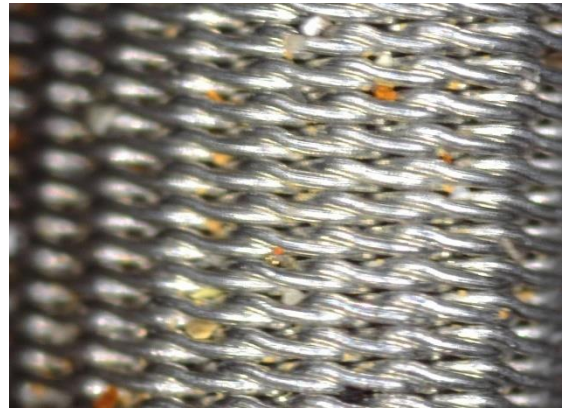
Figure 19: Fine mesh contamination by yellow small particles

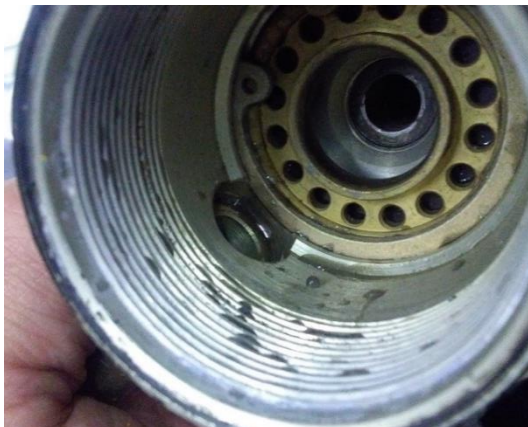
Figure 20: Inside of the fine fuel filter body

After removal of the filter element, the inner side of the fine fuel filter housing was found covered with dirty water droplets. Water was also noticed on the relief valve. After disassembly it became obvious that the entire valve was contaminated with water.

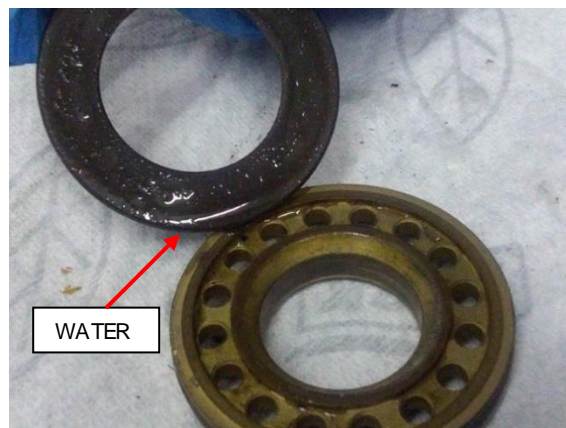
Figure 21: Fine fuel filter relief valve

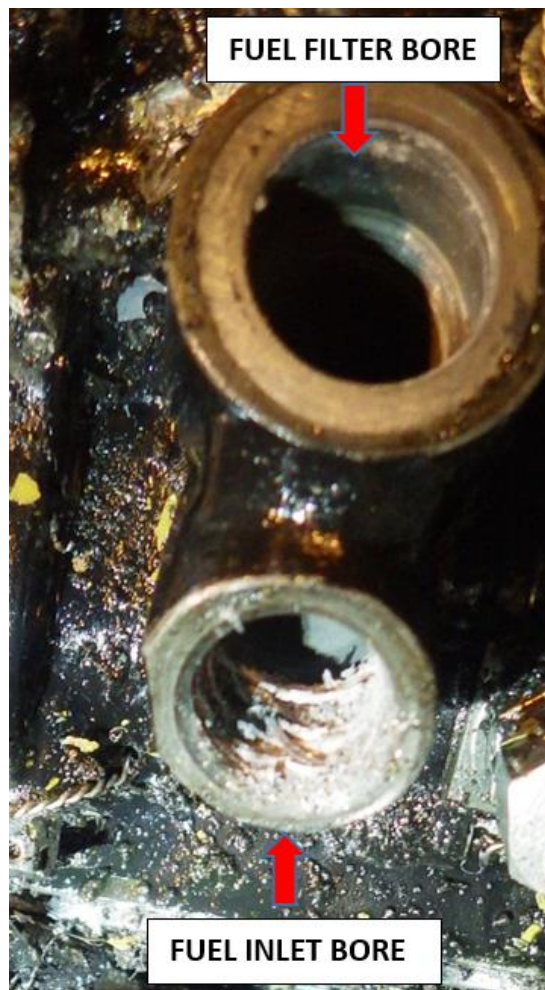
The fuel inlet elbow screwed in a threaded bore of the carburettor was removed. This elbow was hard to unscrew along its complete thread length suggesting that at least one thread was damaged. Examination of the male and female threads concluded that the male thread of the steel elbow was in good condition but the thread in the bore of the carburettor was found badly damaged. Actually, the female thread inside the fuel inlet bore was dramatically corroded.

Figure 23: fuel inlet bore just after removal of the elbow fitting

- The thread of the fuel inlet bore of the carburettor was significantly corroded as well as the feeding chamber of the fuel regulator valve (Mg-Al corrosion). The initial assumption that the thread of the fuel inlet bore had been filled with a 2 component-paste was wrong, the grey friable material was actually the corrosion product of Mg-Al alloy.

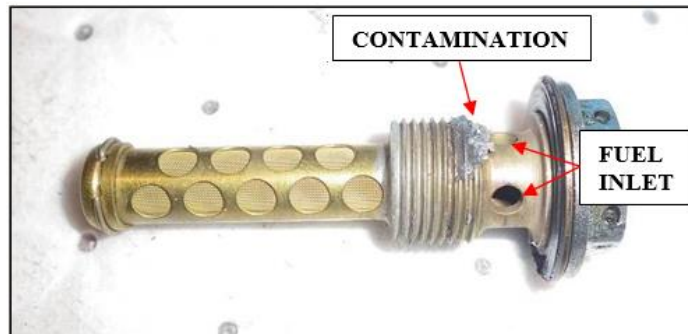
This finding at the carburettor inlet bore prompted the removal and the entire disassembly of the carburettor for a detailed internal examination. The fuel screen filter located in the carburettor casing close to the carburettor fuel inlet bore was easily unscrewed and the threads were found in good condition. But the holder of the screen filter showed an accumulation of a grey product at the end of the thread, at a location in contact with the fuel. Nevertheless, no contamination was found inside the filter mesh.

Figure 24: carburettor filter

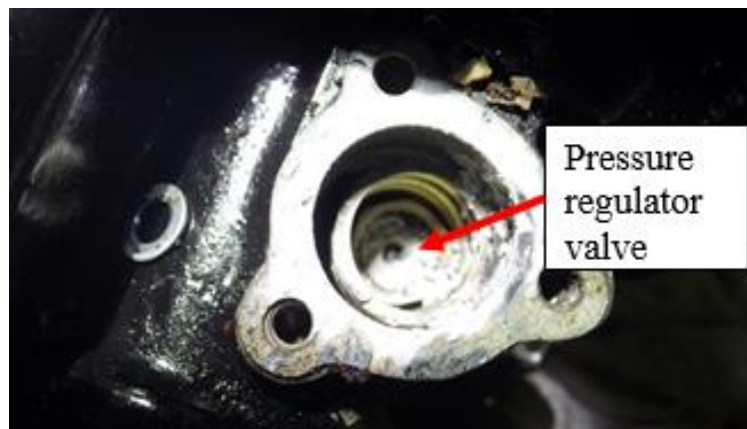
After removal of the cover of the pressure regulator bore, the fuel chamber feeding the pressure regulator valve was found severely contaminated by white crumbly products later identified as corrosion by-products.

Figure 25: Fuel pressure regulator valve at the bottom of a fuel feeding chamber

The amount of contaminant was so significant that the spring located inside the fuel feeding chamber was trapped by the contaminant. However this spring plays no fuel-metering role and serves only as a safety feature to secure the valve holder.

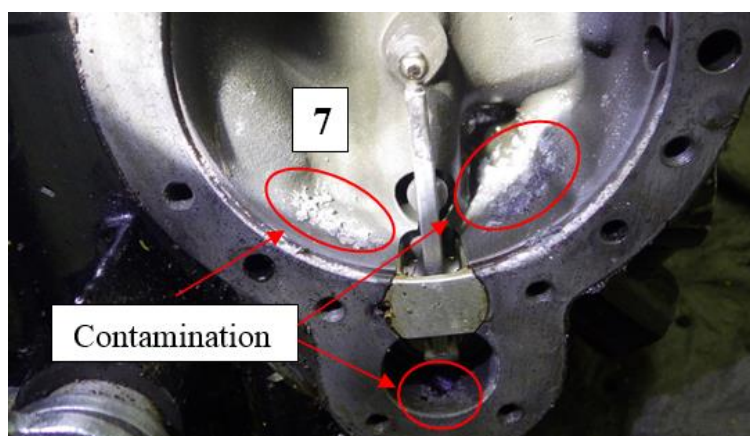
Figure 26: casing of the regulator valve membrane and lever showing contamination

After removal of the membrane, white friable contaminants were found in the lower part of the membrane holder and at the outlet of the pressure regulator valve. The lower part of the

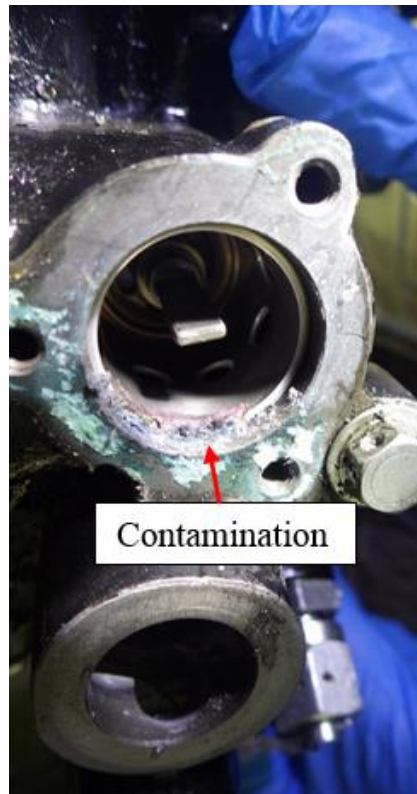
fuel inlet chamber of the metering valve was found contaminated, however the metering valve orifices were found unobstructed.

Figure 27: Upper bore: metering valve chamber.

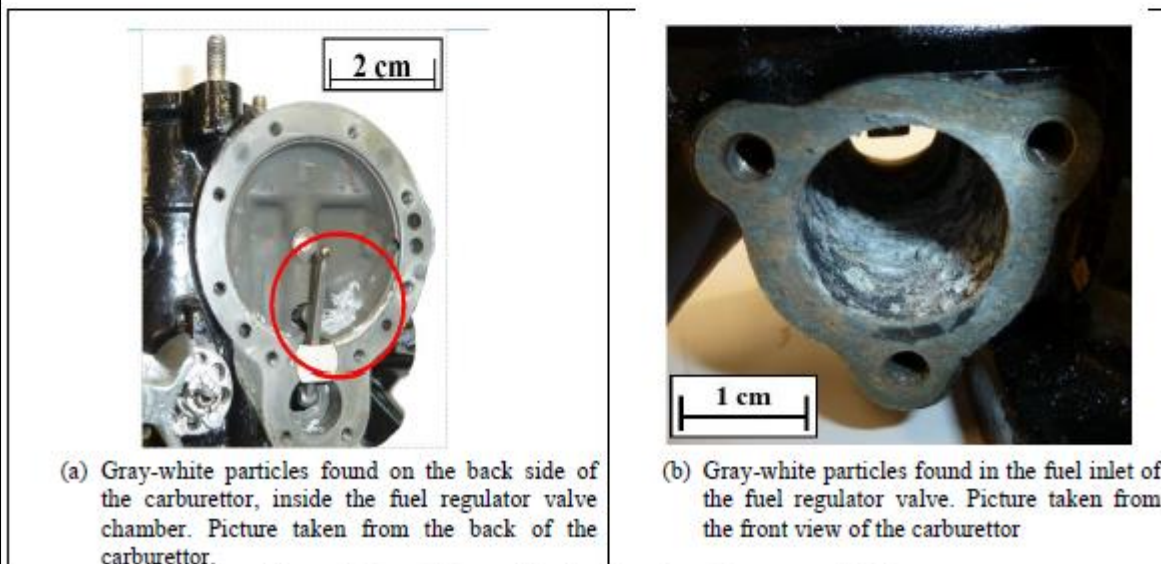
Figure 4: Gray-white particles found on the carburettor main body.

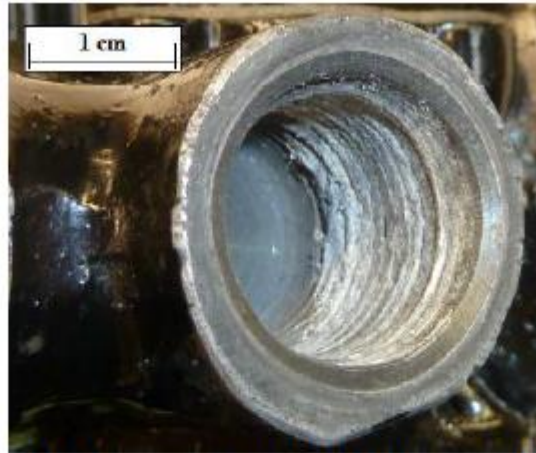
Figure 5: Alleged two-component paste on the fillet of the fuel inlet bore

The fuel inlet bore contains the fillet with the alleged two-component paste, as shown in figure 5. EDX analysis of these particles show that they have a composition similar to that of the other particles found in this report (mostly Mg, Al and Zn). This leads to the conclusion that these particles are not a two-component paste but rather deposited corrosion products originating from the Mg-Al alloy. A longitudinal cut of the fuel inlet bore has been made, in order to check the eventual corrosion of the component. This semi-cylindrical sample was embedded, resulting in the two sections shown in figure 10. Figure 11 shows details of the corroded thread while figure 12 shows an uncorroded part of the thread for comparison.

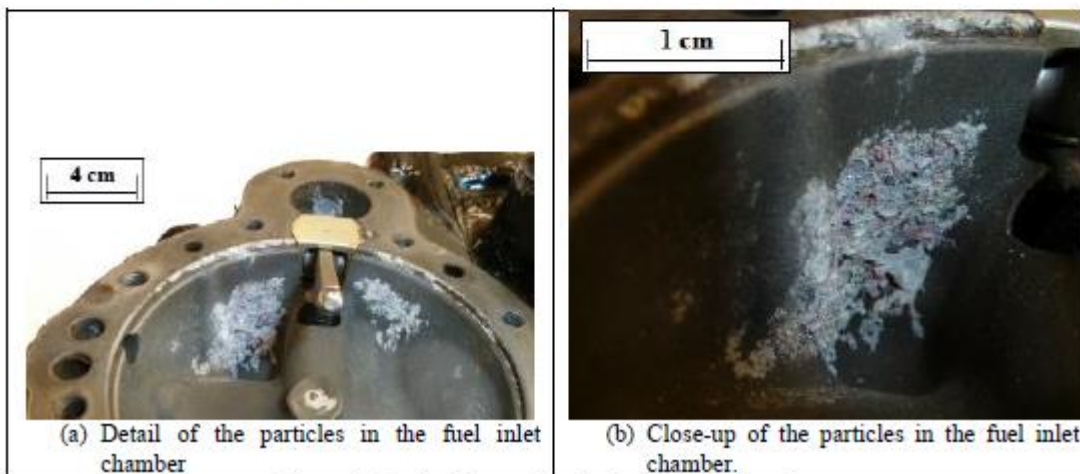
The particles from figure 4.a are shown in more detail in figure 6. A micrograph of a particle taken using the SEM is shown in figure 7. Table A.1 in annex 1 show the results of the EDX analysis for 2 particles and also for a milled sample. The particles are mainly Mg, Al, Br and Si with traces of S, Cl, Ca, Cr, Fe and Zn, which is in accordance with what we would expect after corrosion of the Mg-Al alloy. It is important to note that those particles do not originate from the fuel inlet chamber itself, but have been deposited on that location, since there is no evidence of corrosion of the underlying material.

Figure 6: Detail of the particles in the fuel inlet chamber.

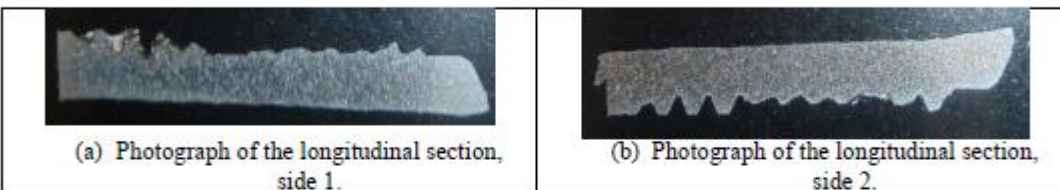
Figure 10: Photographs of the cut out section of the fuel inlet bore, showing signs of wear and/or corrosion.

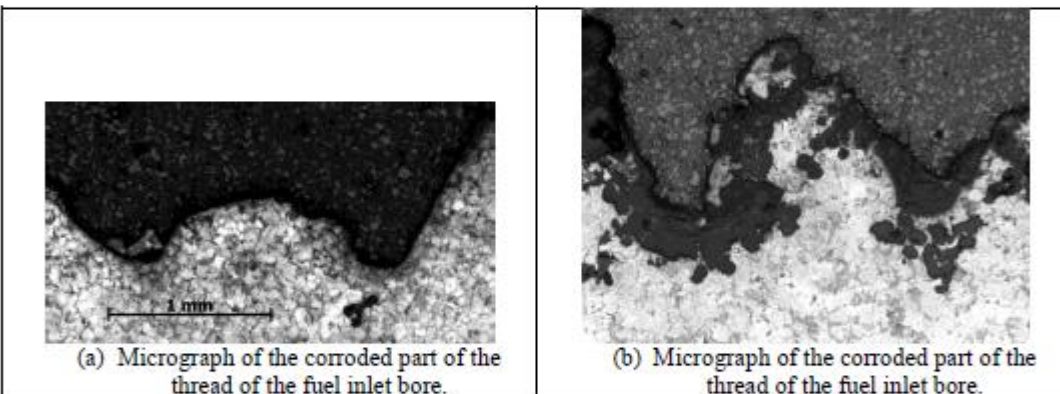
Figure 11: Detail of the corroded parts of the thread of the fuel inlet bore.

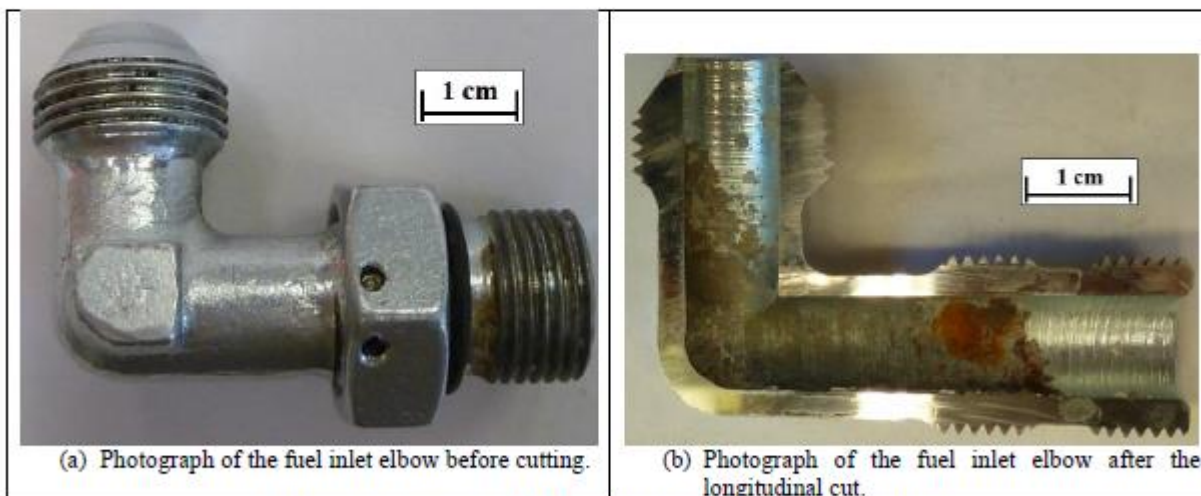
- corrosion of the fuel elbow inlet itself;
- sediment of the corrosion of the Mg-Al alloy;
- parts of the galvanisation layer.

Figure 13: Photographs of the fuel inlet elbow before and after cutting.

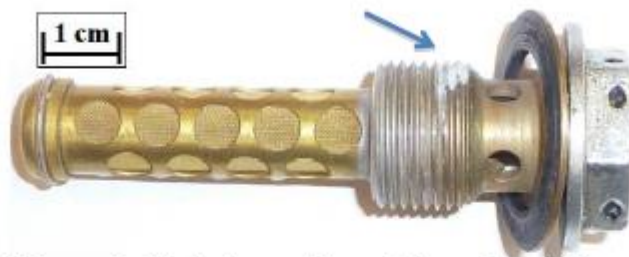
On thread of the fuel screen filter several particles were found (figure 16). These particles have a composition similar to the other particles found in the carburettor (EDX analysis, table A1 in annex 1), coming from corrosion of the Mg-Al alloy, and containing particles of the galvanisation layer.

Figure 16: Photograph of the fuel screen filter, with the particles visible on the thread.

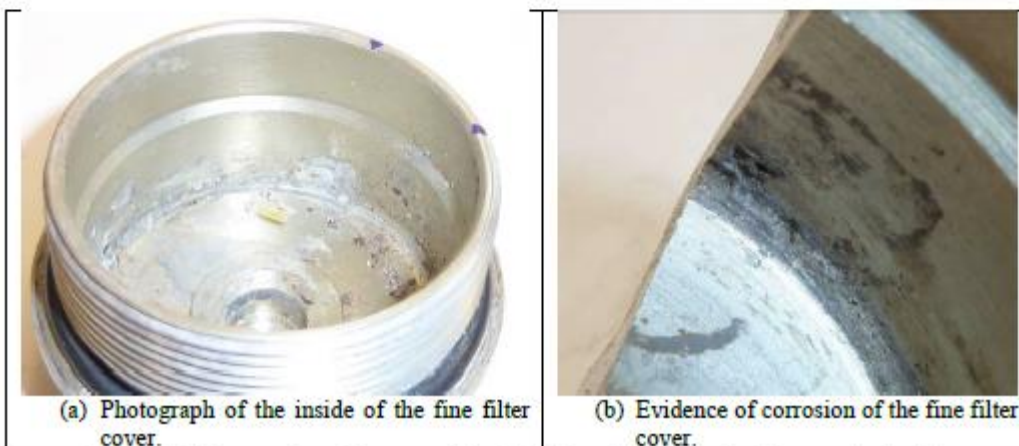
Inside the cover of the fine filter a large number of particles were found. These particles contained a significant amount of Al, with to a lesser extent Mg, Si, S, Cl, Fe, Ni, Cu and Br (EDX analysis, table A1 in annex 1). The base material of the cover is an aluminium alloy (92.7 mass percentage Al with additional Mg, Si, Fe, Ni and Cu). There are also clear signs of corrosion of the cover of the fine filter, which leads to the conclusion that the particles inside the cover come from the cover itself (figure 17). The Lab Materials also received the particles that were recovered after cleaning the fine filter. The gray-white particles have the same composition as the other particles found (corroded Mg-Al alloy), the black particles consist of Ba and S (EDX analysis, table A.1 in annex).

Figure 17: Photographs of the cover of the fine filter, clearly showing the corrosion in (b).

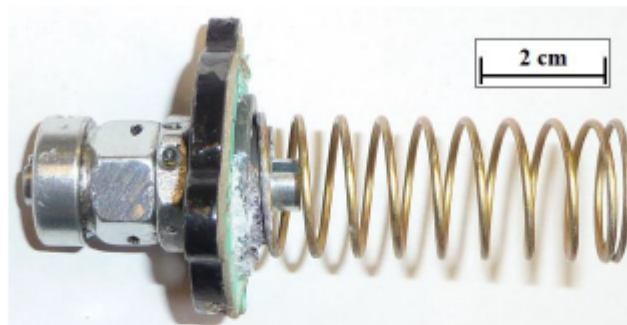
On the metering valve (figure 18) the same corroded Mg-Al alloy particles were found. (EDX analysis, table A.1 in annex). The base material of the metering valve is the Mg-Al alloy, but there are no signs of corrosion, leading to the conclusion that the particles have been deposited.

Figure 18: Metering valve

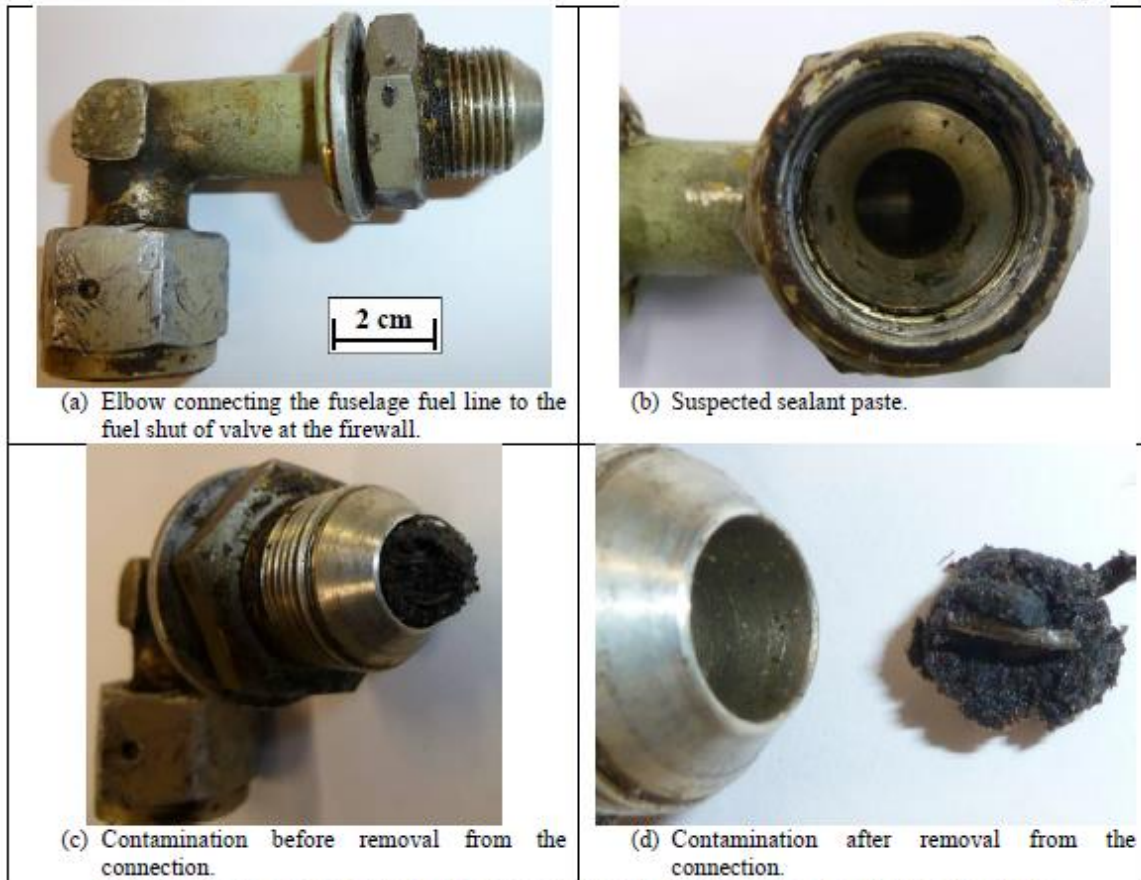
Particle	Description of the particle	Composition of the particle
(a)	Particles found in the fuel shut off valve.	Plastic: polycarbonate
(b)	Suspected sealant paste found on the connection.	Plastic: polyamide
(c)	Contamination in the connection, brown particles.	Plastic: polyethylene
(c)	Contamination in the connection, white fibres.	Plastic: polypropylene
(c)	Contamination in the connection, green fibres.	Plastic: polypropylene
(c)	Contamination in the connection, white particles.	Plastic: polycarbonate
(c)	Contamination in the connection, black residue.	Plastic: polyethylene

Figure 19: Contaminations found in the connection between the shut off valve and the main fuel line.
