Air Accident Investigation Unit (Belgium) City Atrium Rue du Progrès 56 1210 Brussels

Interim Statement

Ref. AAIU-2017-01

Occurrence type: Airprox (MAC)

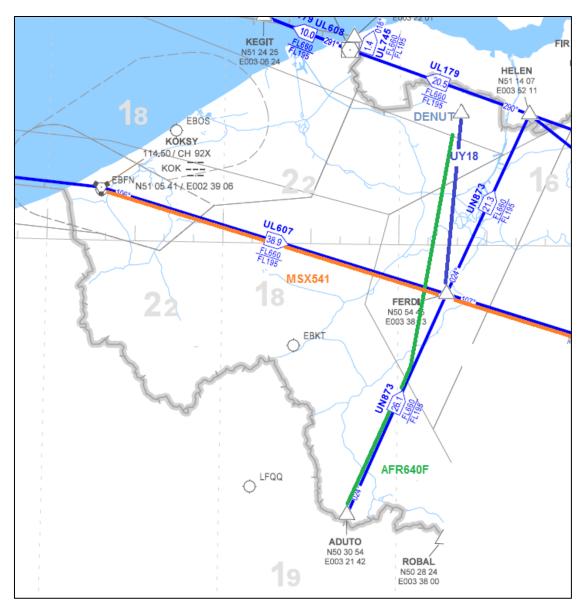
AFR640F was maintaining FL220. The crew called ATC when reaching the Belgian border. The ATC controller instructed AFR640F to fly towards Hamstede before reaching the FERDI waypoint, in order to speed up the crossing.

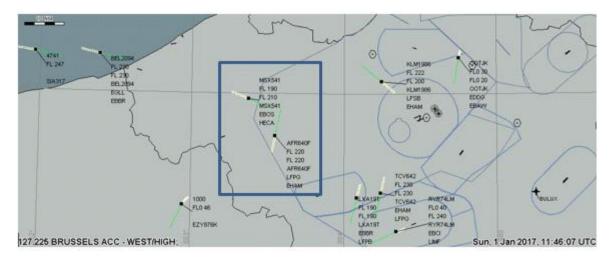
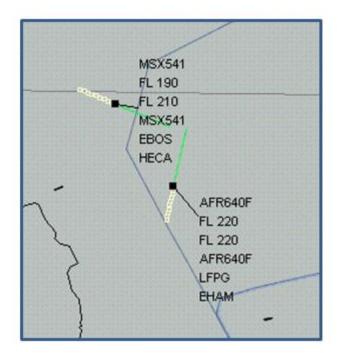
At 11h45 MSX541 received traffic information about the AFR640F – crossing traffic above from right to left A320 -. The Readback from MSX541 of maintaining FL210 was correct.

Immediately after, AFR640F was advised about the climbing Egypt Air aircraft.

When the 2 aircraft were approaching from each other, the TCAS system initiated a warning in each airplane, first a TA (Traffic Advisory) – indicating the vicinity of another airplane – then a RA (Resolution Advisory) – to require an action (Climb, Descend, Maintain level) from the crew.

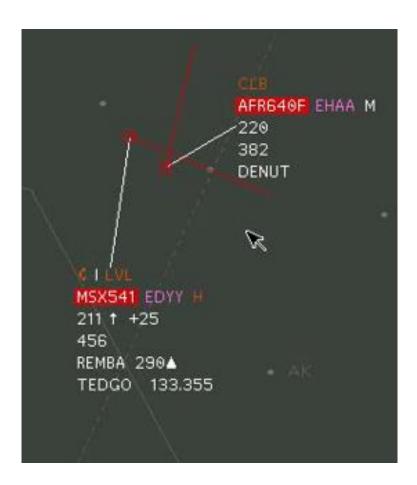
- The downlink of the TCAS instruction generated on the MSX541 and reported on the radar screen shows the level off "LVL" instruction. The crew of the MSX541 later stated they understood a "CLIMB" instruction. The captain took control from the autopilot and increased the rate of climb up to 3500 ft/min (instead of levelling off).
- On AFR640F, the TCAS generated a CLIMB "CLB" instruction, at 11:46:57 and AFR640F started to climb at 11:47:02 at a rate of 1500 ft/min as required.

When MSX541 was passing FL213, the TCAS gave a "DESCEND" instruction which was followed immediately by a reduction of the climb rate by the captain of MSX541 (instead of a descend rate of 1500 ft/min).

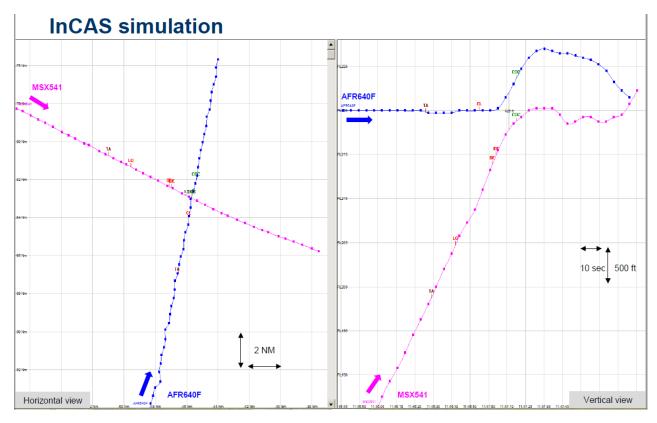
Both MSX541 and AFR640F received Clear of conflict messages at 11:47:16.

The closest point of approach occurred at 11:47:11. The separation was 0.69 NM and 427 feet. Both aircraft cover this distance in 4 seconds when flying at cruise speed.

Tracks crossed at 11:47:06 with AFR640F passing right to left 1.2NM in front of MSX541 being 522 feet below, still climbing.
