# Safety Investigation Report

**Ref.:**  
AAIU-2018-06-08-01

## **ACCIDENT AIR COPTER A3C-T IN MATAGNE-LA-PETITE ON 8 JUNE 2018**

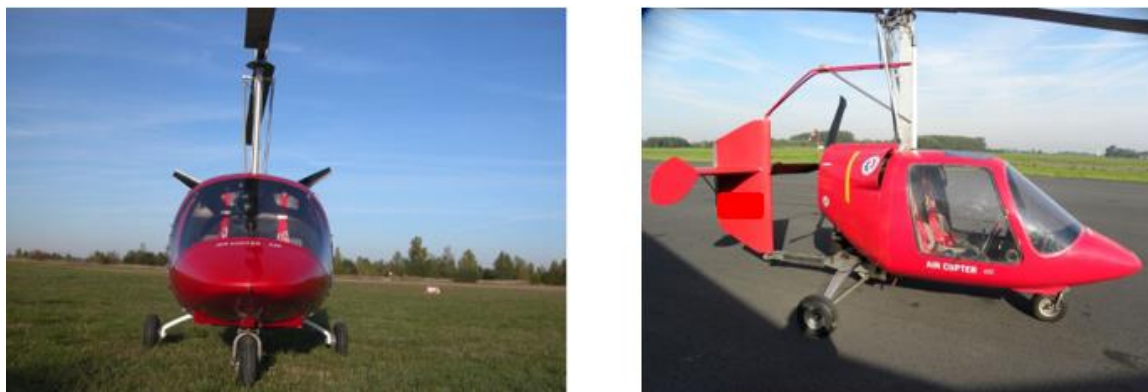
The gyrocopter was equipped with a ROTAX 914UL engine with serial number 4419068. The propeller initially installed by Air Copter was a 3-blade DUC Windspool. However, the propeller found installed on the gyrocopter after the accident was a ARPLAST 5-blade propeller, obviously installed later by the owner<sup>1</sup> and whose installation was not approved by the gyrocopter manufacturer.

Figure 1: the accident gyrocopter.

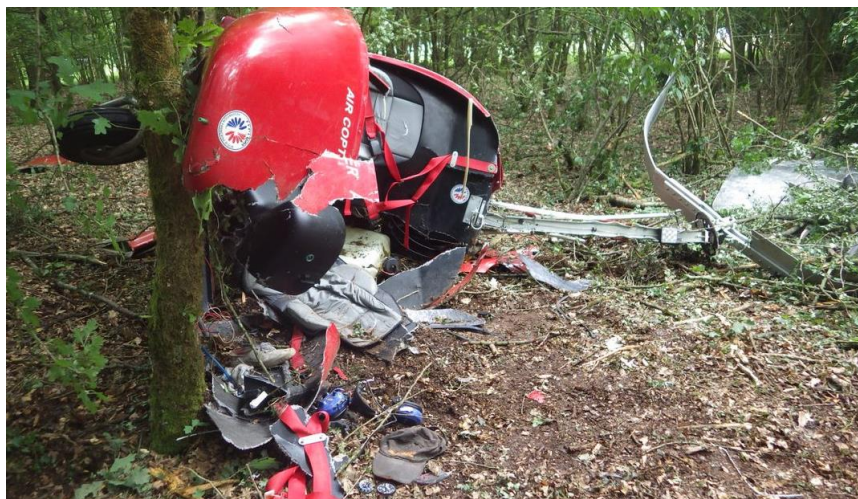
The left side of the cockpit, where the pilot was sitting, was totally destroyed by the collision of the gyrocopter with a tree.

Figure 3: The left side of the cabin was completely destroyed.

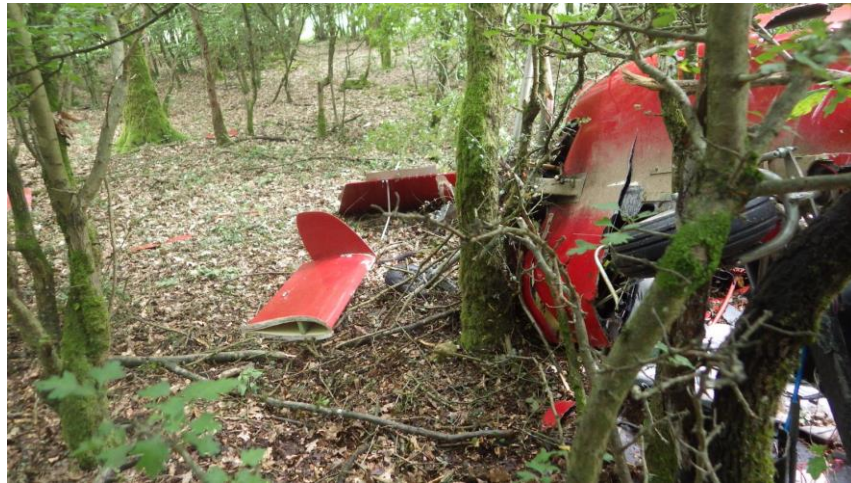
All the parts that separated from the wreckage were found in the close vicinity of the cabin and show signs of rupture at the final impact. However, the winglet of the left-side horizontal stabilizer and the left side horizontal stabilizer were found a little further, at about 5 to 7 meters north of the main wreckage, suggesting that they separated just before the final impact.

Figure 4: Scattered tail parts in relation to the belly of the cabin.

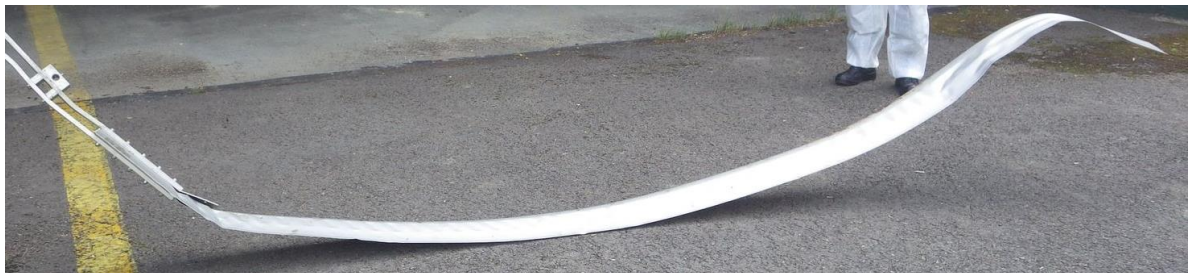
Both rotor blades are bent upwards at the root but the curvature changes to the opposite direction about at the half-span of the blades, featuring a S shape.

Figure 5: One rotor blade (with the hub bar still attached) featuring a S shape

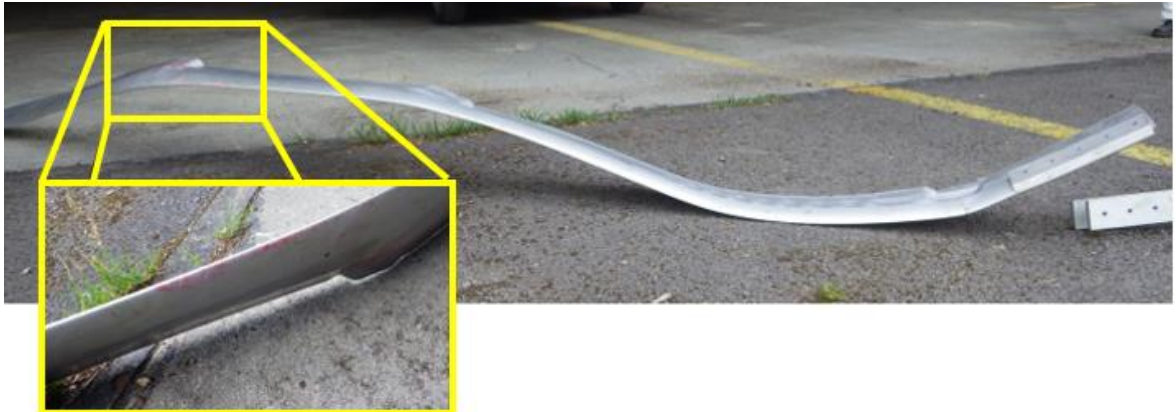
Traces of red paint, similar to the paint of the airframe, are present on the leading edge and on both the lower and upper surfaces of the rotor blades at a position compatible with an impact with the left vertical winglet and the leading edge of the left horizontal stabilizer.

Figure 6: Second rotor blade also featuring a S shape deformation and red traces of contact with aircraft's tail section.

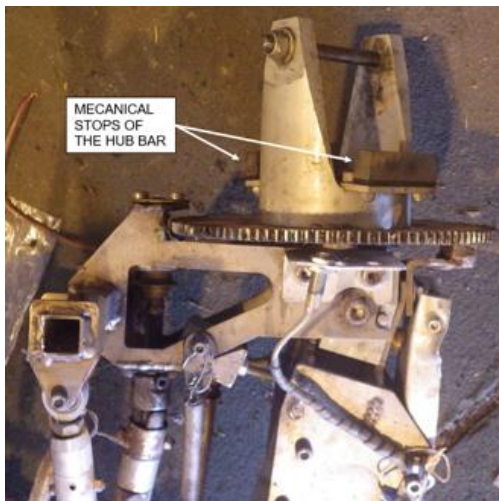
Both mechanical stops of the hub bar are bent downwards obviously resulting from impact(s) with the rotor hub bar. This hub bar, consisting of 2 parallel strong aluminium plates fixed on a tower block, showed deformations compatible with impacts with the stops installed in the hub. As can be seen in Figure 7, the hub bar and the blades were removed from the rotor hub for the transportation of the wreckage.

Figure 7: Both mechanical stops of the hub are bent downwards.

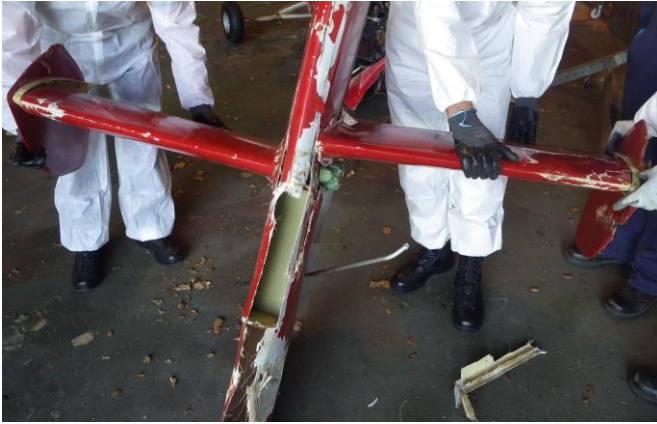
Reconstruction of the tail section shows damage compatible with an impact of the rotor blades with the left-side vertical winglet and with the leading edge of the left-side horizontal stabilizer.

Figure 9: Reconstruction of the tail section.

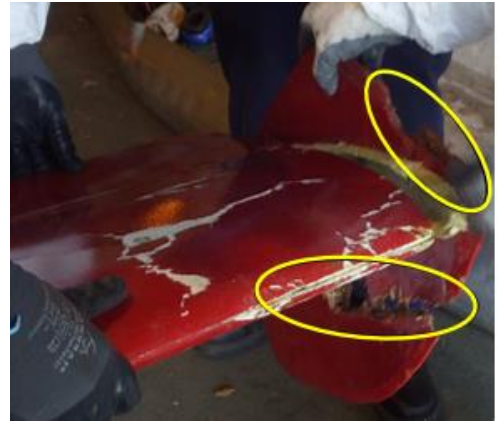
Figure 10: Damage compatible with rotor blade impacts.

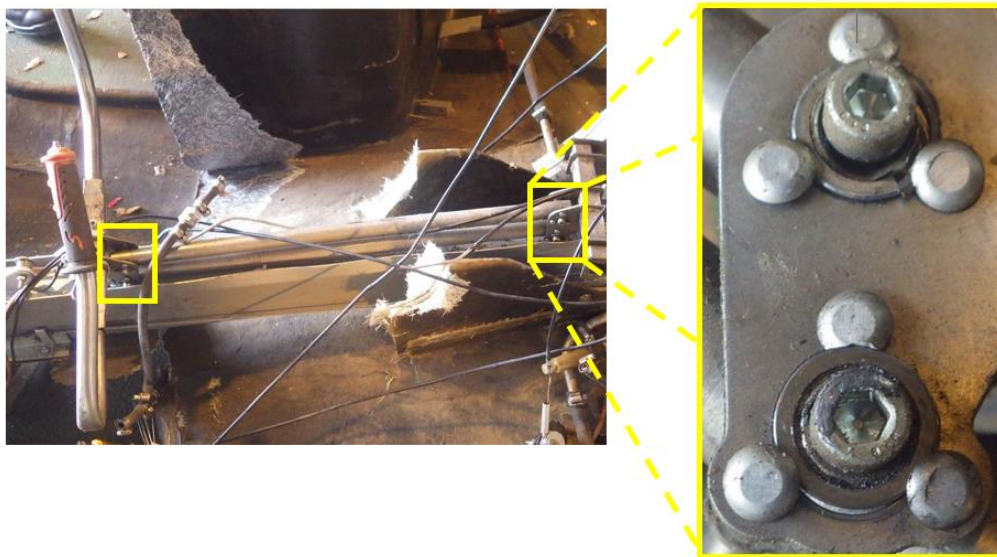
However, significant play was detected at the ends of the pitch and roll rods located between the stick frame and the control horn. The resulting play in the left-to-right direction (roll) at the control handle was determined to be approximately 4 cm. The same evaluation of the play in the front-to-rear direction (pitch) could not be performed because one bearing was damaged, likely due to the impact.

Verification of the tightening of the nuts and bolts located at the end of each rod revealed that they could be easily tightened with an angle between 45° and 90° under a very moderate torque. Retorquing resulted in a significant reduction of the play at each rod end assembly. After retightening, the play in the left-to-right direction (roll) at the control handle was dramatically reduced from about 4 cm to 4 mm in the left-to-right direction (roll).

Figure 11: Bolts (4) assembling the roll and pitch rods were found insufficiently torqued.

The significant play found at the ends of the pitch and roll rods located between the stick frame and the control horn could also have been a contributing factor for a possible loss of control of the gyrocopter. The rotor blades could enter into resonance with the vibrations produced by the propeller and result in rotor blade flapping.

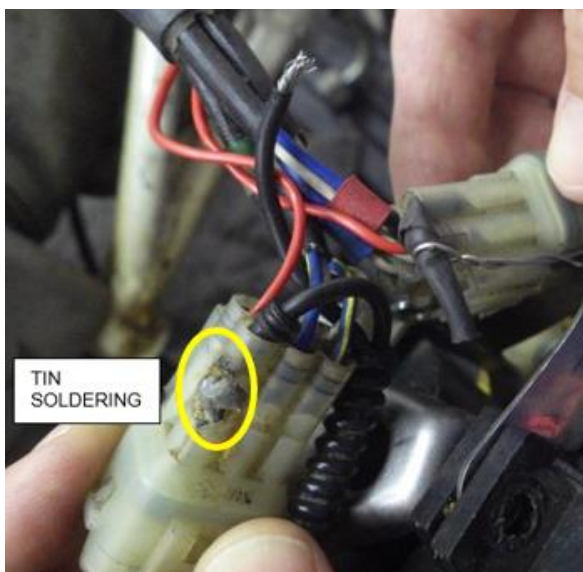
- Bad welding (showing cracking, lack of fusion, spatter and undercutting) of a support for a non-genuine rotor brake pad.
- Bad arc welding of 4 non-genuine steel blocks on the pre-rotator gear plate for the magnetic rotor speed sensor.
- Inadequate soldering of a wire inside the plastic housing of an electrical connector of the engine ignition.

Figure 12: Inadequate soldering of a wire.

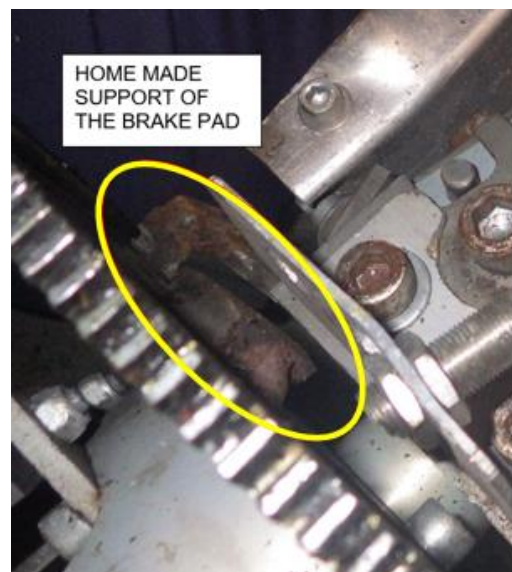
Figure 13: Bad welding of a support for a non-genuine rotor brake pad.

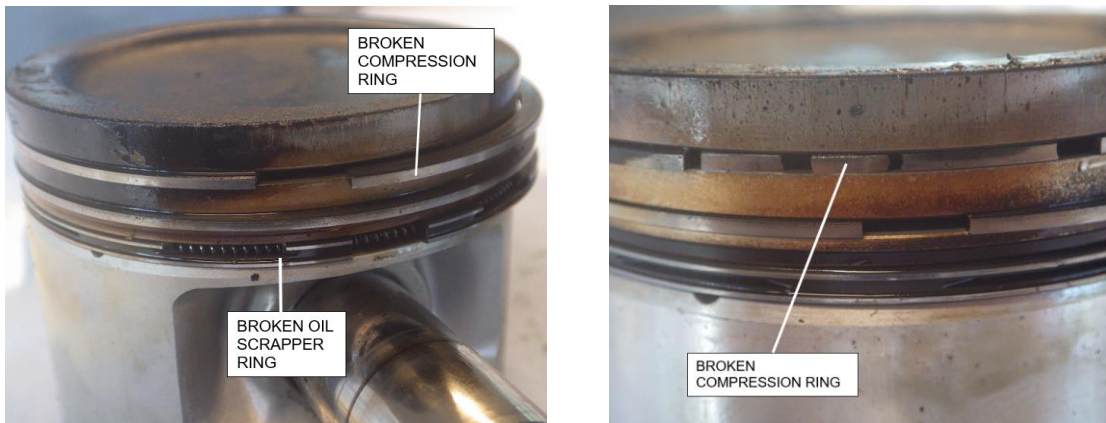
Figure 14: Pictures of damaged ring installed on 2 different pistons

The removal of the cylinder heads and the cylinders revealed that the compression ring of one piston was fractured in 5 pieces and the compression ring and oil scrapper ring of another piston were also fractured (compression ring: into 2 pieces, oil scrapper: numerous pieces). In spite of the visible damage to the piston rings, the concerned cylinders were easy to remove. There was no indication of piston seizure both onto the cylinder walls and the pistons. The assembly of the connecting rods didn't show any play and they were free to rotate. The crankshaft could be turned freely without sticking.

The damage found on the piston rings (compression ring of 2 different pistons and 1 oil scrapper ring of one of them) reduced the performance of the engine, increased the oil temperature and caused an excessive oil consumption. However, as no indication of a piston seizure was found, these conditions did not cause the engine to stop operating. There is probably a link between the great number of alarms recorded by the TCU and the damage found to the piston rings. This damage suggests that the engine suffered from the repetitive over-boost and over temperature events. As stated by the manufacturer, each alarm triggers a warning sign to the pilot (cockpit indication). In this case, appropriate corrective action needs to be taken without delay. The damage found indicate the situation existed for some time.

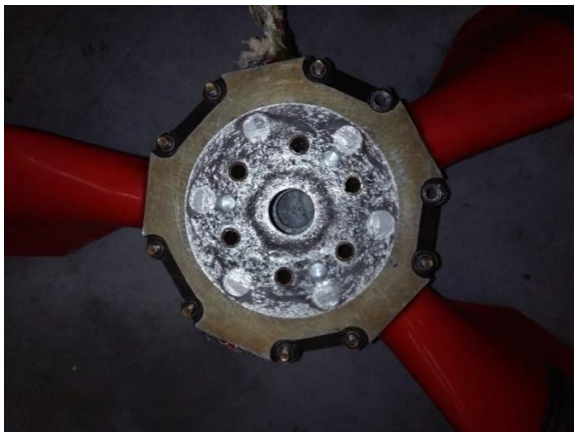
Beyond the damage caused to the propeller by the accident, the contact surface of the propeller hub with the spacer showed evidence of severe fretting. The fretting had been caused by an inadequate installation of the propeller onto its spacer, using too long bolts. As the end of the bolts came into contact with the driving pulley of the pre rotator, the clamping force between the spacer and the propeller was insufficient to avoid a relative movement between them.

Figure 15: propeller hub damaged by severe fretting

- The propeller hub was found with noticeable surface damage resulting from an earlier problem. The hub was obviously repaired after the event, but the contact surface remained uneven. A significant play was also present in the flight controls. The combination of both anomalies could have generated unwanted vibrations.

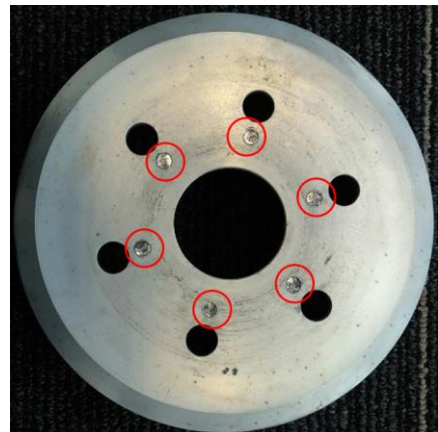
Figure 16: pre rotator pulley showing bolts end contact damage
