# Safety Investigation Report

**Ref.:**  
AAIU-2020-09-13-01

**ACCIDENT  
RANS COYOTE  
AT LASNE  
ON 13 SEPTEMBER 2020**

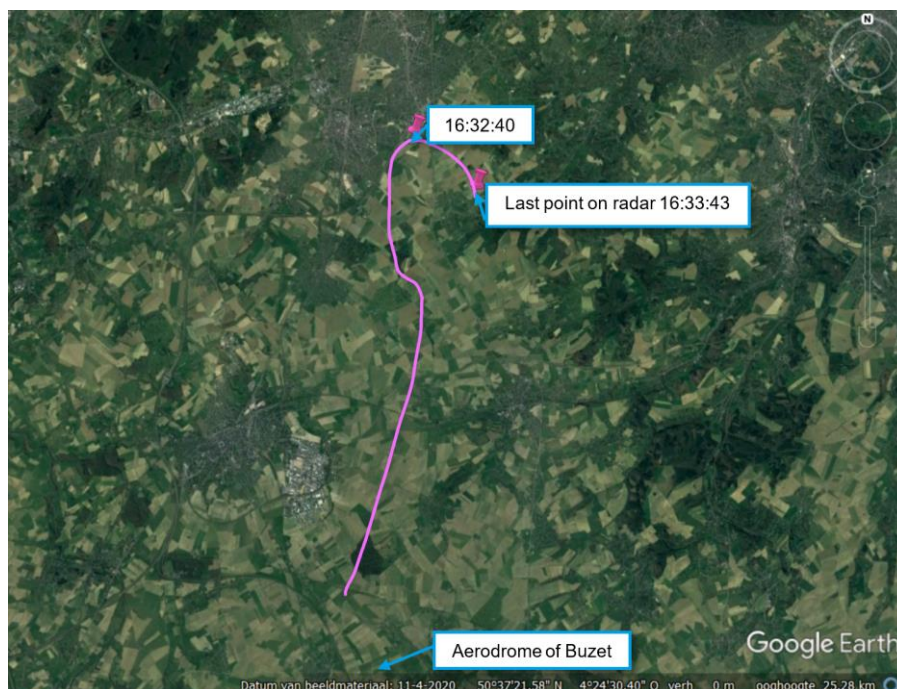
Figure 1: Flight from EBBZ to Waterloo reconstructed from primary radar images

The flight was more or less in a straight line, from EBBZ to the ‘Lion’s Mound’ (Fr: ‘Butte du Lion’, NI: ‘De Leeuw van Waterloo’), a man-made conical hill, followed by a wide righthand turn around that monument towards the village of Plancenoit (a district of the municipality of Lasne). From that point the aircraft was not visible anymore on the primary radar, probably due to the aircraft in a descent on low height. .

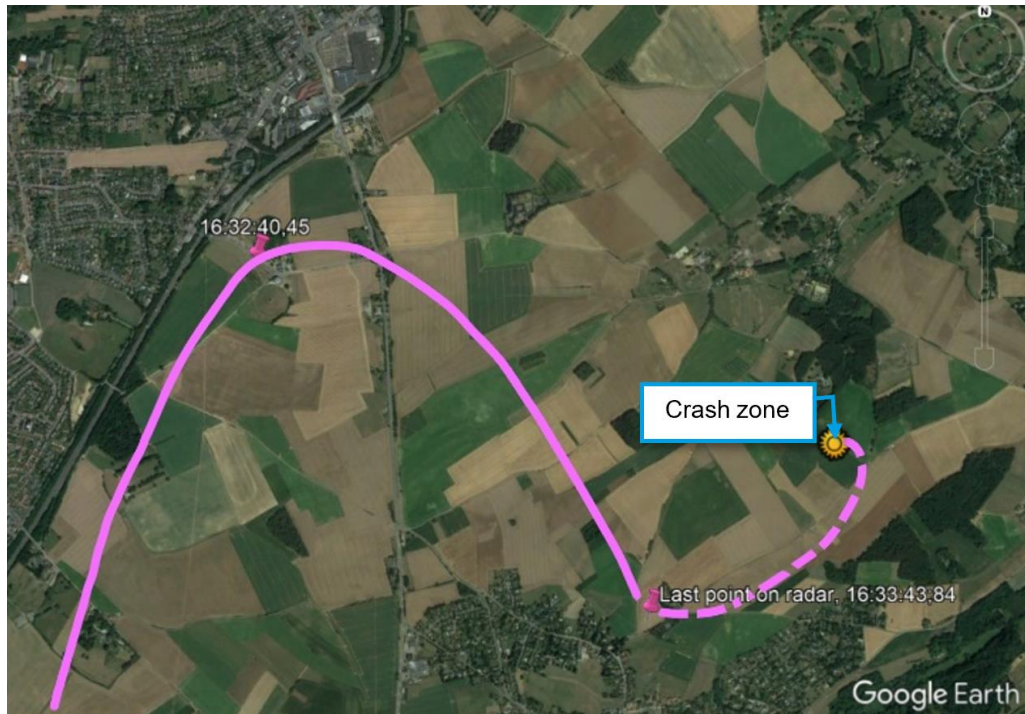
Figure 2: Last part of the flight: dotted lines are not covered by the radar

The aircraft then made a left turn with a 'high' bank angle. The airplane was then seen plunging to the ground.

The aircraft hit the ground almost vertically and immediately took fire. The 2 occupants died upon impact.

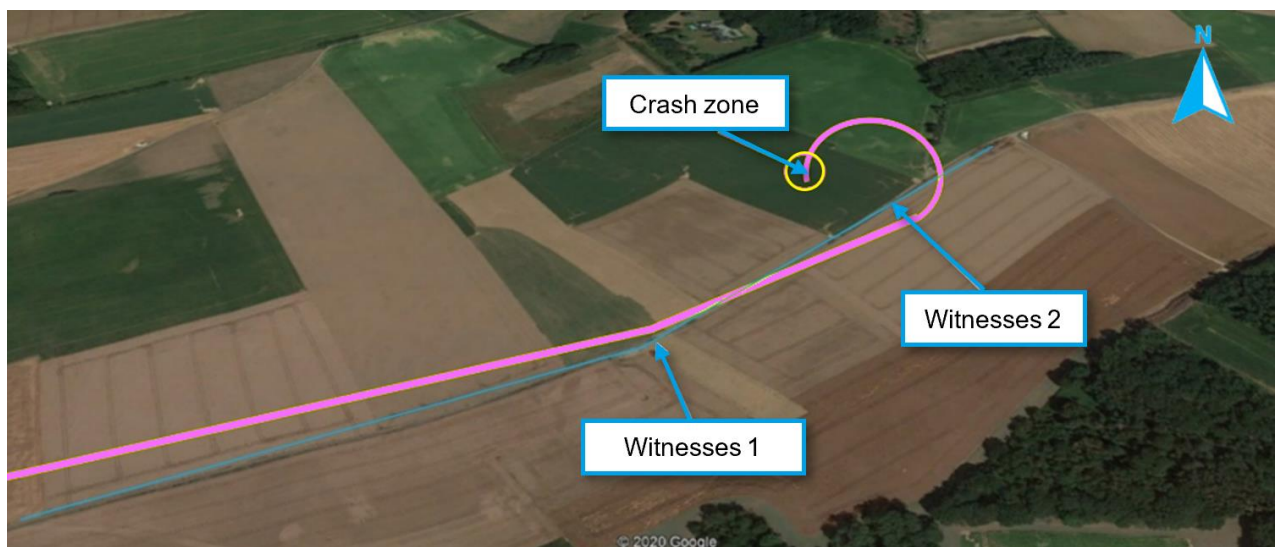
Figure 7 : Last part of flight path, surroundings and position of witnesses

A couple (hereafter named witnesses 1) was walking on the dirt road, northwards, when they heard the airplane coming behind them. The witnesses stated : “the airplane came towards us at a very low height, so that we felt the need to duck”. The airplane continued its flight above the field next to the dirt road, going up a little (estimated 30 m above ground), then initiated a turn to the left, going back in our direction. We saw the airplane turning in front of the small wood with the wings at a bank angle of 45-60 degrees. The witnesses then saw the wings levelling off and the airplane immediately plunging to the ground. The fuselage and wing were clearly visible. Before the crash the engine made a regular noise.

Another couple (hereafter called witnesses 2) was walking down the dirt road, They saw the airplane coming towards them, from Waterloo. He turned and came at a very low altitude, above the dirt road. The airplane went up a little when passing their position, above the field next to the dirt road. The couple saw one of the occupants of the airplane waving to them and as all appeared to be normal with the airplane, they waved back. . They estimate the airplane was 60 m away from the dirt road at that moment. The airplane then initiated a turn to the left. The bank angle of the airplane during the turn was estimated between 45 and 60 degrees. The next thing the witnesses saw was that when the airplane completed the 180 degrees turn, suddenly it plunged vertically to the ground.

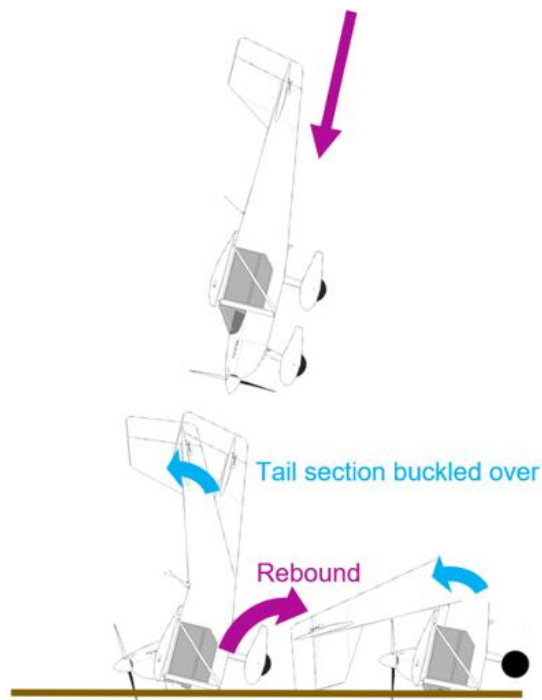
Figure 10: Impact sequence

The witnesses account of the event and the traces on the ground confirms the nearly vertical impact of the aircraft and the subsequent rebound of the wreckage, most probably due to the hard ground.

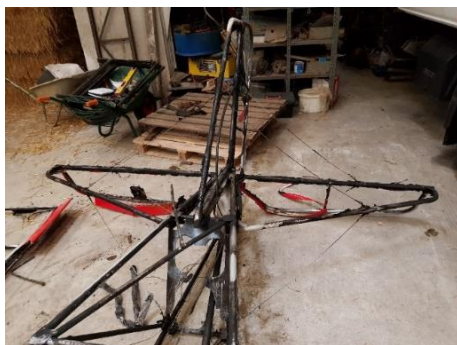
Figure 11: Tail section

The 2 elevators were still correctly hinged and connected to the horizontal stabilizer with bolts, nuts and safety pins. The elevator rod was torn out at the level of the cockpit junction. A manual input on the elevator rod revealed that both elevators surfaces were functioning normally and still linked and synchronized together with their associated hardware. The surfaces were working normally up and down on manual input on the control rod.

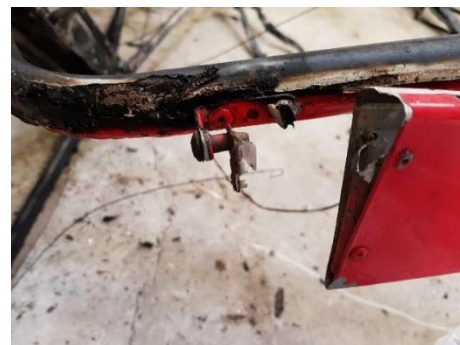
Figure 12: Trim tab broken hinge

The elevator trim tab was still present on the right hand elevator and connected to the electrical motor located on the right elevator surface. All parts, bolts, nuts and hinges of the tab system were present but the trim tab surface was broken at the level of elevator/tab inner hinge. The trim tab actuator rod was bent due to this rupture. The tab system electrical wiring was still present with one electrical wire of the trim motor broken and other wirings separated at their welded point, probably due to impact and the damage to the tab hinge.

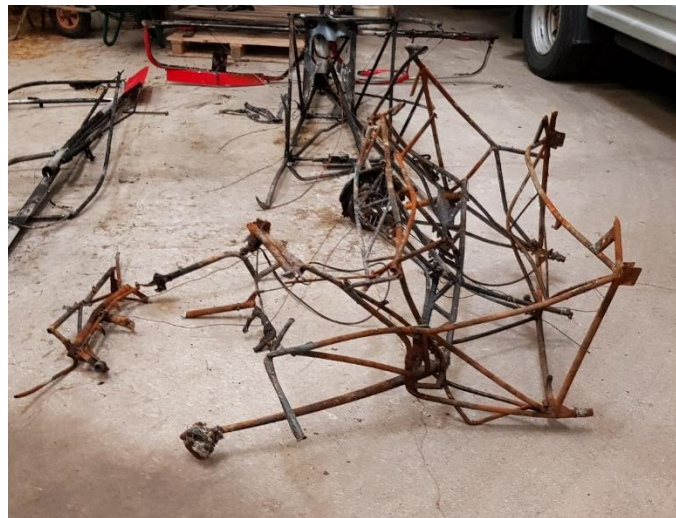
Figure 13: Fuselage structure

- the remaining of the flight controls pulleys and cables (aileron cockpit controls & associated pulleys & cables, elevator broken torque tube, remaining of rudder controls, flaps control & cable) ;
- 1 control stick on the right side and associated torque tube;
- the 2 main landing gear legs and associated brakes and tires.

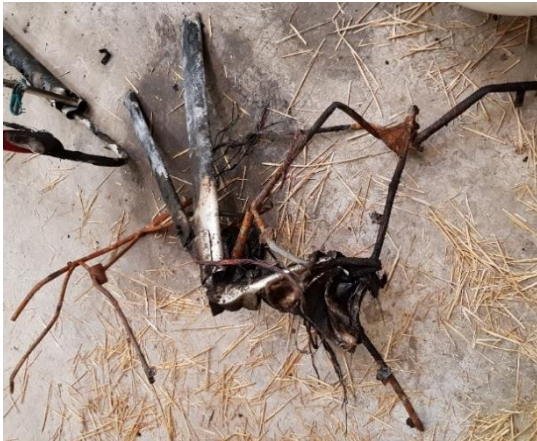
Figure 14: Wing strut - fuselage junction

The fuselage junction of the wing strut was found severed but still attached to a torn part of the lower cockpit structure.

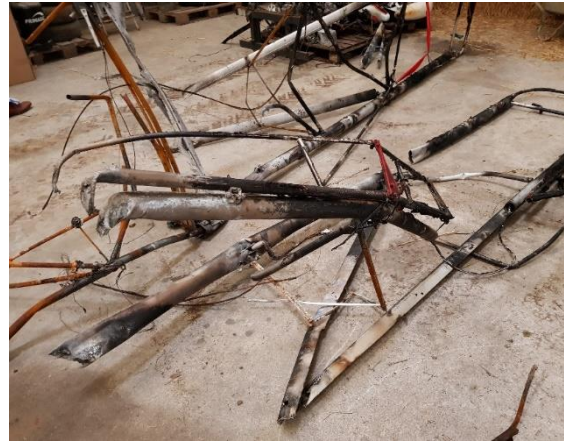
Figure 15: Right wing

The wing tubular section was bent and broken at the level of the wing to fuselage junction. The flaps and aileron surfaces were still connected to the wing. The wing leading and trailing edge were broken on 2/3 of the wing mid length. From this trailing edge rupture, the wing tubular structure at the flaps area was severely bent, with significative torsion in an upward direction.

The 2 right wing struts were still connected to the wing but bent at their respective wing leading and trailing edge attachment points and broken forward of their fuselage point of connection.

The flaps & aileron were still connected on the wing hinges and manually operable up and down. The flaps were more damaged due to the wing torsion at this area.

The wing torque tubes, yokes and attaching hardware were still present but broken and bent on several different places of the wing structure.

The structural damages to the right wing appear to be far more extensive than on the left wing.

The more consequent damages (ruptures & bending) observed on the right wing, with damage on the propeller confirm a vertical impact of the airplane with the right wing advancing forward ( also observed with the impact marks on the ground).

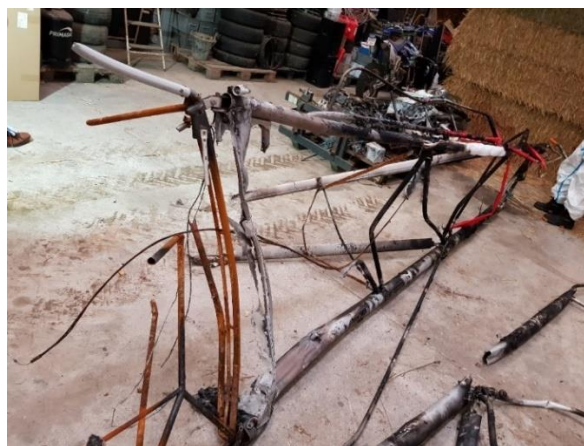
Figure 16: Left wing

The left wing was still connected with bolts to the tubular structure of the cockpit upper section. The wing was complete with flaps & aileron and with no significant apparent deformation, other than from the impact with the ground) or rupture on the wing structure.

The 2 wing struts were still connected to the wing leading and trailing edge and resting in place, in their normal position, they were severed at the broken junction to the fuselage.

The flaps & aileron were still connected on the wing hinges and manually operable up and down. All the wing movable surface controls were in place, with the wing torque tubes, yokes and attaching hardware still present and not presenting any significant marks of rupture or bending other than the normal deformation due to the ground impact.

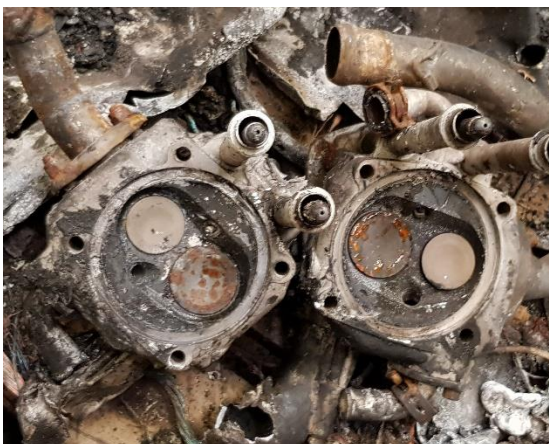
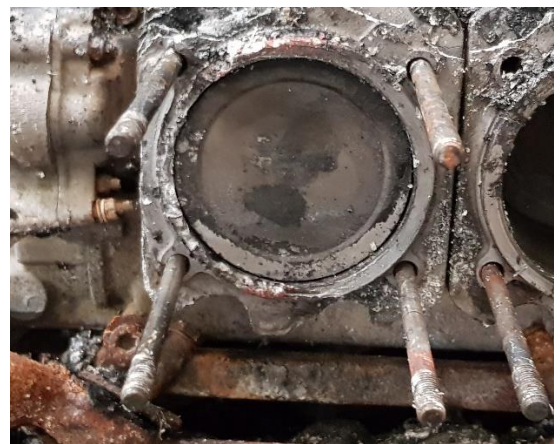
Figure 17: Cylinders and Valves

- the ignition sparks did not show any sign of abnormality;
- the cylinder valves, cylinder heads and piston surfaces did not show any sign of abnormality.

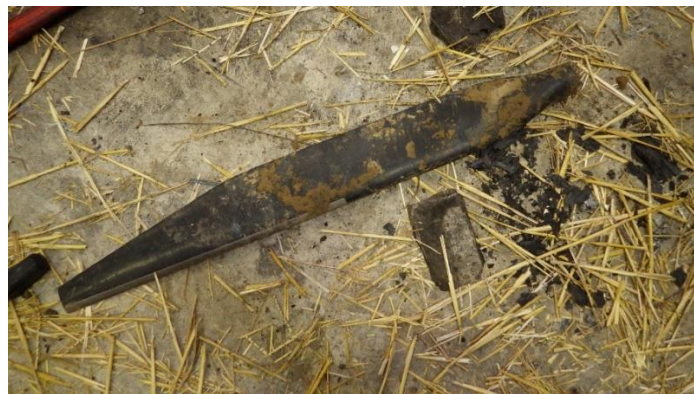
**Figure 19: 10 o'clock propeller blade**

The blade located at 10 o'clock was found complete, covered by soil, and broken from the hub at the level of the root but in general good condition.
