# Safety Investigation Report

Ref. AAIU-2020-01-31-01  
Issue date: 31 January 2022  
Status: Final

Occurrence class	Incident
Occurrence category	System/component failure or malfunction [non-powerplant] (SCF-NP)
Date and time <sup>1</sup>	31 January 2020 11:30 UTC
Location	51,235624°N - 004,437490°E
Aircraft	Partenavia P68B
Aircraft category	Fixed wing - Small aeroplane (MTOW ≤ 5700 kg)
Location of departure	Aerodrome of Antwerp/Deurne (EBAW)
Planned destination	Aerodrome of Antwerp/Deurne (EBAW)
Type of operation	Non-commercial - Cross-country
Phase of flight	Initial climb
Injuries	None
Aircraft damage	Minor

During a local flight after maintenance, when the aircraft was climbing at 1000 ft, the emergency door fell out. The door landed at short distance of a car.

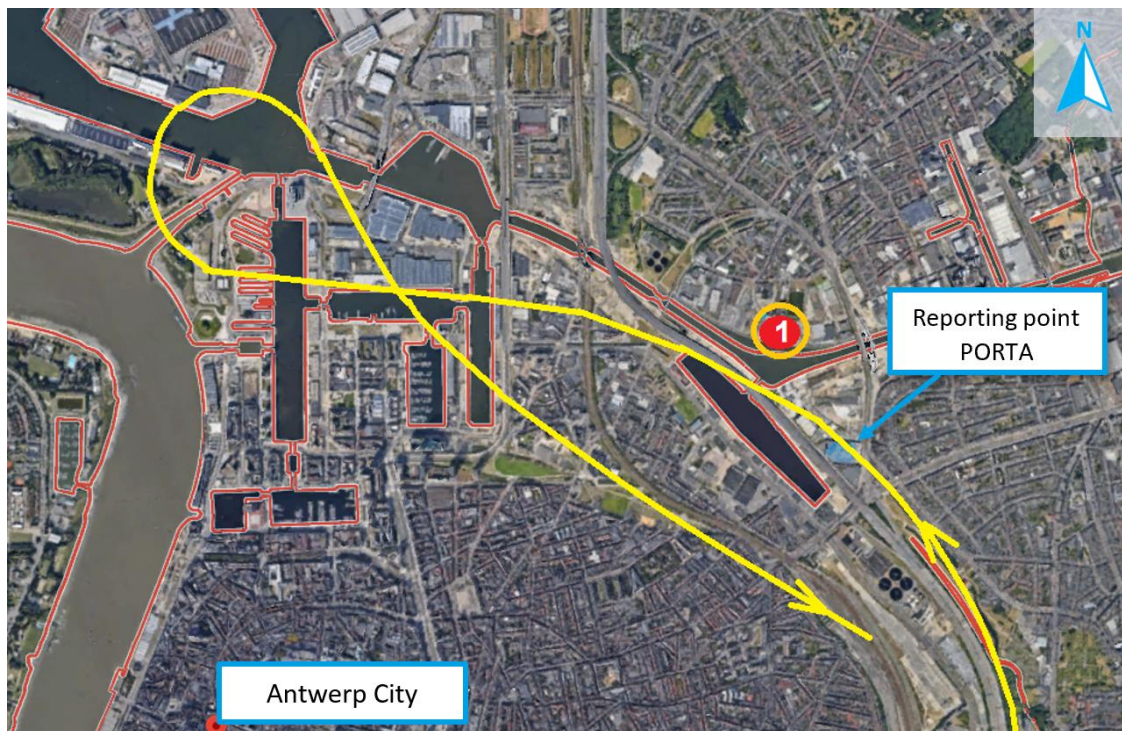
Figure 1: Flight track and position (1) of the part (© Google Earth - 2019)

The falling part was spotted by a woman and her son, driving around in the neighborhood. The son noticed a plane flying over, when he suddenly saw that an object fell from the plane. This object landed +/- 15m from the vehicle next to the road on a piece of wasteland (position 1 on Figure 1).

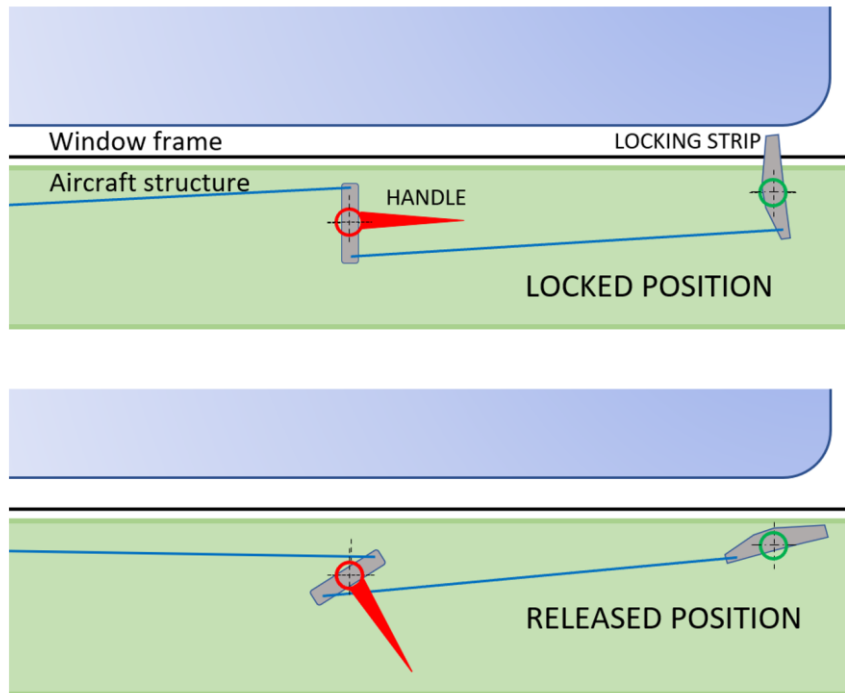
Figure 5: Emergency Window handle operation

The release of the window in flight was obviously caused by the operating handle being inadvertently left in the 'release' position after maintenance. The inadequate position was not identified during the mandatory inspections mandated by the POH and Maintenance Manual.

The marking present on both aircraft, although literally complying with the wording found in the POH, did not determine a clear and unambiguous position of the emergency window operating handle (window locked / released).
