Safety Investigation Report

Ref. AAIU-2022-07-02-01

On July 2, 2022, about 13 UTC, a Piper PA-25-235 airplane was destroyed when it impacted terrain during initial climb after take-off from the Tournai-Maubray airfield, Belgium. The airline transport pilot suffered only minor injuries and could escape from the wreckage before it caught fire and was totally destroyed. The aircraft was towing a Schleicher KA 6E sailplane at the time. The sailplane pilot stated that during the initial climb, the tug aircraft disappeared from his sight and he released the tow cable. The sailplane could return to the airfield for a safe landing.

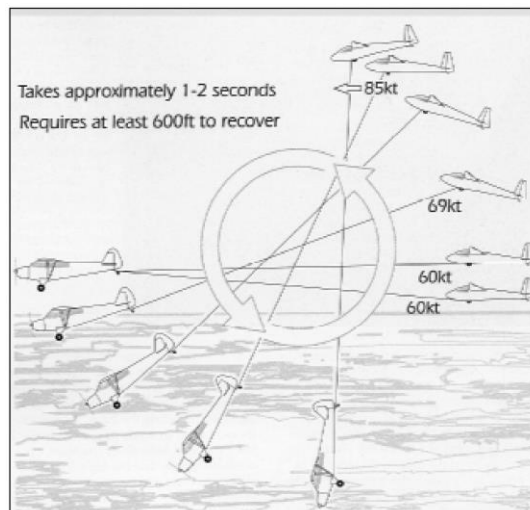
Figure 7: Typical sequence of glider 'winch launching' behind the tug. Glider speeds are based on a constant tug speed of 60 kts

A typical sequence is shown in the illustration on the previous page, with a simplified rope load/angle plot in the illustration below. In reality the situation is worse than shown because the glider zoom climbs behind the tug, its total energy increases (simultaneous increase in height and speed). This energy can only come from the momentum of the tug and therefore its speed will rapidly decay. This means that just when a high download is required to be generated by the tailplane/elevator to retain control and break the weak link on the rope, the capability to do so is vastly reduced by the decay in airspeed. This may result in the tailplane, and possibly the wing, stalling. Typically, 600 feet or more may be required to recover from an upset.

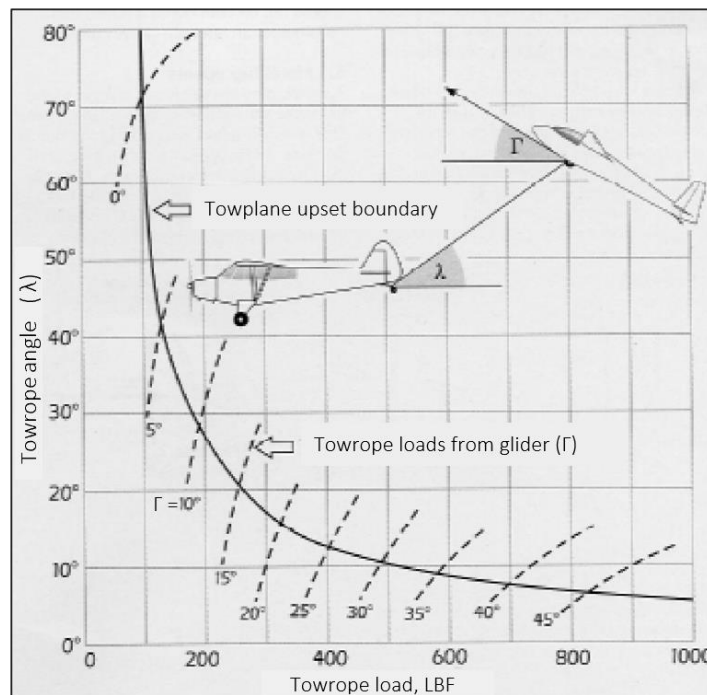
Figure 8

The solid line corresponds to the vertical component of the tow rope load which will upset the tug, and the dashed lines represent the loads applied by the glider calculated as if tow ropes were extremely long. For typical ropes, the loads are greater than shown – much greater for steep flight paths. The tug will therefore be upset at small rope angles by rather gentler manoeuvres than this diagram suggests. The rope weak links will protect the tug at the right side of the diagram while rope release is the only solution at the left side

The reference documentation (chapter 1.18.1) and further studies⁴ show that a tow airplane upset can occur while the load on the tow cable remain below the break-up value of the weak link (typ. 4000 N / 890 lbf). The weak link will only provide protection against very steep glider attitudes (Γ angle above 45 degrees) at low tow cable angle (λ angle below 10 degrees), the situation shown at the right side of the diagram in [Figure 8](#). of chapter 1.18.1. In this last case, a weak link would be effective as a safety barrier.

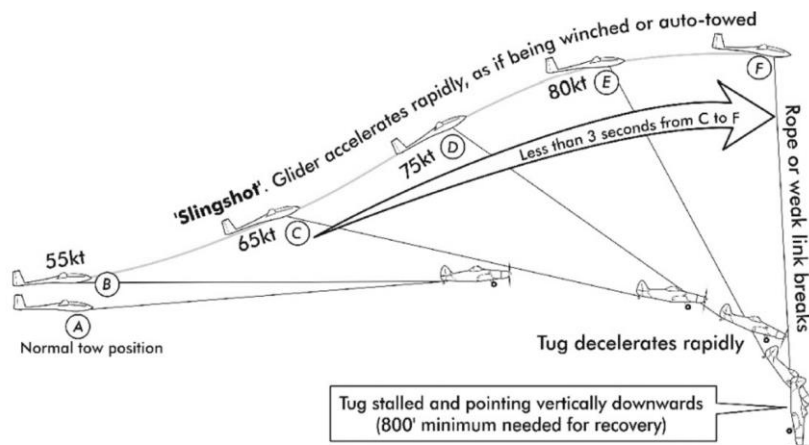
Figure 9

These are serious, and have caused the deaths of a number of tug pilots. If the glider is allowed to climb rapidly behind the tug, it can very quickly become impossible to prevent it accelerating upwards in a slingshot action (rather like a winch launch), and tipping the tug over into a vertical dive.

Once that has happened only height can save the tug pilot from disaster. Downward displacement of the glider to a position below the slipstream is quite acceptable, but upward displacements are much more critical.

Typical sequence of glider 'winch launch' behind the tug. Glider speeds are based on a constant tug speed of 60 kt
