***Air Accident Investigation Unit***

# **FINAL REPORT ON THE ACCIDENT TO BRT EIDER (F-PMIC) IN CERFONTAINE ON SEPTEMBER 15 2007**

**Ref. AAIU-2007-14**  
**Issue date: 30 April 2008**  
Status: Final

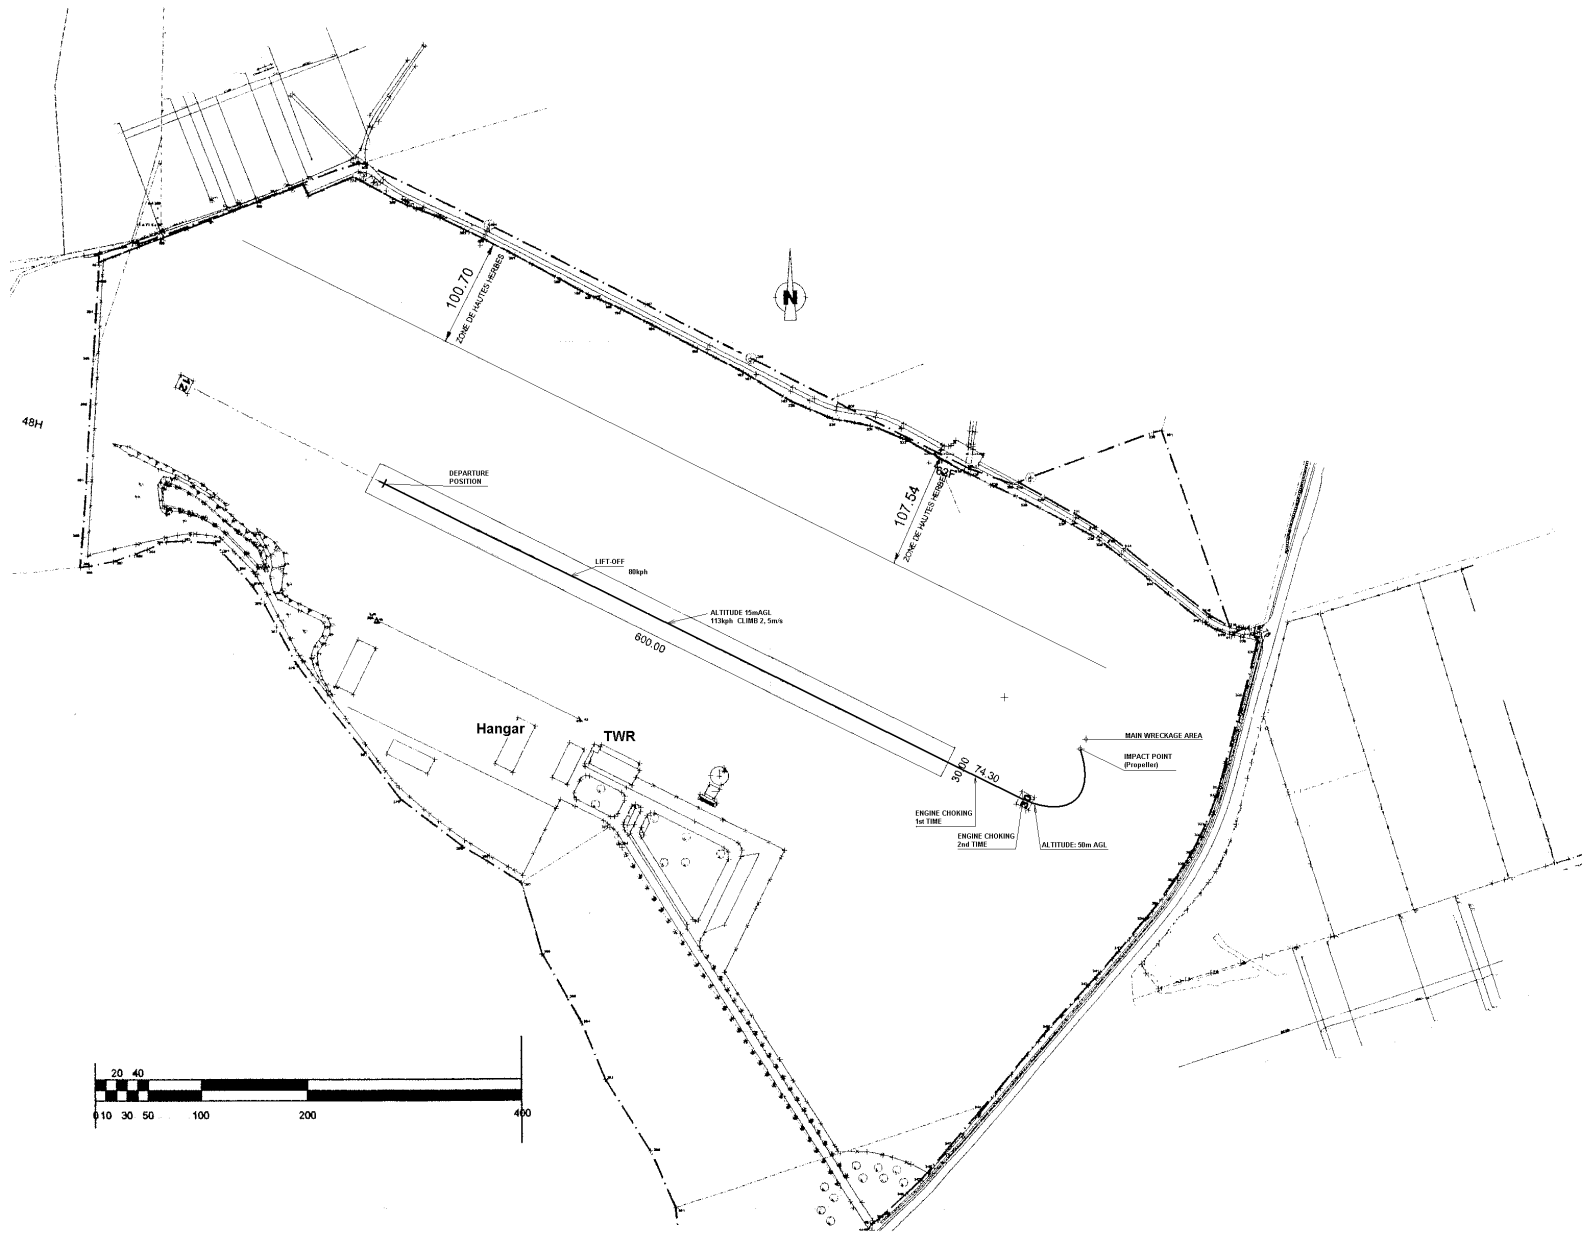
The aircraft hit the ground, bounced back and caught fire.

The aircraft was totally destroyed by fire, and the two occupants died in the crash.

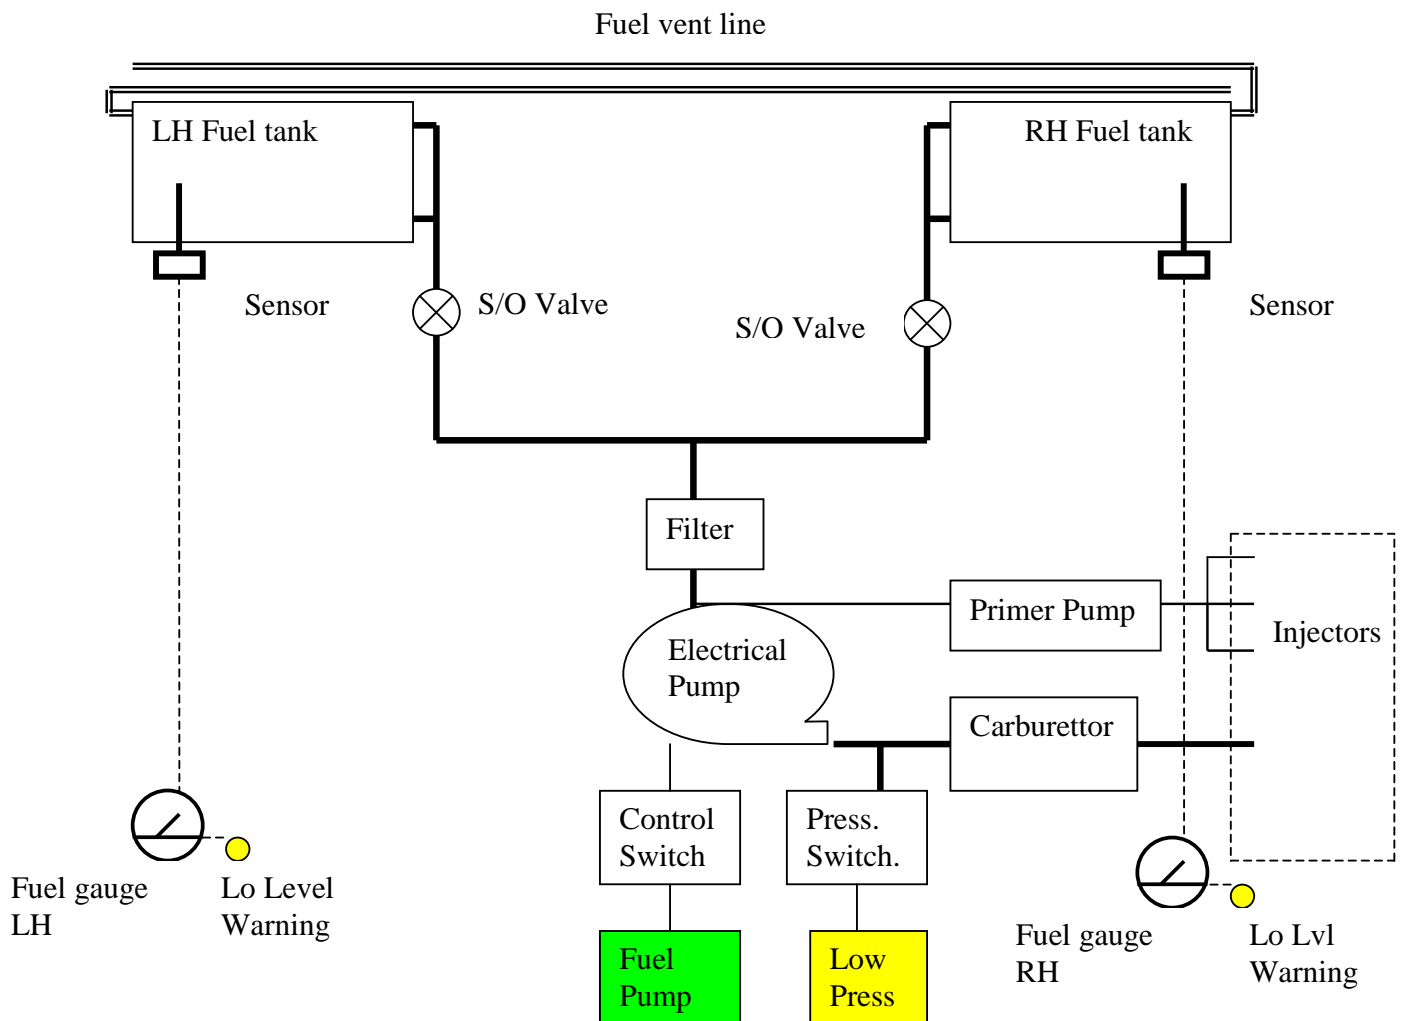
- removal of the fuel tank selector switch.
- Installation of 2 manual shut-off valves
- Replacement of fuel lines by flexible Aeroquip 491-6 hose.
- Installation of an electrical fuel pump between the fuel filter and the carburetor – because of the lack of mechanical fuel pump on the 0-320 engine. The pump is controlled by a switch in the control panel, and has a condition (on/off) light.
- Installation of a second connection in each fuel tank. Each tank has a front and a rear connection.
- The fuel lines are installed behind the firewall and connected to the Fuel filter inside the engine compartment.
- The primer fuel pump is connected to the fuel injectors.
- A fuel gauge is installed for each tank, with a low level warning light.
- A fuel pressure warning light is installed on the control panel.

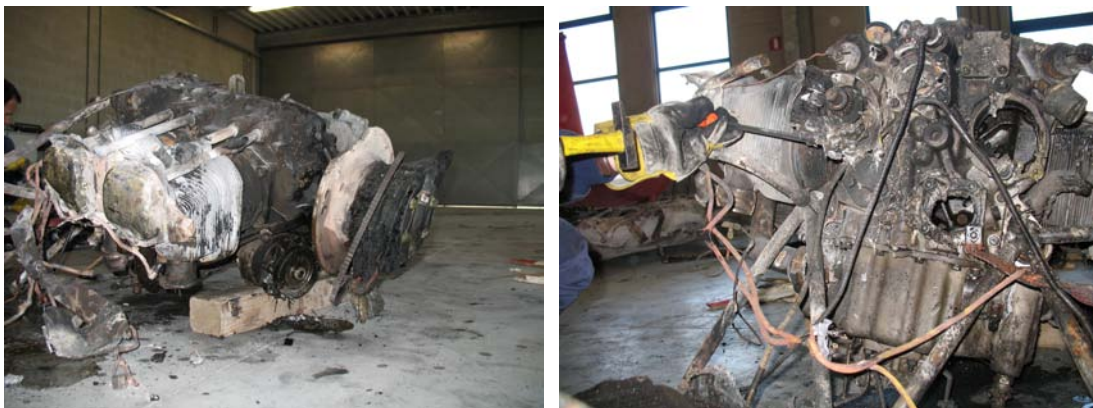
The engine was inspected on-site, and subsequently sent to a repair station for further analysis.

The on-site inspection was basically an external visual check of the condition of the engine, its accessories and spark plugs. The engine was found rotating.

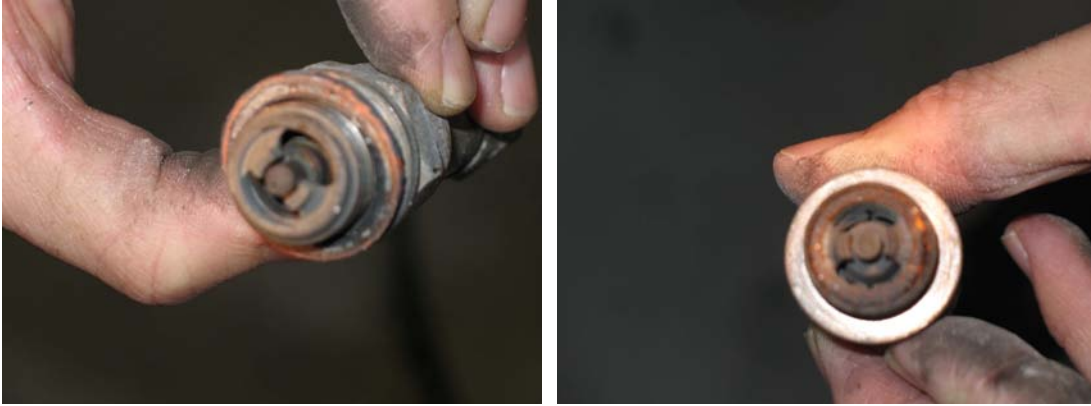
8. Worn out spark plugs.  
This would only cause a reduction in power, but the spark plugs were found in good condition.

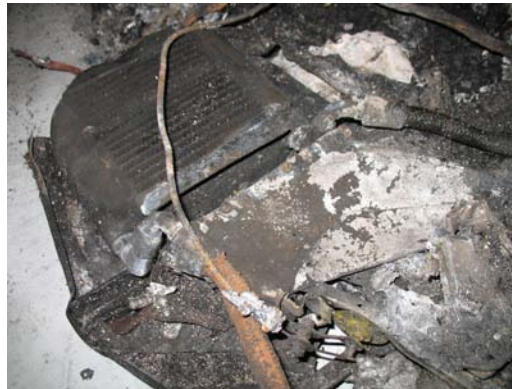
9. Air filter dislodged and stuck in intake system thereby cutting off the air supply.  
As the air inlet is crushed by impact force, this was impossible to determine.

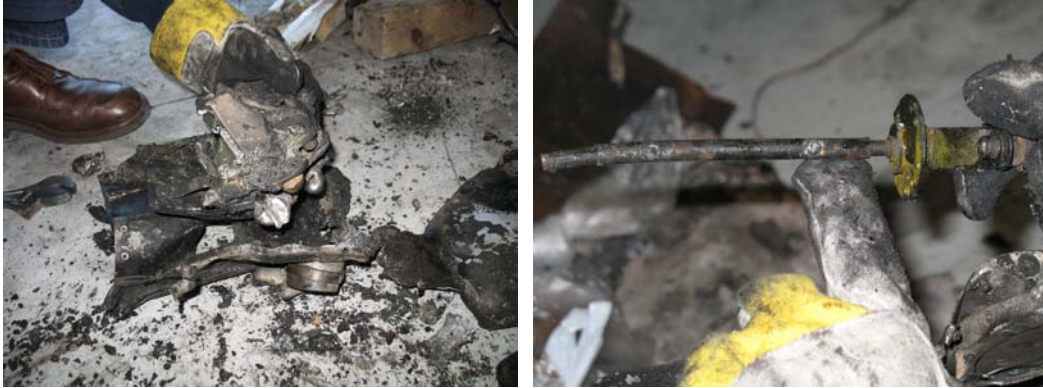
10. Carburetor heat flapper valve in the air box partly open  
As the air inlet is crushed by impact force, this was impossible to determine.
