Safety Investigation Report

ACCIDENT TO A CESSNA 172 AIRPLANE AND AN AVEKO VL-3-B IN LES MOERES (FRANCE) ON 02 OCTOBER 2010

Ref. AAIU-2010-43-Les Moères
Issue date: 29 August 2014
Status: Final Draft

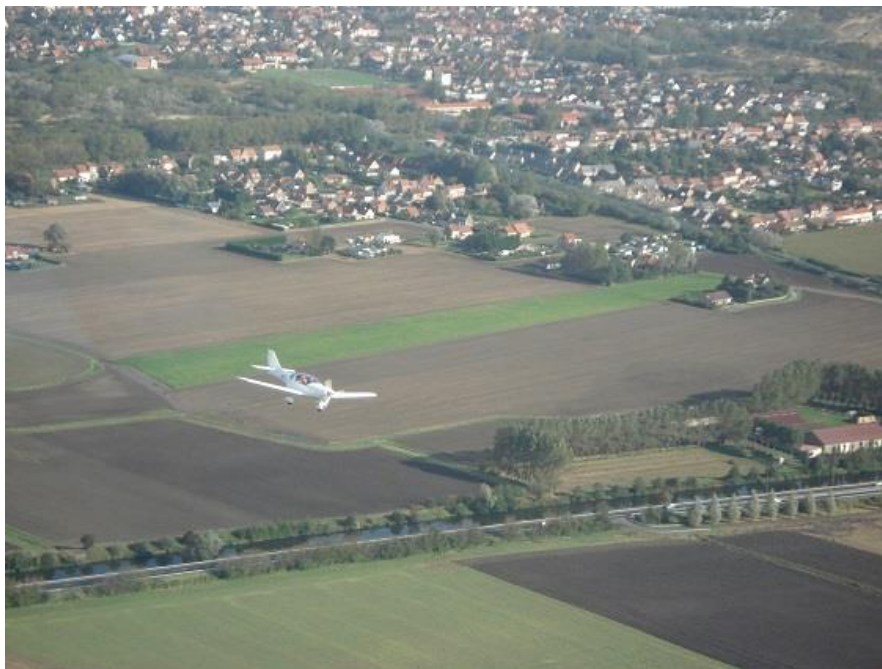
Figure 7: Images. 2890-93: VL3 behind and lower

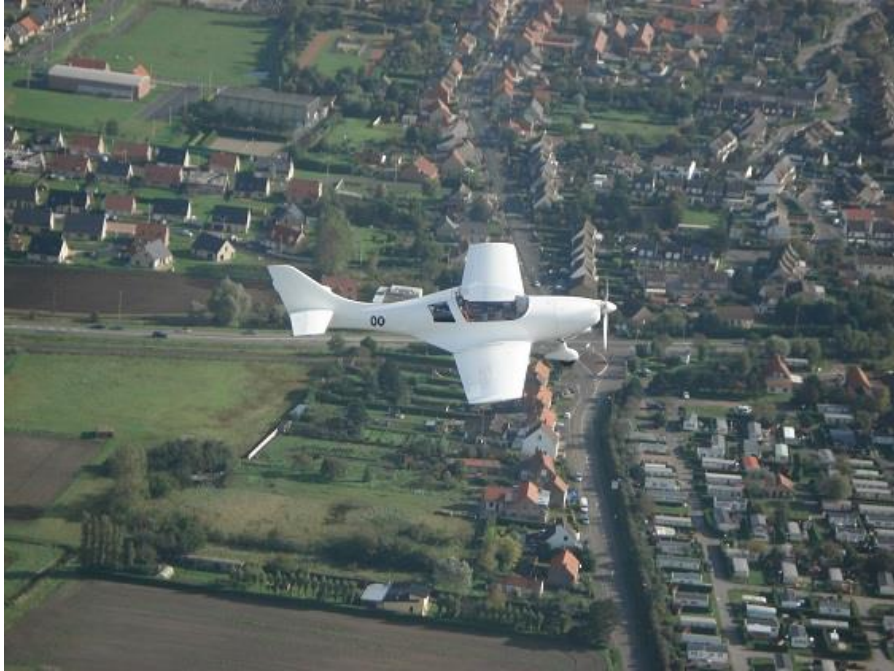
Figure 8: Image 2894: VL3 and C172 side-by-side, VL3 lower.

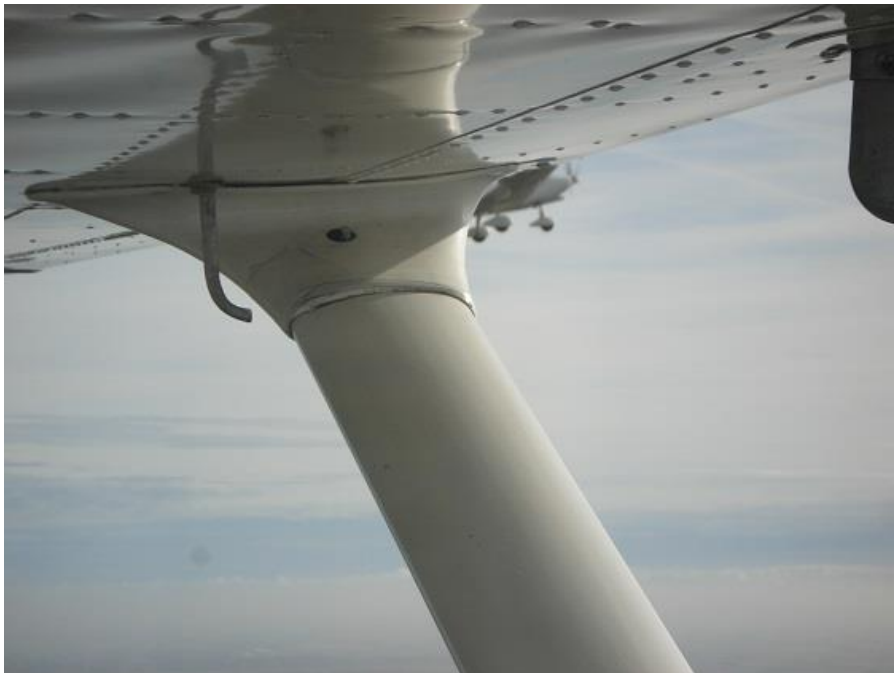
Figure 9: Image 2896 – 97 VL3 above C172 and in front

In addition to the differences in performance of both aircraft, the aircraft are also different in configuration; the C172 is equipped with a high wing, while the VL3 is equipped with a low wing. This causes a difference in visibility outside of the cockpit: This is demonstrated with image 2896 when the VL3 flew higher than the C172; both pilots would have had difficulties to see each other’s aircraft.

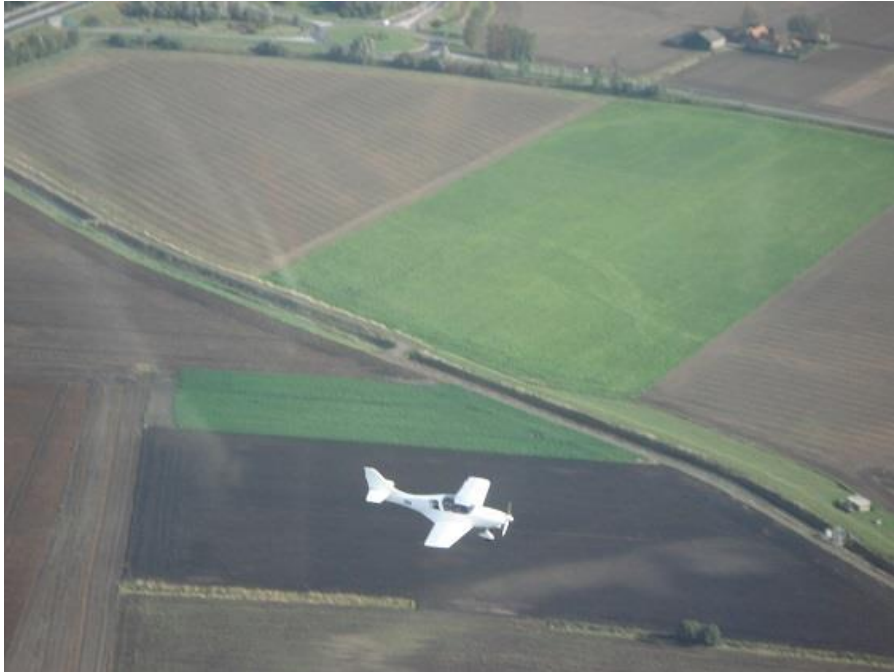
Figure 10: Image 2897 VL3 behind and lower.

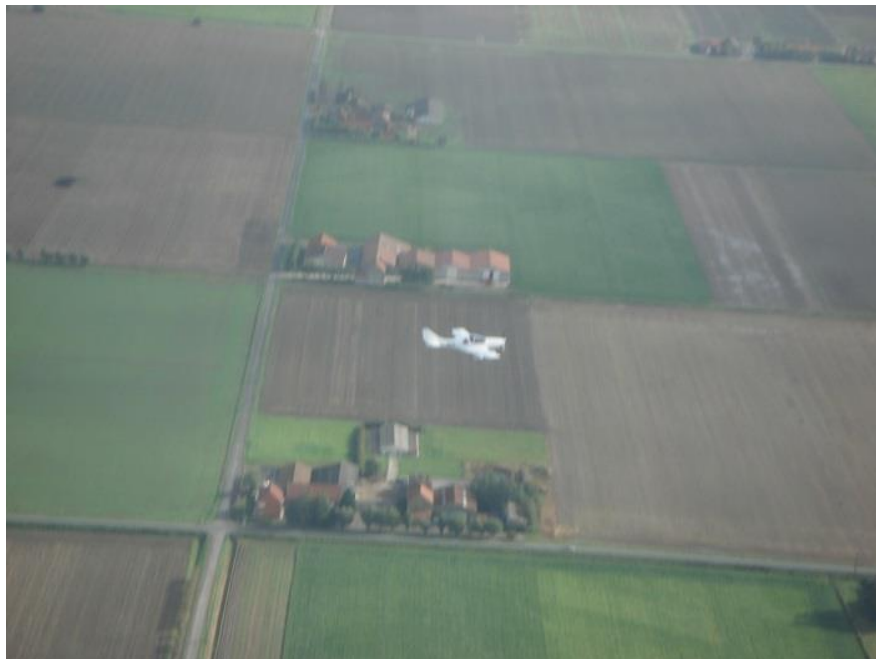
Figure 11: Image 2898 and 2899 (last picture taken): VL3 in front and lower

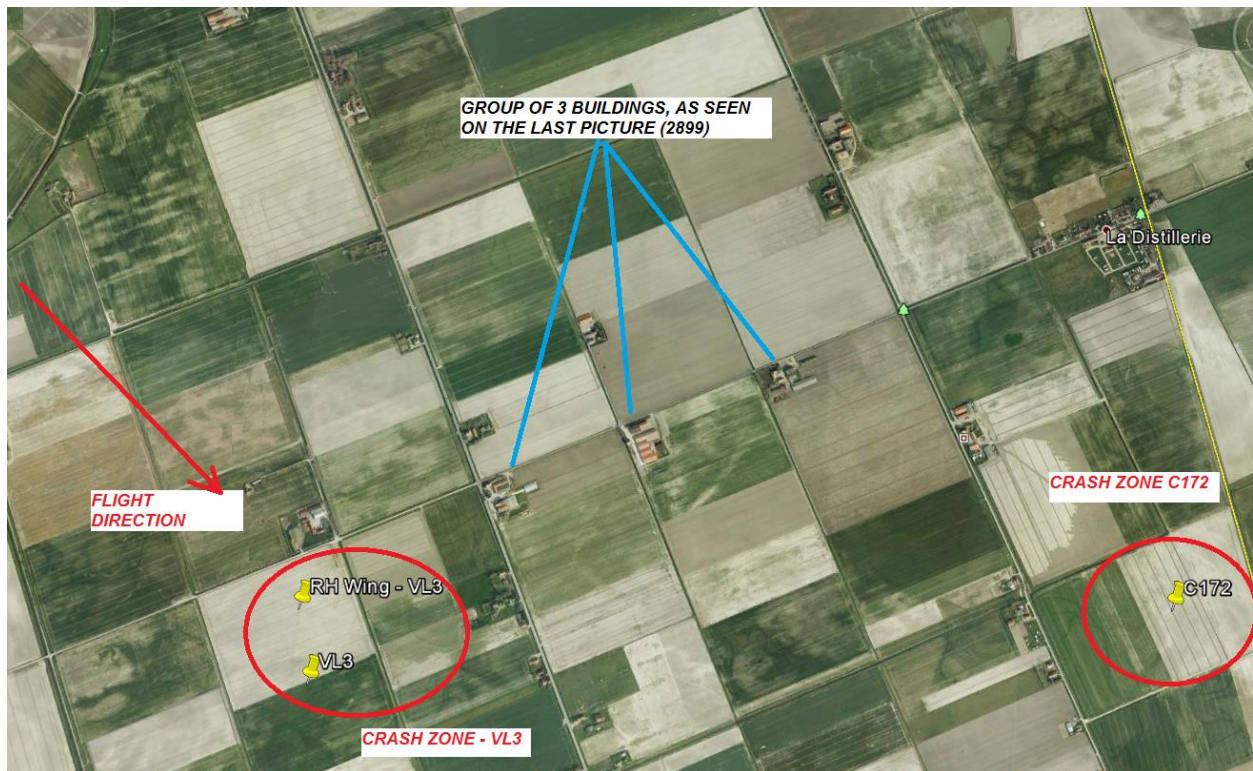
Figure 13: Position of crash zones.

The C172 crashed 2 km away eastward of the location where the wreckage of the VL3 was found.

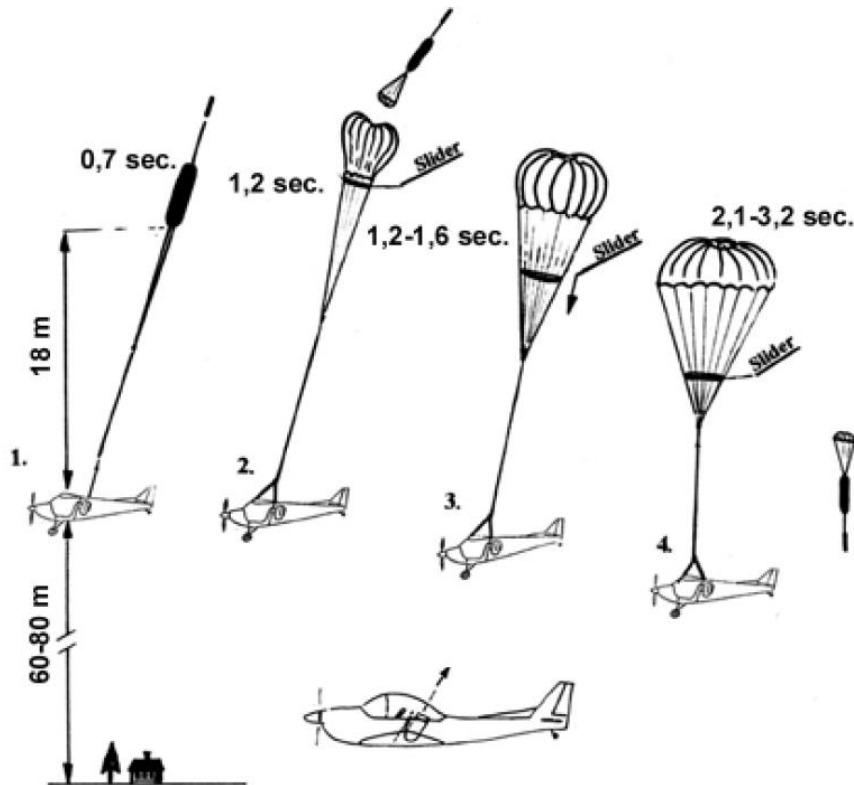
Figure 28: Operation of the rescue ballistic parachute

According to the manufacturer, the rescue parachute should be fully opened in 2.1 to 3.2 seconds.

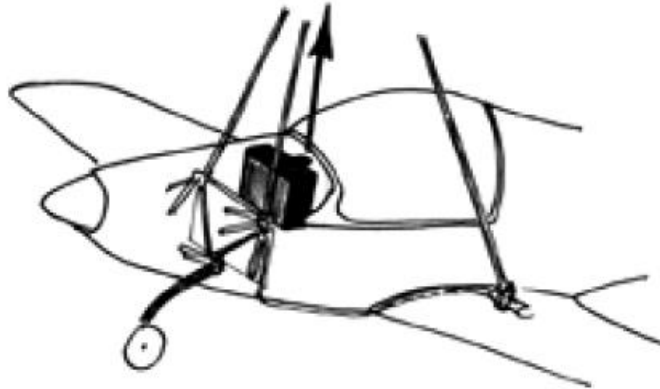
Figure 29: parachute ropes installation: typical.

The four ropes, attaching the airplane to the parachute were found connected to the respective attachments. However, three attachments were found separated from the airplane's structure. Only the rear left attachment was still connected.

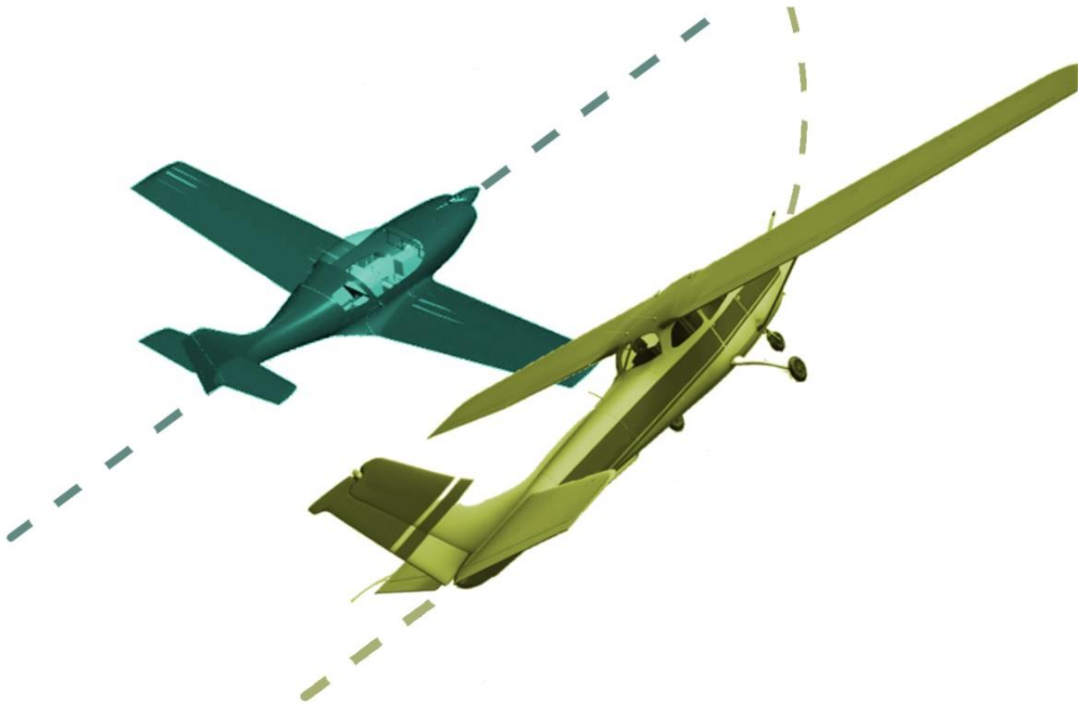
The inspection of the C172 wreckage showed that the leading edge of the left wing of the C172 impacted the trailing edge of the right wing of the VL3, with a penetration angle of 45°. Additionally, thorough examination of the VL3 wing damage showed the lower wing skin was bent downward, and ripped off by the C172 wing impacting the VL3 from above. The forces on the wing of the VL3 caused the rupture of the main spar.

The Right wing of the VL3 separated from the fuselage. The C172 did not suffer any catastrophic failure, and was able to perform an emergency landing.

Figure 35: sketch of in-flight collision
