Safety Investigation Report

ACCIDENT TO THE SCHLEICHER Ka6CR SAILPLANE IN EBSH ON 13 AUGUST 2010

Ref. AAIU-2010-39-EBSH
Issue date: 29 August 2012
Status: Final

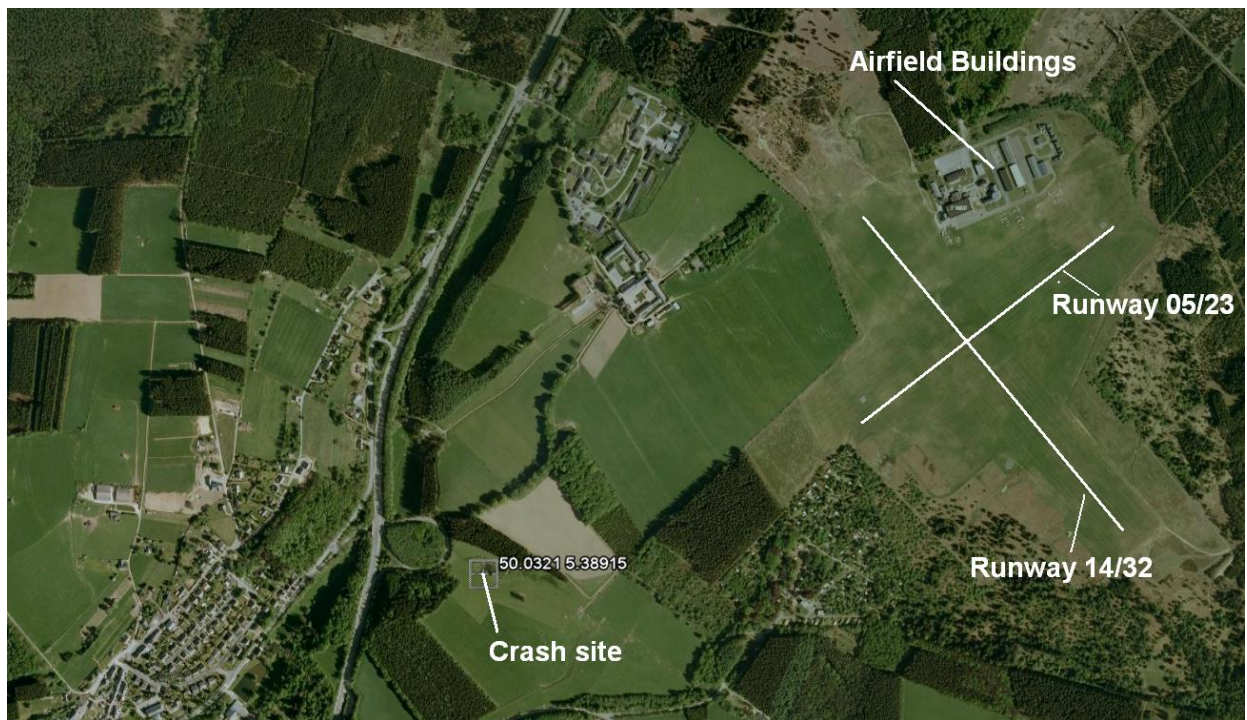
Fig.8 Crash site location

The damage to the vegetation shows the sailplane fell vertically.

The sailplane nose is shattered, and RH wing is broken to pieces. The LH wing was stopped by the branches of a tree.
