FINAL REPORT ON THE ACCIDENT TO THE SAILPLANE EIRIAVION PIK 20D REGISTERED OO-YEB IN WEELDE ON JUNE 12, 2010

Ref. AAIU-2010-27
Issue date: 7 January 2011
Status: FINAL

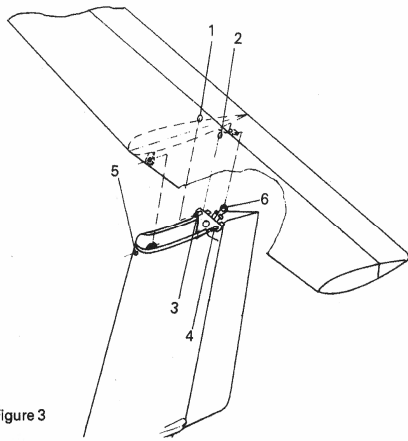
Figure 3

The tail unit is a cantilever T-tail. Fixed incidence tailplane with one-piece elevator articulated on 4 hinges, and activated by a rod connected by a quick release l'Hottellier Coupling.

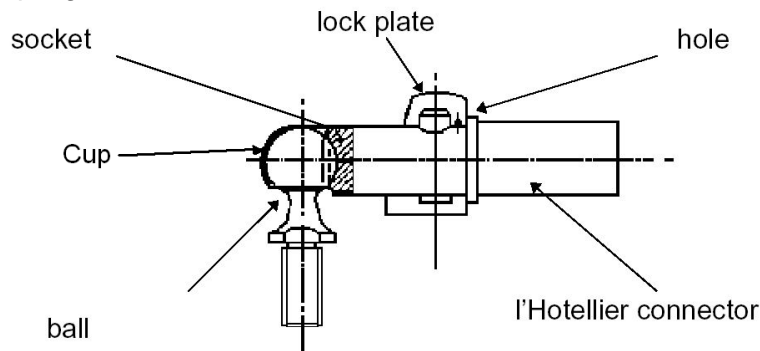
A l'Hottellier coupling is a quick-release connector, consisting of a ball fitting in a spring loaded socket. The coupling is secured by a lock plate.

On the wreckage, the l'Hotellier couplings of the flight controls of OO-YEB were found connected at the exception of the elevator which was found separated. The safety pin of this connector was not engaged as well.

On the wreckage, the l'Hotellier coupling of the elevator was found not connected; as the safety pin does not show any sign of damage, it is obvious that the safety pin was not installed upon sailplane assembly.

The l'Hotellier coupling itself does not show obvious sign of damage, or deformation that would be subsequent to a brutal opening at impact.

From the above, we can reasonably deduct that the l'Hotellier coupling of the elevator, during sailplane assembly, was inadequately connected and not secured.

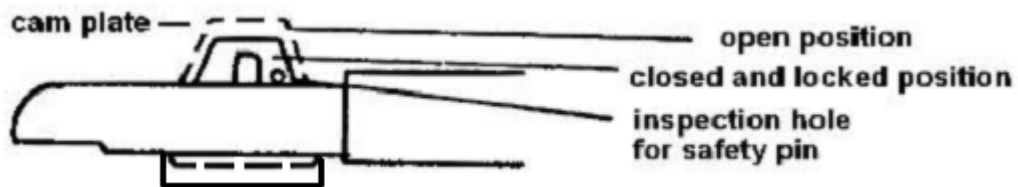
Diagram of the socket of a l'Hottellier coupling showing the cam plate and inspection hole

To connect the l'Hottellier coupling, the cam plate is depressed from its open position so that the narrower side is flush with the body of the cup. The cup is slipped over the ball on the other part of the coupling and the cam plate is released. If the ball is correctly located, the cam plate will spring back to the 'closed and locked' position in which the inspection hole will be completely visible as shown above.
