Safety Investigation Report

ACCIDENT TO CESSNA F152 AT LOMMEL ON 09 JUNE 2011

AAIU-2011-17

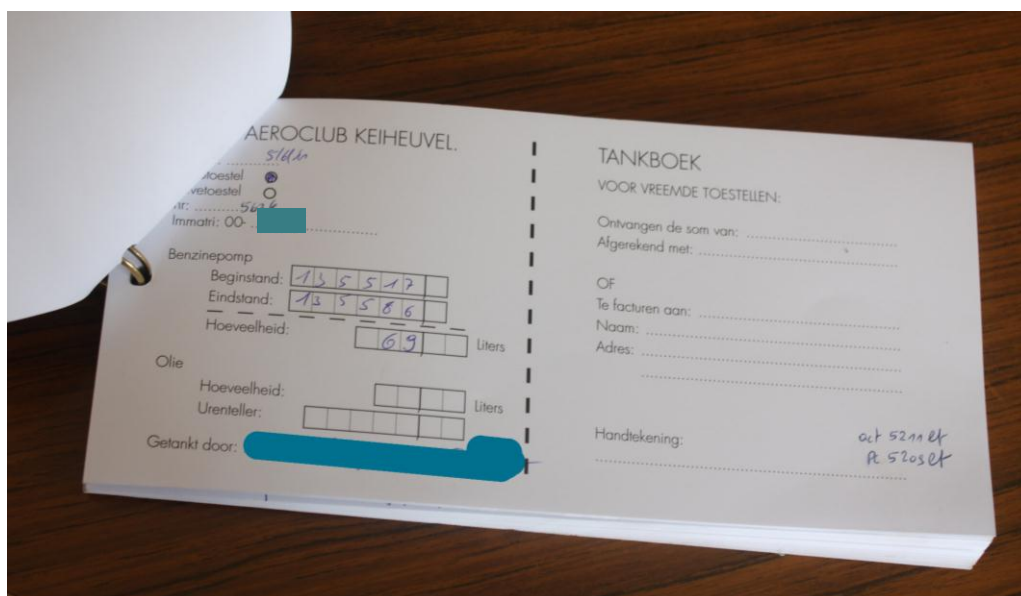
Figure 6: Refuel book with last refuelling of the aircraft

The last refuelling on the airfield was not completely logged in the refuel book of the aeroclub, as required by the Aero Club Rules of Procedure; the hours on the hobbs meter were not recorded.

When refuelling, the refuel book has to be fully completed: the time on the hobbs meter of the aircraft should also be noted.

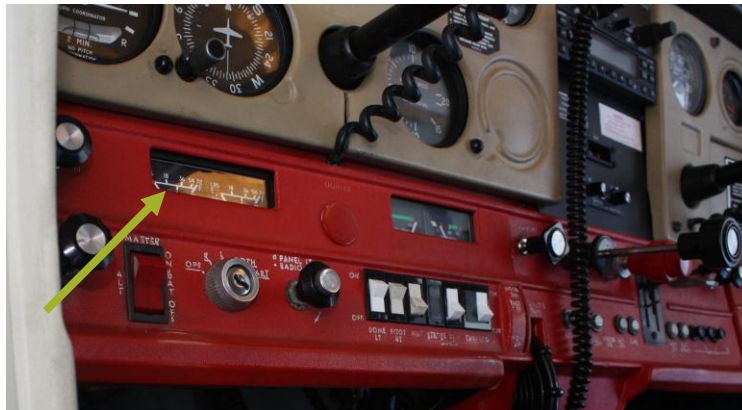
Figure 7: Cockpit view with Fuel Quantity Indicators

- As the quantity indicators are of the moving magnetic type, they can be influenced by external magnetic field changing the magnetic orientation of both the moving and the permanent return magnet;
- As the floats are installed in the forward part of the tanks and the fuel surface aligns with the gravity, they only give a correct value when the airplane is level;
- Mechanical damage to the float arm (bending) may lead to incorrect readings
- The gauges need (periodic) calibration

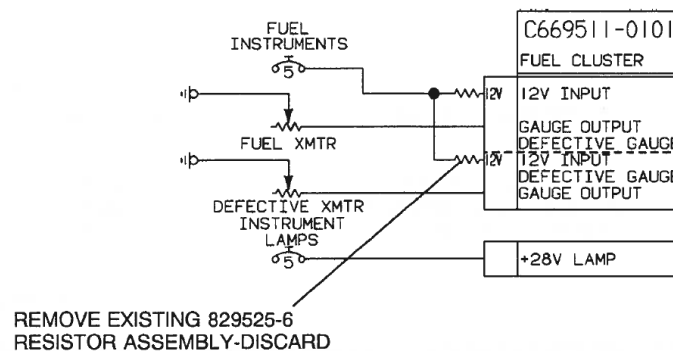
When replacing the old fuel gauge, the dropping resistor and the steel backplate has to be removed and discarded, see wiring diagram.

Figure 10: Wiring diagram before modification

The fuel quantity indicators were removed from the aircraft to inspect their working. During the removal it was found that a dropping resistor was installed on both gauge inputs, although it had to be discarded as per SEB91-7 Revision 1 (see paragraph 1.6.9).

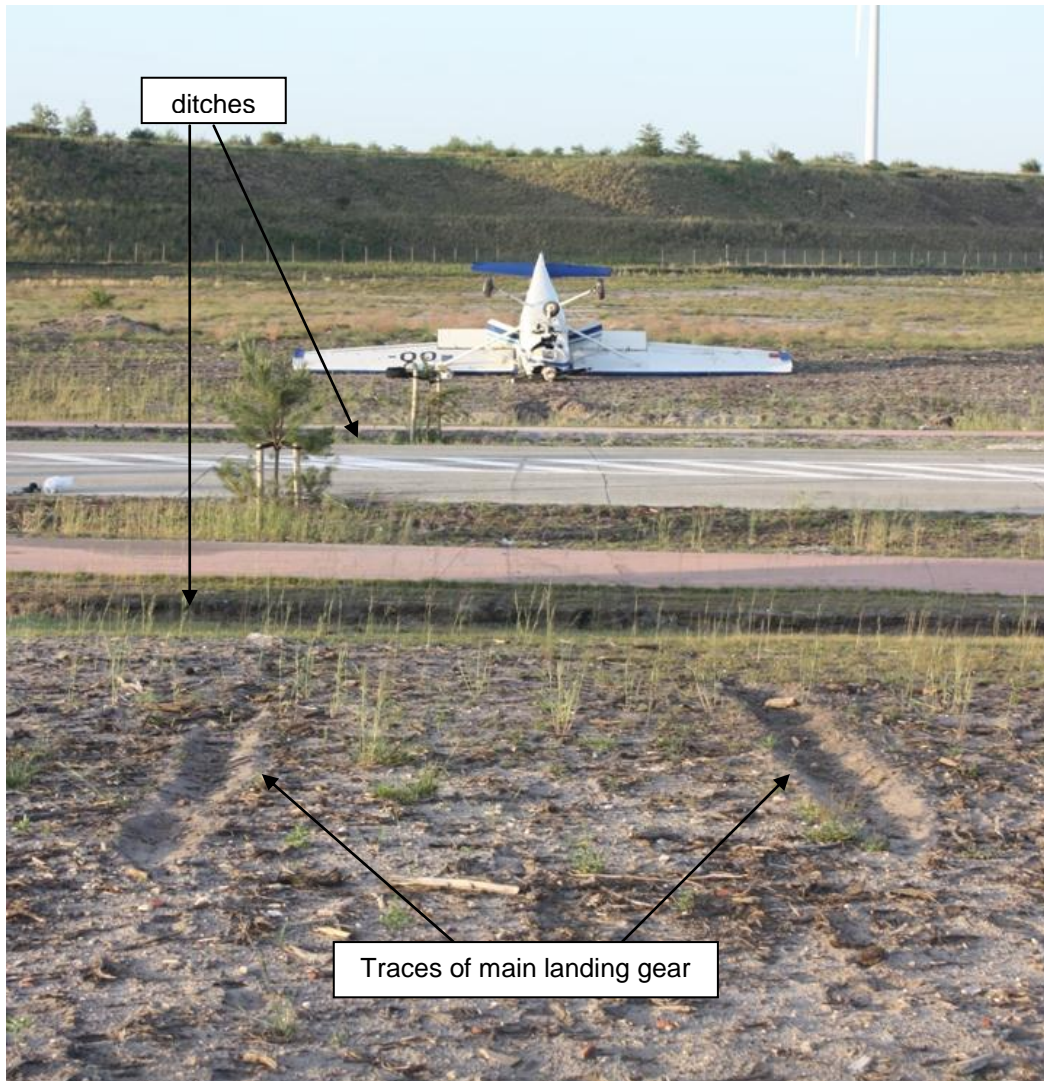
Figure 15

It first touched the ground on a field, just before a road that was surrounded by 2 ditches the pilots first didn't notice. During this manoeuvre, the nose landing gear probably suffered some damage by hitting this ditch. The aircraft was slightly pulled up again to cross the road but upon entering the second ditch, the nose landing gear broke. The engine ploughed into the ground and the plane flipped over.

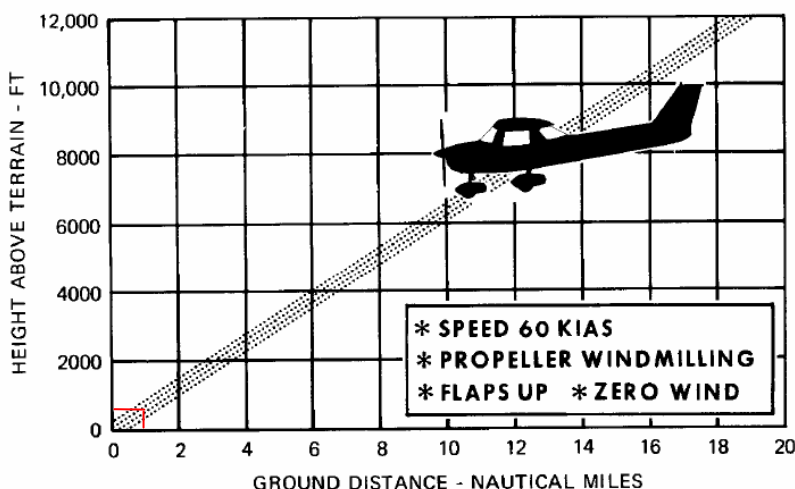
The maximum glide distance is showed in the figure of the POH below.. We can see that the altitude needed to reach a distance of 0,9 nm is approx. 600 ft. However this is only valid under the condition that flaps are up and there's zero wind. In this case flaps were already selected to 20° and there was an upwind between 5 to 11 knots. The aircraft would never have reached the runway and the instructor took the right decision to choose another landing area.

Figure 21: Maximum glide
