Safety Investigation Report (Interim Report)

ACCIDENT TO THE BOEING B737-45D REGISTERED SP-LLB IN EBBR ON 26 MAY 2011

Ref. AAIU-2011-16-EBBR-SP-LLB
Issue date: 25 May 2013
Status: Interim

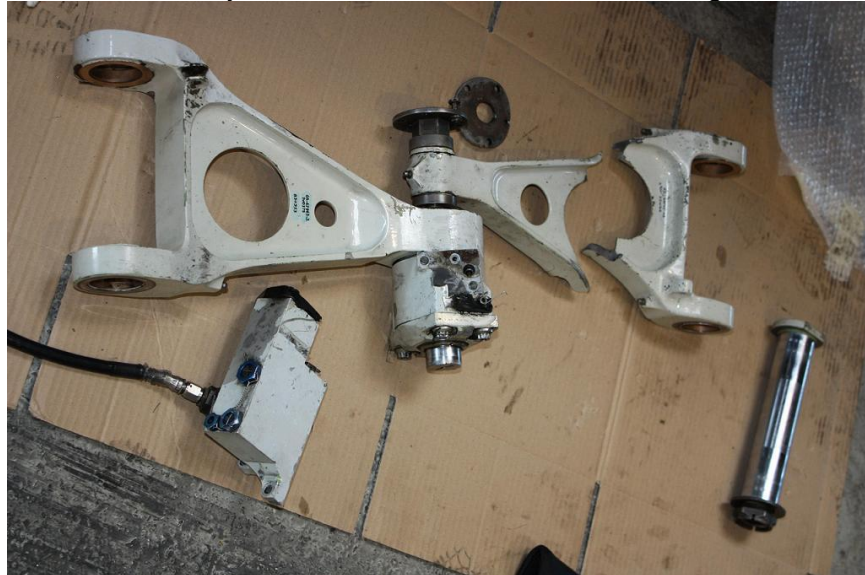
Shimmy damper.

- **PN: 65-44771-4; SN: TRI4745**
- **CYCLES SINCE INSTALLATION: 10775 FC**
- **INSTALLATION DATE: 16.01.2002**

The shimmy damper upper body (manifold casing) was found separated from the lower body.

All bolts attaching the shimmy damper upper body were found sheared.

Only one bolt attaching the shimmy damper lower body to the upper torsion link was found sheared, all 4 others were pulled through. One bolt was not found.

The attachment bracket was broken, showing deformation.
