Safety Investigation Report

Ref. AAIU-2012-25

Classification: Accident
Level of investigation: Standard
Date and hour: 11 November 2012 at 14:00 UTC
Aircraft: Rockwell Commander 112 SN 196. The aircraft was registered in Belgium and held a Certificate of Airworthiness and a valid Airworthiness Review Certificate (ARC)
Total flight time: 3347:57 FH
Accident location: Off EBTN airfield
Type of flight: Cross-country
Persons on board: The pilot was on board alone. **Phase:** Landing
Injuries: None

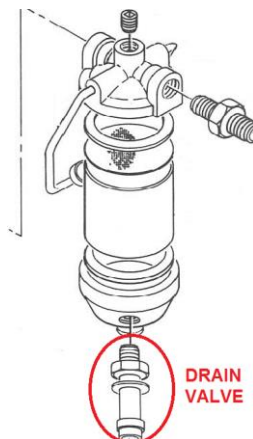
Figure 5: Gascolator

The gascolator was equipped with a drain valve accessible after removal of the engine cowlings. No remote control of this valve was installed.

However, the possibility exists to reach the drain valve without removal of the engine cowlings, but it was very difficult and required the pilot to lie on his back on the floor.

The fuel gascolator was disassembled showing semi-solid other contaminants looking like a kind of white gelatine. Thereafter, the screen filter located inside the injection system was removed and the inspection confirmed the contamination. Droplets of water were found in the injection system.
