Federal Public Service  
Mobility and Transport  
Air Accident Investigation Unit

## Safety Investigation Report

# ACCIDENT TO HELICOPTER ROBINSON R-22 AT HUY ON 6 APRIL 2012

Ref. AAIU-2012-06-Huy  
Issue date: 30 January 2013  
Status: Final

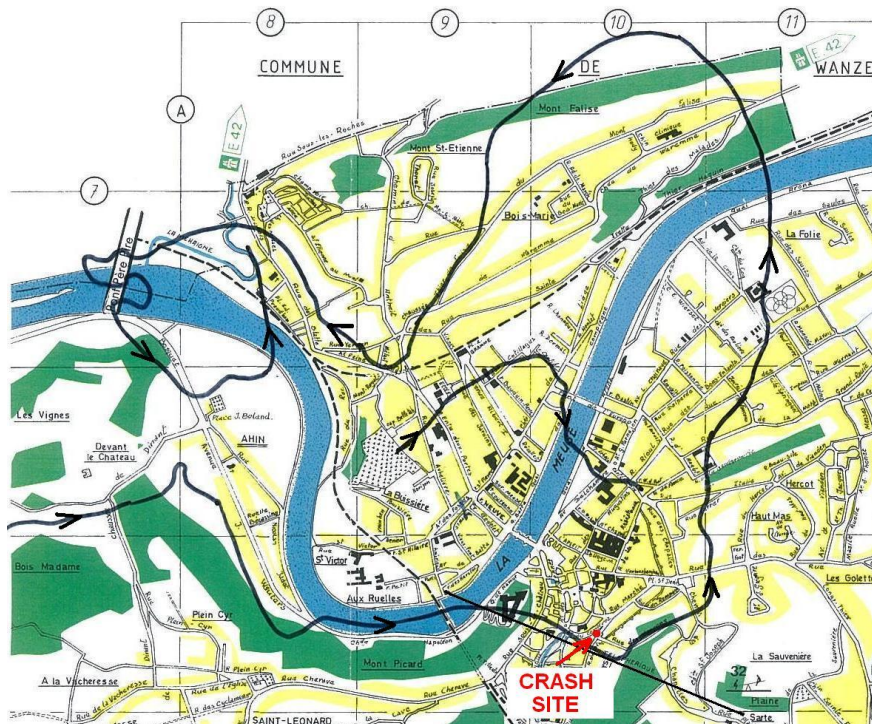
**Figure 2: Flight path above Huy**

As seen on the following drawing, the flight path was reconstructed based on the recorded radar echoes and was superimposed on a map of the city. The general path of the helicopter began with a counter clockwise flight around the most densely populated areas and finished by an over flight of the market place (Grand Place) before proceeding near the cableway cable.

Three witnesses declared that they saw the helicopter flying above the city and starting to hover approximately at the height of the cableway cables, close to them. The helicopter was hovering north of the cable with the cabin pointing to the North North-East and the tail pointing to the South South-West.

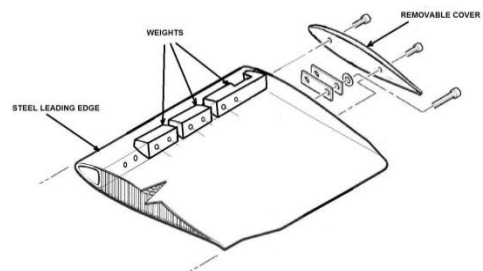
**Figure 7: Main rotor blade tip**

The leading edge is mostly hollow except close to the end of the blade where weights are installed.

The shape of the blade is obtained by using formed honeycomb material and aluminium sheet metal which are glued together and to the beam.

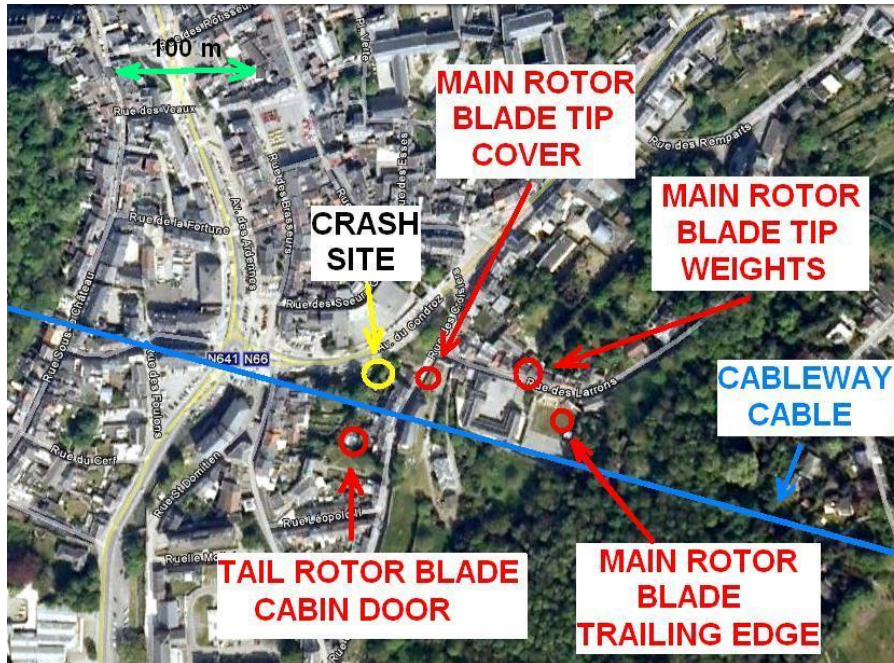
**Figure 14: View of the in-flight separated parts.**

The examination of the wreckage could determine that both main rotor blades extremities collided the cableway cable(s). First contacts of the blades with cables occurred with the underside of the leading edges and at the intrados before striking directly the cable(s). One 15 cm long part separated in flight from the end of one blade as well as a 67 cm long part of the other blade.

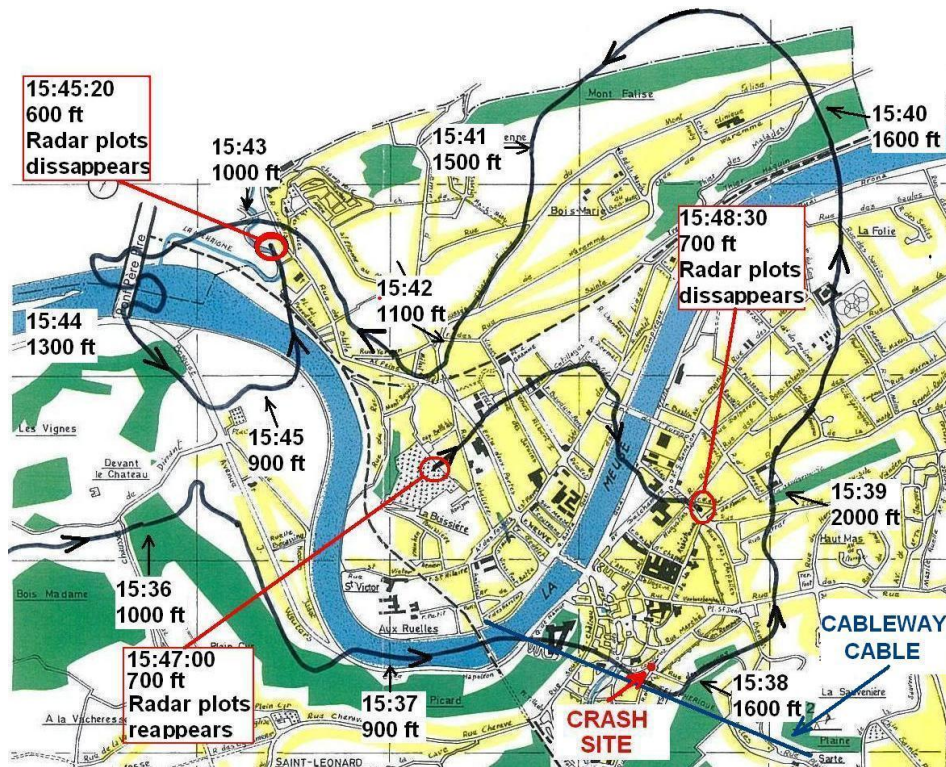
**Figure 21: Flight path above Huy, including time and MSL altitude.**

As seen on the left side of the above drawing, the helicopter appeared in the vicinity of Huy around 15:36, likely coming directly from its home base EBNM. At that time the helicopter was flying at 1000 ft QNH and was already cleared to enter the CTR of Liège. ( Note: Huy is around 250 ft above mean sea level ).

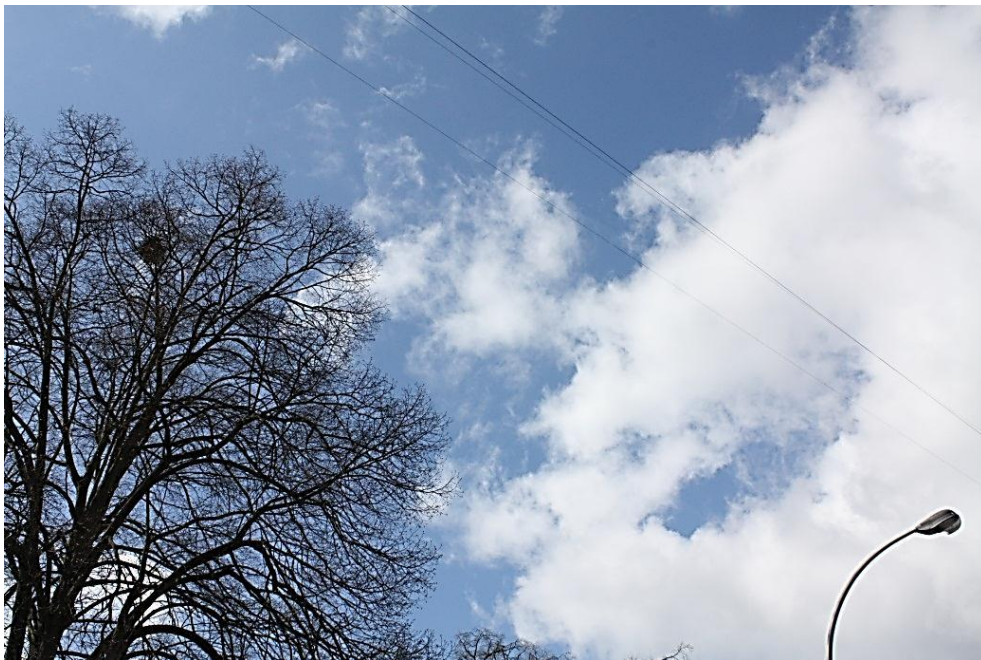
**Figure 25: Example where cables are visible due to a light background.**

The possibility exists the pilot didn't see the cables because of the 10° descent slope approach causing the cables to be positioned between the helicopter (and pilot's eyes) and the dark landscape. The cable car season was not yet started causing the cables to be dark and unpolished and therefore less visible. In other words, there was a poor visual contrast between the cables of a dull colour and the dark landscape.

Moreover, at 15:50 the sun was oriented at 252°, with an elevation of 23° which could have caused the pilot to be dazzled.

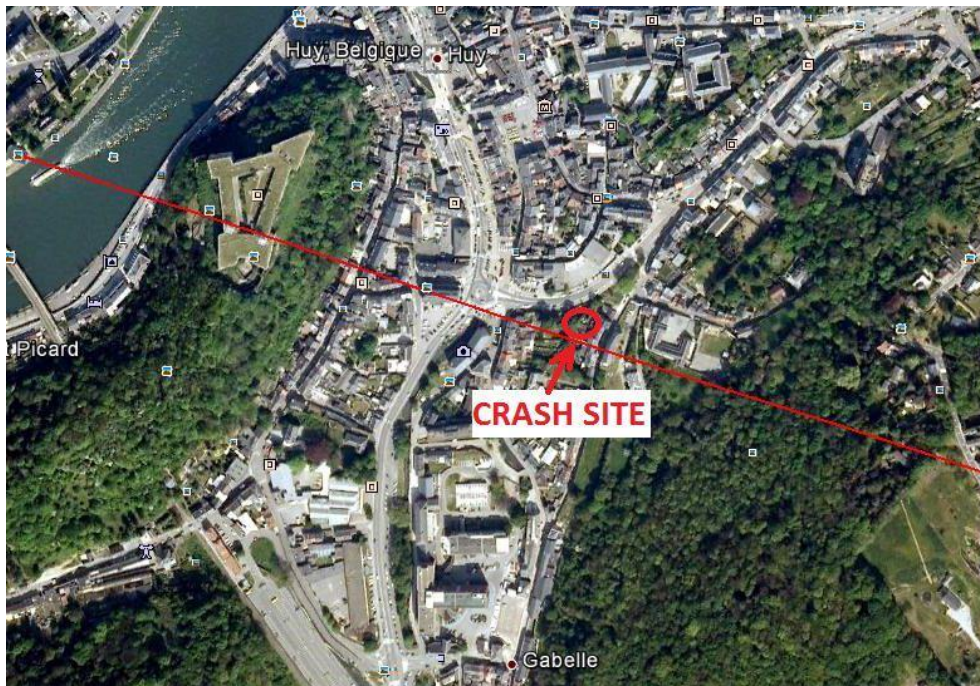
**Figure 28: The crash site is located on the edge of the not built up area.**

- The helicopter was positioned above a zone on the edge of the built-up area of the city of Huy
- This zone featured houses but also areas likely to be used as landing area for the helicopter in case of emergency.
- We cannot positively be certain that the pilot actually saw the cableway in order for him to identify it as an obstacle.
