Safety Investigation Report

SERIOUS INCIDENT POWER OUTAGE AT CANAC 2 AIR TRAFFIC CONTROL CENTER ON 27 MAY 2015

Ref.:
AAIU-2015-05

Issue date:
8 November 2016

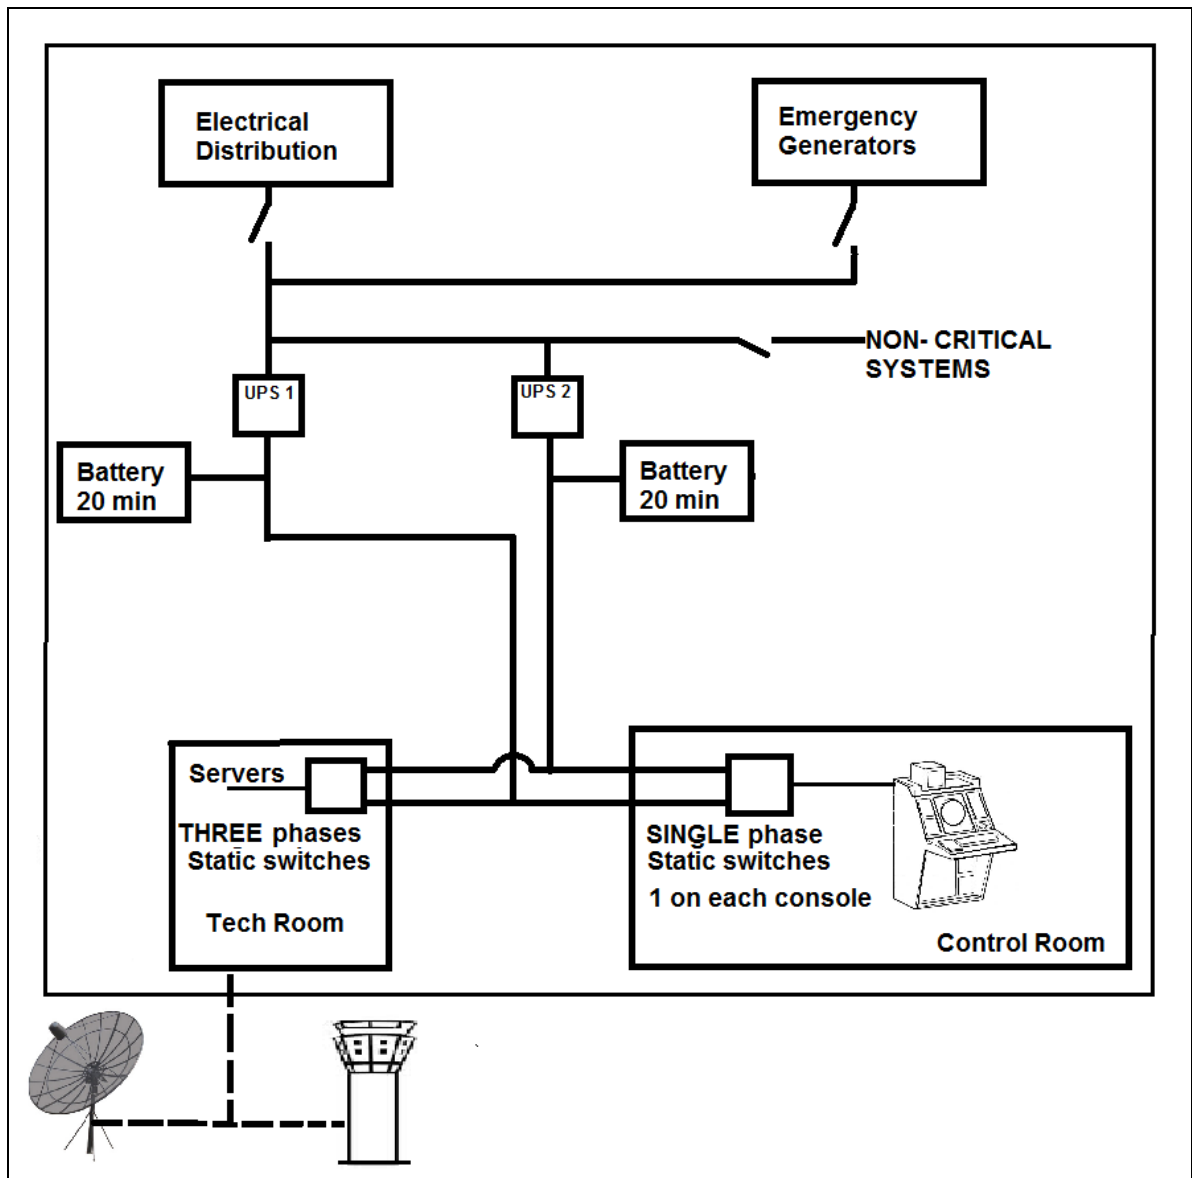
Figure 11: Power Supply (schematic)

The main voice communication system of the Operational Room was connected to a dedicated and specific UPS power supply through a Static switch before being distributed in each console. When this Static switch failed, the operating panels were no longer powered and the main voice communication system was interrupted.

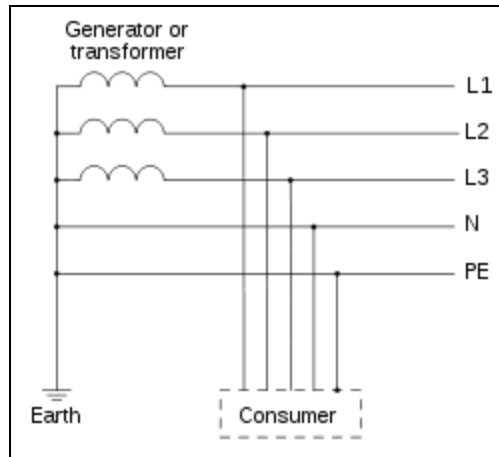
Figure 14: TN-S Earthing system

The electrical circuitry of the Belgocontrol facilities is a TN-S earthing system in which the PE conductor (protective earth – the ground) and the N conductor (connecting the star point in a 3-phase system) are connected together only near the power source.

The actual wiring connection of the circuit, as found after the event, is similar to an IT earthing system

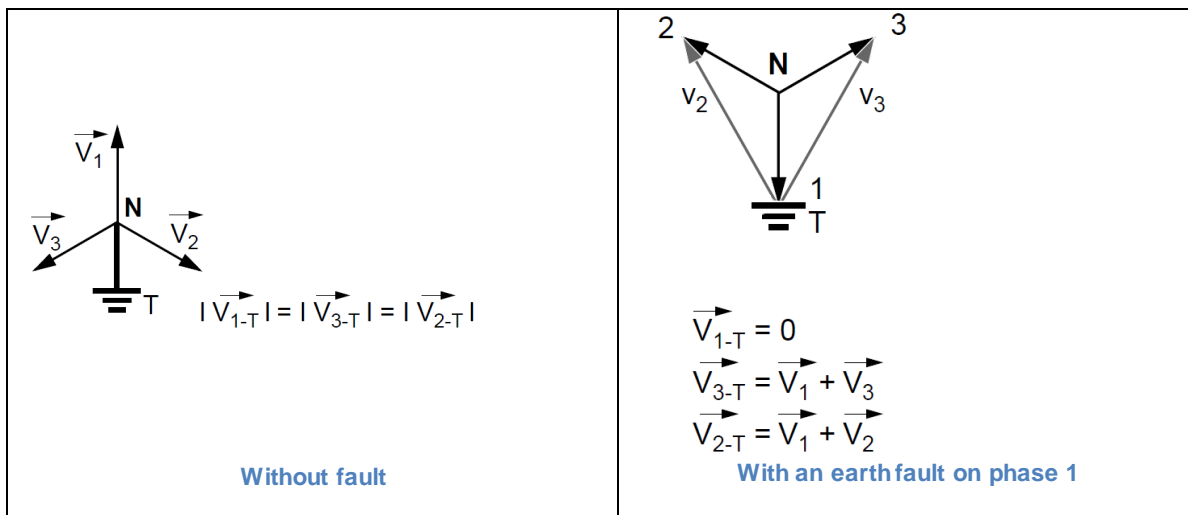
Figure 16: Vector charts of a network in the IT system

However, in a IT earthing system, if one of the phase conductors is shortened to earth, it can cause the rising of the voltage of the other phases from 230 V to 400V relative to earth.

In event of a full fault on phase 1, the potential of phase 1 is brought at earth potential. The neutral-to-earth potential is thus equal to phase to neutral voltage V_1 and that of phases 2 and 3 with respect to earth is equal to phase-to-phase voltage.
