Safety Investigation Report

Ref. AAIU-2016-03r1

SYNOPSIS

Subsequent examination identified the part as a rear latch access door of the Rolls-Royce RB211-535C thrust reverser, released by a Boeing B757-236(SF) aircraft during a flight from EBBR to EDDP on 3 November 2015.

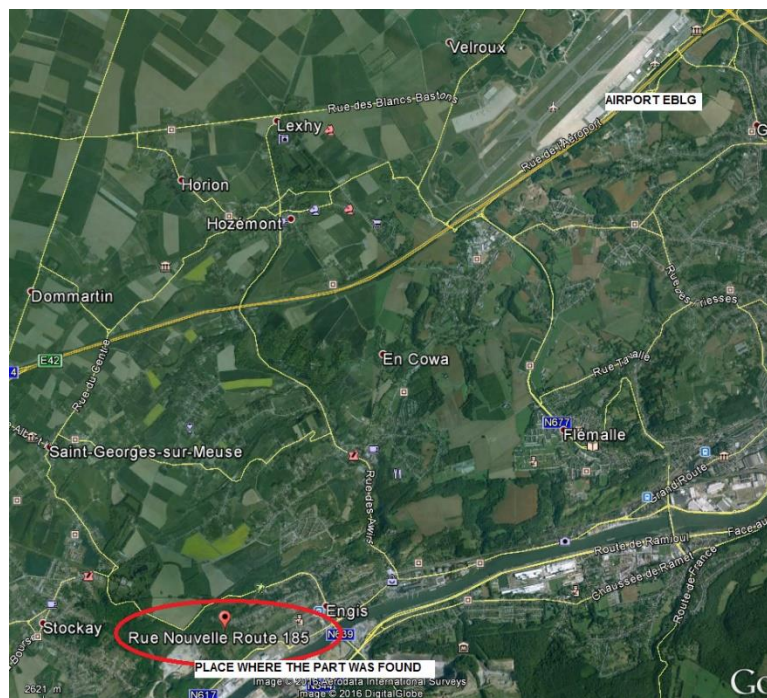
Figure 1: location of the part

After 3 weeks, he called the police, that took the part and contacted the airport of Liege, located nearby. The place where the part was found is located in the extension of runway 23L of EBLG airport, at a distance of 6 km from the end of the runway.

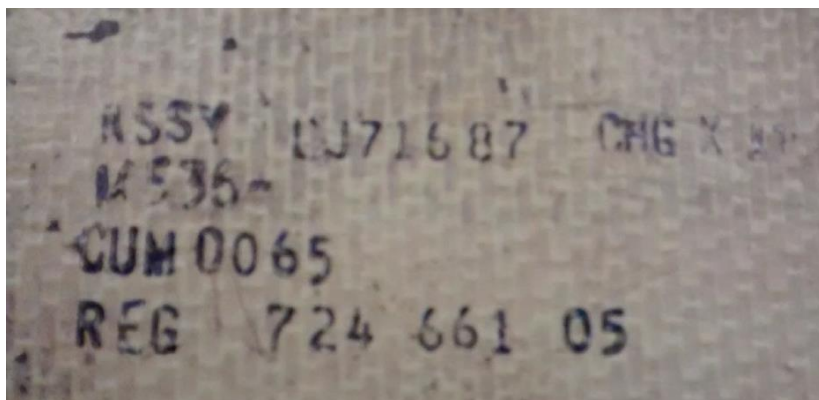
Figure 3

The part was inspected and the part number written on the body could allow the identification of a Thrust Reverser Unit (TRU) rear latch access door (P/N: LJ71687) from a Rolls Royce RB211-535C.

Investigation with Rolls Royce and the concerned operators established that the latch access door was detached from RB211-535C Engine ESN 30083 installed on the N°2 position of a B757-200 aircraft operated by DHL during a flight from EBBR to EDDP on 3 November 2015.
