Safety Investigation Report

Ref.:
AAIU-2017-11-19-01

Issue date:
22 January 2021

**ACCIDENT
ULTRALIGHT ESQUAL VM 1C
AT LANDEGEM
ON 19 NOVEMBER 2017**

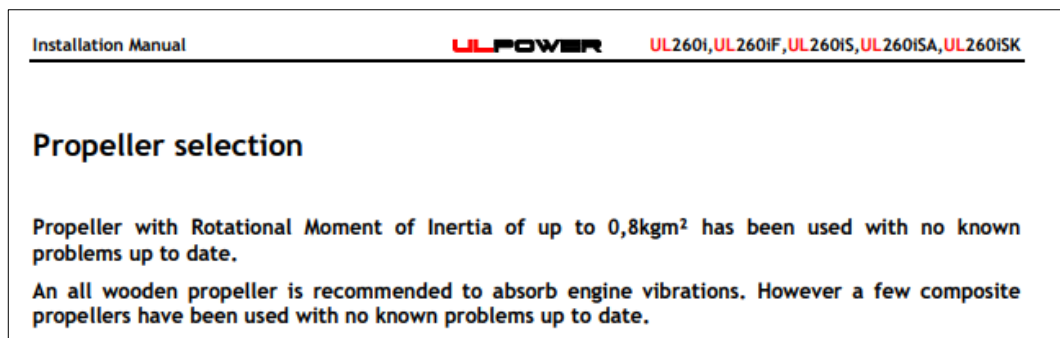
As seen in the figure below, although several composite propellers are used without known problem, ULPower recommends to use wooden propeller deemed to better absorb engine vibrations.

Figure 5 : Recommendation of ULPower on propeller selection

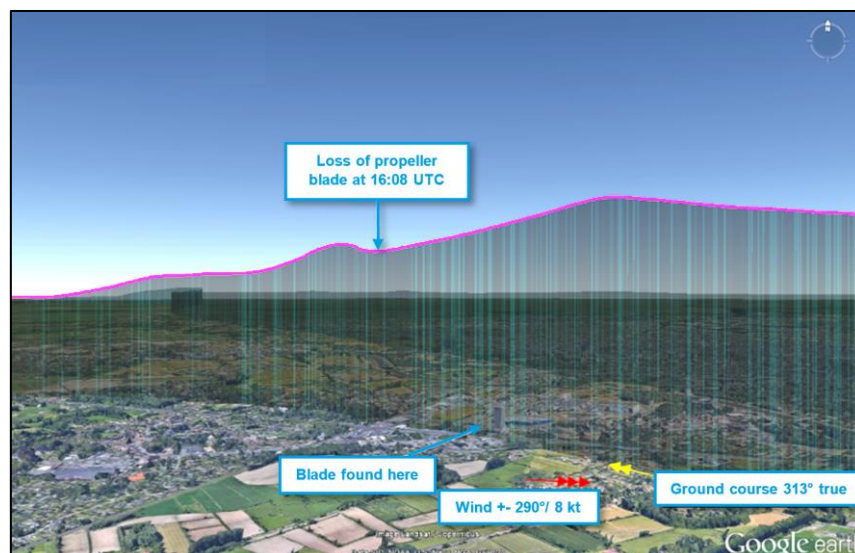
Few seconds later, just after flying above the east side of the city of Gent, when the aeroplane was descending, the pilot reported a light vibration, that disappeared when he reduced RPM. This vibration is not visible in the parameter records. At 16:08:54 UTC, the record shows a peak in vertical and horizontal acceleration – corresponding to the loud bang and heavy vibration felt by the pilot – and the engine RPM drops to zero. This moment corresponds to the propeller blade failure and departure from the aircraft.

Figure 15 : zoom on the phase in flight where the propeller was broke off

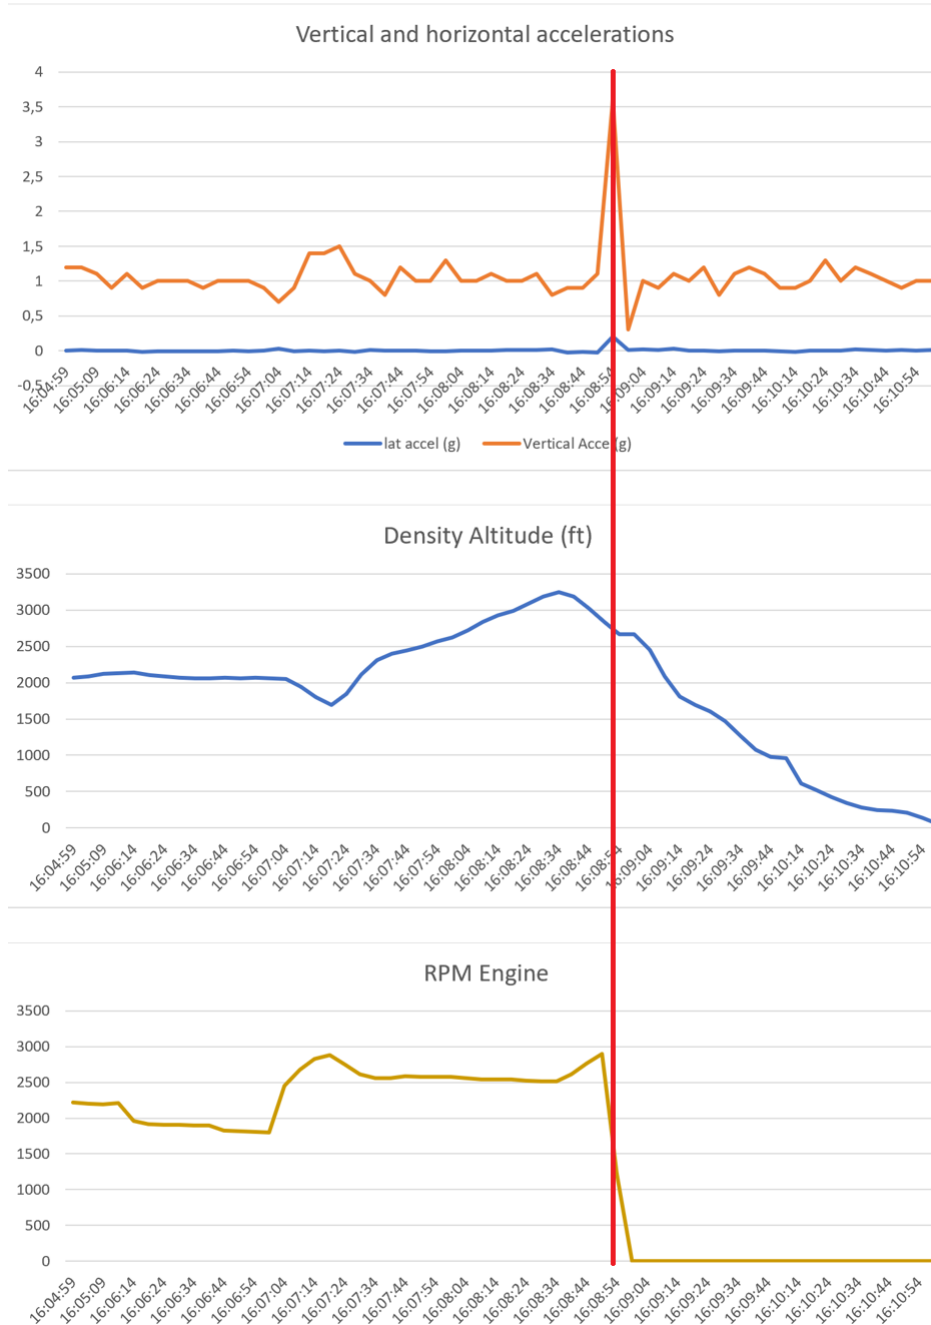
Figure 17 : zoom on the parameters during the propeller loss

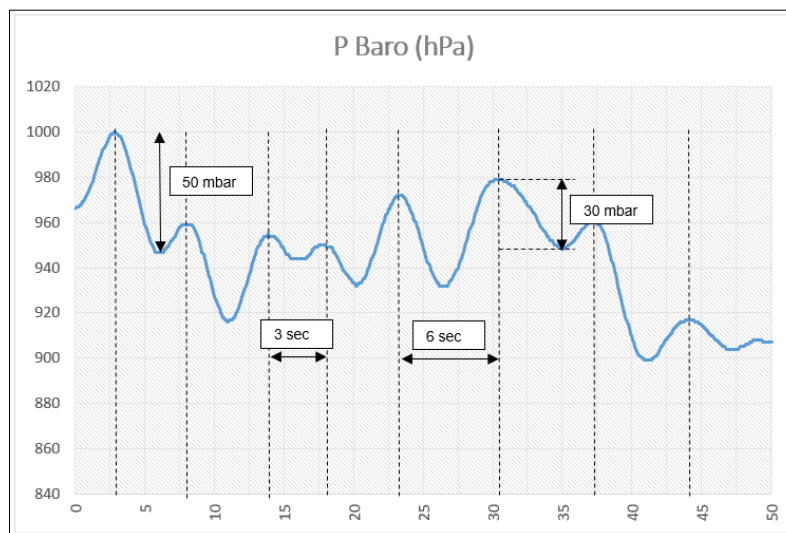
The recorded ECU data were examined to establish the facts and verify whether it could have had an impact on the working of the engine, particularly the generation of specific vibrations. The analysis determined that the air pressure inside the engine air filter box became unstable as soon as the engine speed was above about 2400 RPM regardless the aeroplane was stationary on the ground or in flight. This finding was made at different engine settings (above 2400 RPM) including when the throttle was in a fixed position and the engine was running at a constant engine speed. Sinusoidal air pressure fluctuations were observed inside the air filter box⁸ with a period between 3 and 6 seconds and a peak-to-peak amplitude comprised between 30 and 50 mbar. The observation of the engine data also revealed that the airspeed of the aeroplane was not a factor influencing this phenomenon.

Figure 18 : intervals of the pressure fluctuations

The investigation could not determine the origin of this phenomenon, besides it having an effect similar to a “side window buffeting”.

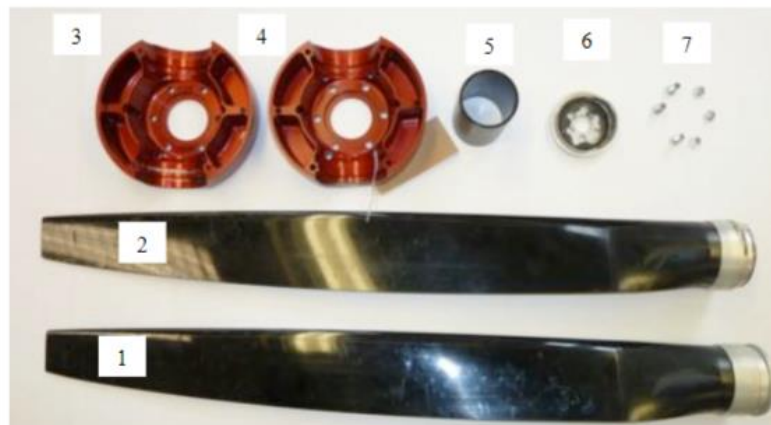
All received parts are numbered from 1 to 7 as shown on figure 1.

Figure 1: the received fragments are numbered from 1 to 7

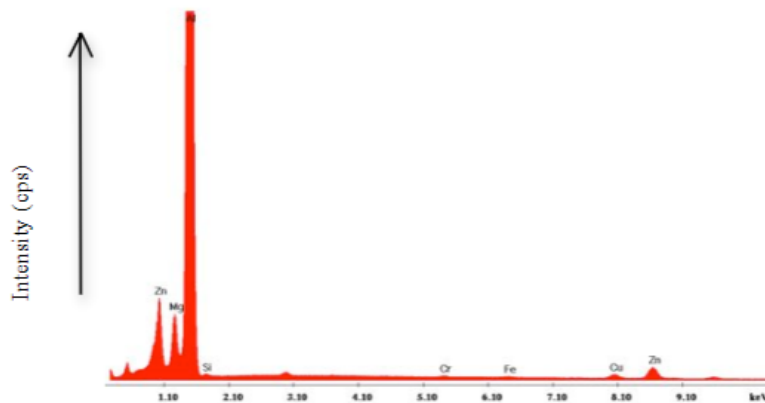
The propeller fixation ring is made from an 7000 aluminium alloy with composition given in table 1 (see figure 2 for the EDX spectrum).

Figure 2: EDX energy spectrum of the propeller fixation ring

Element	Al	Zn	Mg	Cu	Si	Cr	Fe
Weight%	86,9	7,1	3,2	2,1	0,2	0,2	0,3

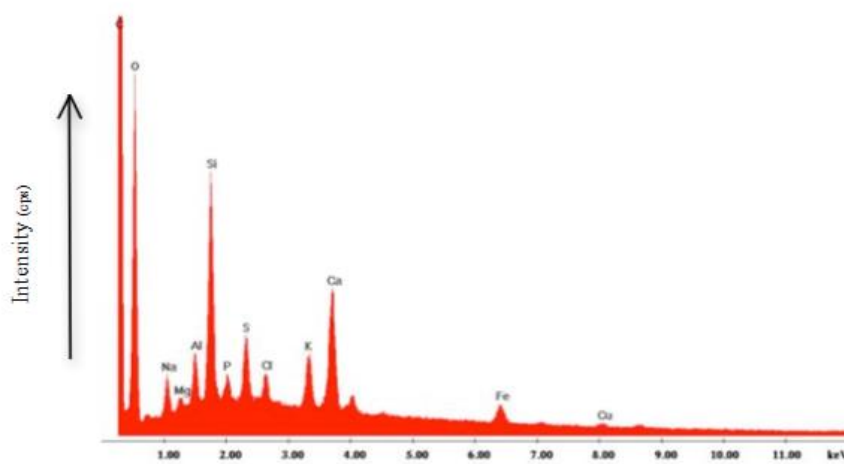
Figure 17 shows the trailing edge of the extremity of blade 2; two particles have been found (see figure 18(a) and (b)). Both particles have a brownish colour and a fibrous texture. The EDX spectrum of particle 1 (see figure 19) reveals carbon and oxygen (hydrogen is not visible using EDX) and a variety of elements between Na and Cu. Particle 2 has a similar spectrum. Both particles are organic, probably wood, with small contaminations of other elements.

Figure 19: EDX spectrum of particle 1 found on the extremity of propeller blade 2
