Federal Public Service  
Mobility and Transport  
Air Accident Investigation Unit

# Safety Investigation Report

## ACCIDENT YAKOVLEV 52 AT COUVIN ON 14 FEBRUARY 2017

Ref.:  
AAIU-2017-AII-02

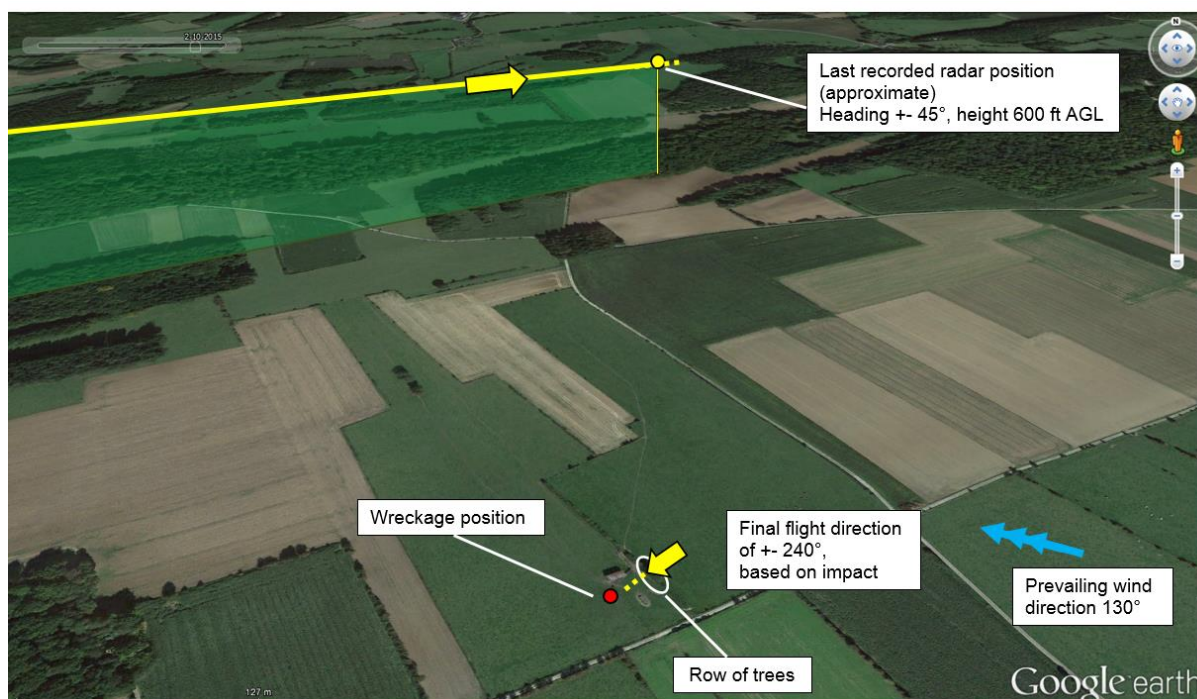
Figure 1 : part of the last recorded flight path and path at impact

The duration of the event was very short. The period of time from the decision to land until the crash was estimated by the pilot to less than 20 seconds. The direct distance between the last recorded radar position and the impact position was approximately 0,5 NM.

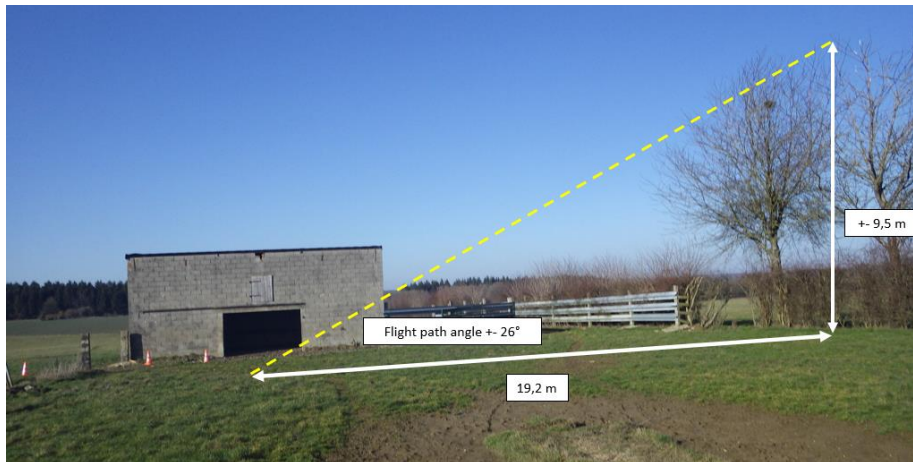
Figure 7: Approximate last flight path angle

Although several pieces were scattered around the main wreckage, all parts of the aeroplane were found at the accident site. The top of a tree showed few broken branches (about 30 mm diameter) that were found on the ground, in the direction of the flight at a distance of 8 to 12 metres from the tree. The flight direction was determined to be about 240° and the wreckage direction was 230°. The height of the tree was estimated to be 9,5 metres and the distance from the tree to the impact was measured at 19,2 metres, deducting that the nose down flight path angle from the top of the tree to the place the aeroplane impacted the ground was about 26°. Examination of the wreckage shows that the landing gear was in extended position and the flaps were fully lowered. The pilot was wearing the safety harness that properly withstood the impact forces.

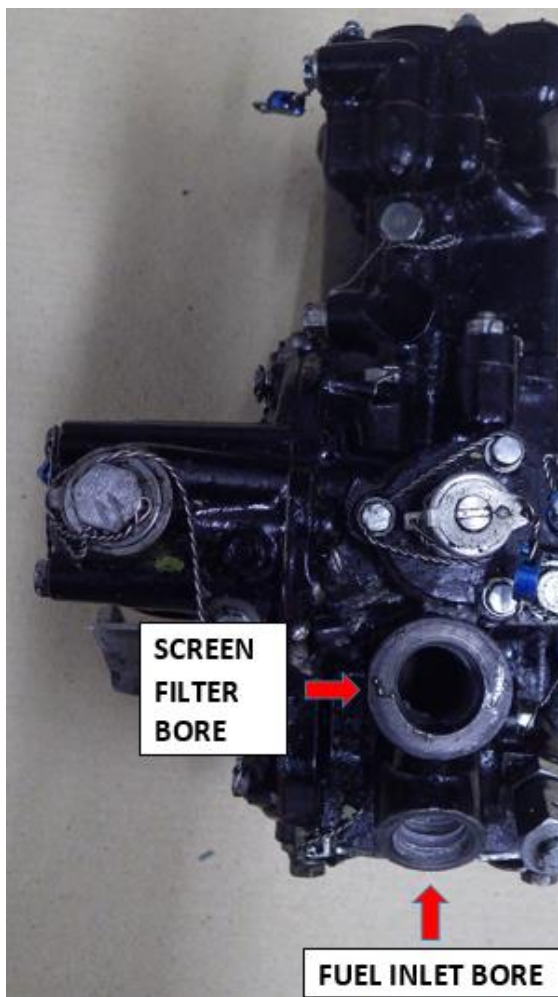
Figure 22: carburettor vertically positioned, as installed on the engine.

The fuel inlet elbow screwed in a threaded bore of the carburettor was removed. This elbow was hard to unscrew along its complete thread length suggesting that at least one thread was damaged. Examination of the male and female threads concluded that the male thread of the steel elbow was in good condition but the thread in the bore of the carburettor was found badly damaged. Actually, the female thread inside the fuel inlet bore was dramatically corroded.

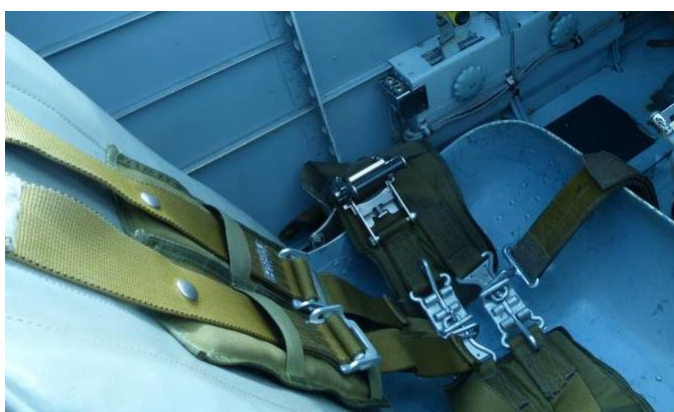
Figure 28: Safety harness

The pilot survived the impact amongst others thanks to his full aerobatic safety harness system that was in good condition and was carefully fastened.

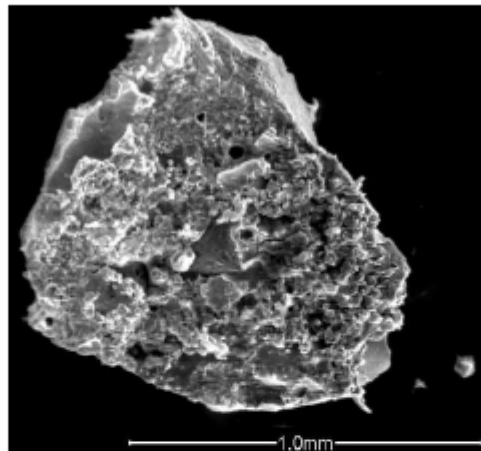
The particles from figure 4.a are shown in more detail in figure 6. A micrograph of a particle taken using the SEM is shown in figure 7. Table A.1 in annex 1 show the results of the EDX analysis for 2 particles and also for a milled sample. The particles are mainly Mg, Al, Br and Si with traces of S, Cl, Ca, Cr, Fe and Zn, which is in accordance with what we would expect after corrosion of the Mg-Al alloy. It is important to note that those particles do not originate from the fuel inlet chamber itself, but have been deposited on that location, since there is no evidence of corrosion of the underlying material.

**Figure 7: Micrograph of a particle found inside the fuel inlet chamber. Micrograph taken with the SEM at magnification 150x.**

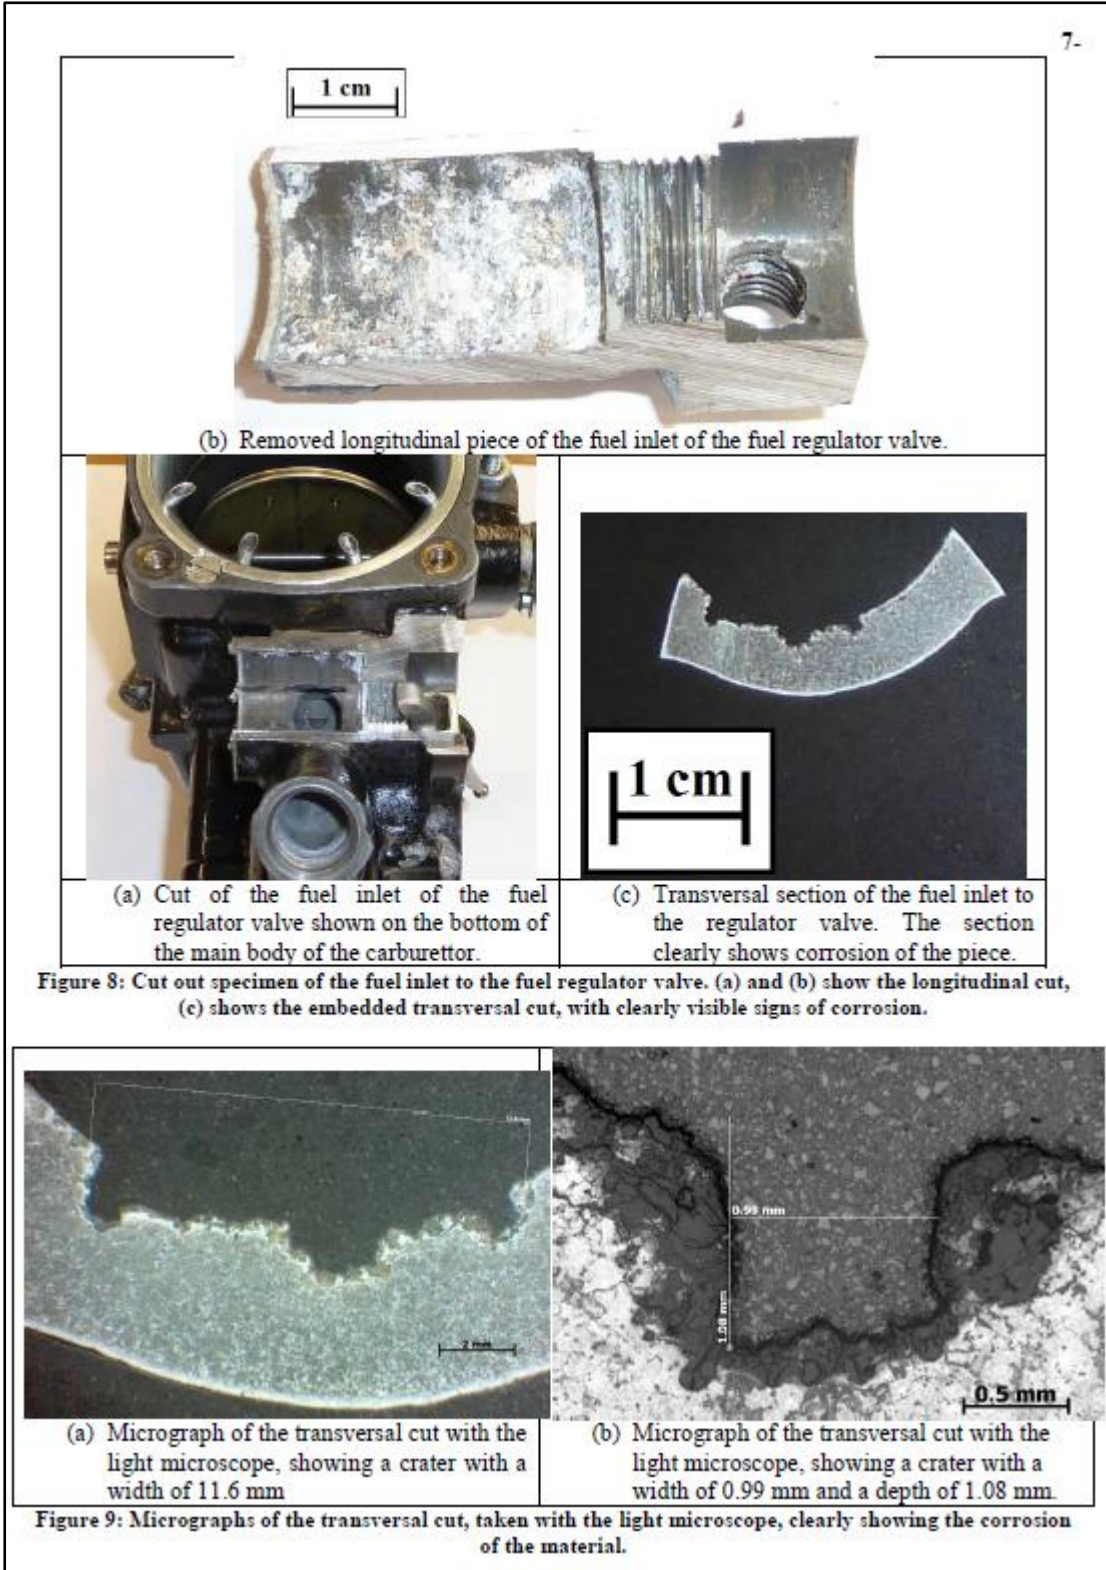
The fuel inlet of the fuel regulator valve, shown in figure 4.b, has the same particles as the fuel inlet chamber. The EDX analysis (Table A.1 in annex 1) shows a similar composition as the particles found in the fuel inlet chamber (paragraph 5.1.b), namely the corrosion product of the Mg-Al alloy. In order to verify whether these particles are a sediment, as in the fuel inlet chamber, or the result of corrosion inside the fuel inlet, a longitudinal cut of the fuel inlet was made. From this longitudinal section a transversal section was taken, embedded in a resin and polished, to be examined in the SEM (figure 8). The transversal section clearly shows signs of corrosion. Also visible inside the fuel inlet were several particles (figure 8). The inside of the fuel inlet has been galvanized (EDX analysis shows presence of Zn, table A.1 in annex1). The micrographs of the transversal cut taken with the light microscope (figure 9) show that the corrosion is clearly visible and has made several big craters in the material. Consequently, this part is a possible source of the deposited corrosion products found on other parts.

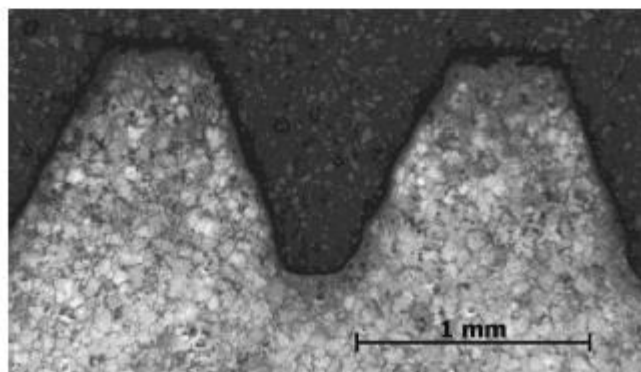
The fuel inlet bore contains the fillet with the alleged two-component paste, as shown in figure 5. EDX analysis of these particles show that they have a composition similar to that of the other particles found in this report (mostly Mg, Al and Zn). This leads to the conclusion that these particles are not a two-component paste but rather deposited corrosion products originating from the Mg-Al alloy. A longitudinal cut of the fuel inlet bore has been made, in order to check the eventual corrosion of the component. This semi-cylindrical sample was embedded, resulting in the two sections shown in figure 10. Figure 11 shows details of the corroded thread while figure 12 shows an uncorroded part of the thread for comparison.

Figure 12: Micrograph of an uncorroded part of the thread of the fuel inlet bore.

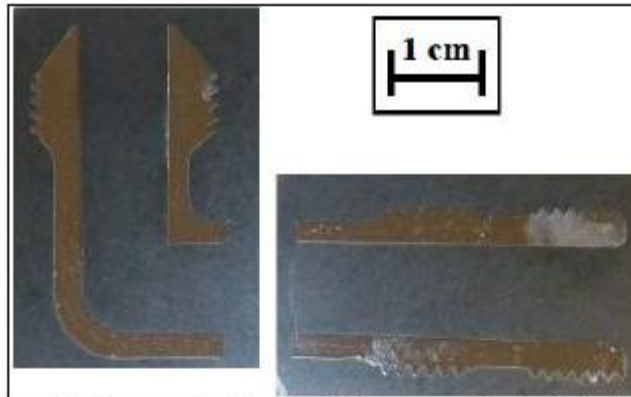
Inside the fuel inlet elbow several particles were visible. In order to be able to examine them, we made a longitudinal section through the elbow (figure 13). Two parts of this longitudinal section have been embedded and polished for examination in the SEM (figure 14). The micrographs taken with the SEM are shown in figure 15, clearly showing corrosion of the fuel inlet elbow. The EDX analysis (table A.1 in annex 1) shows that the base material is made from steel and that the part has been galvanised. The observed particles can be linked to three different origins:

Figure 14: Photograph of the embedded sections of the fuel inlet elbow.

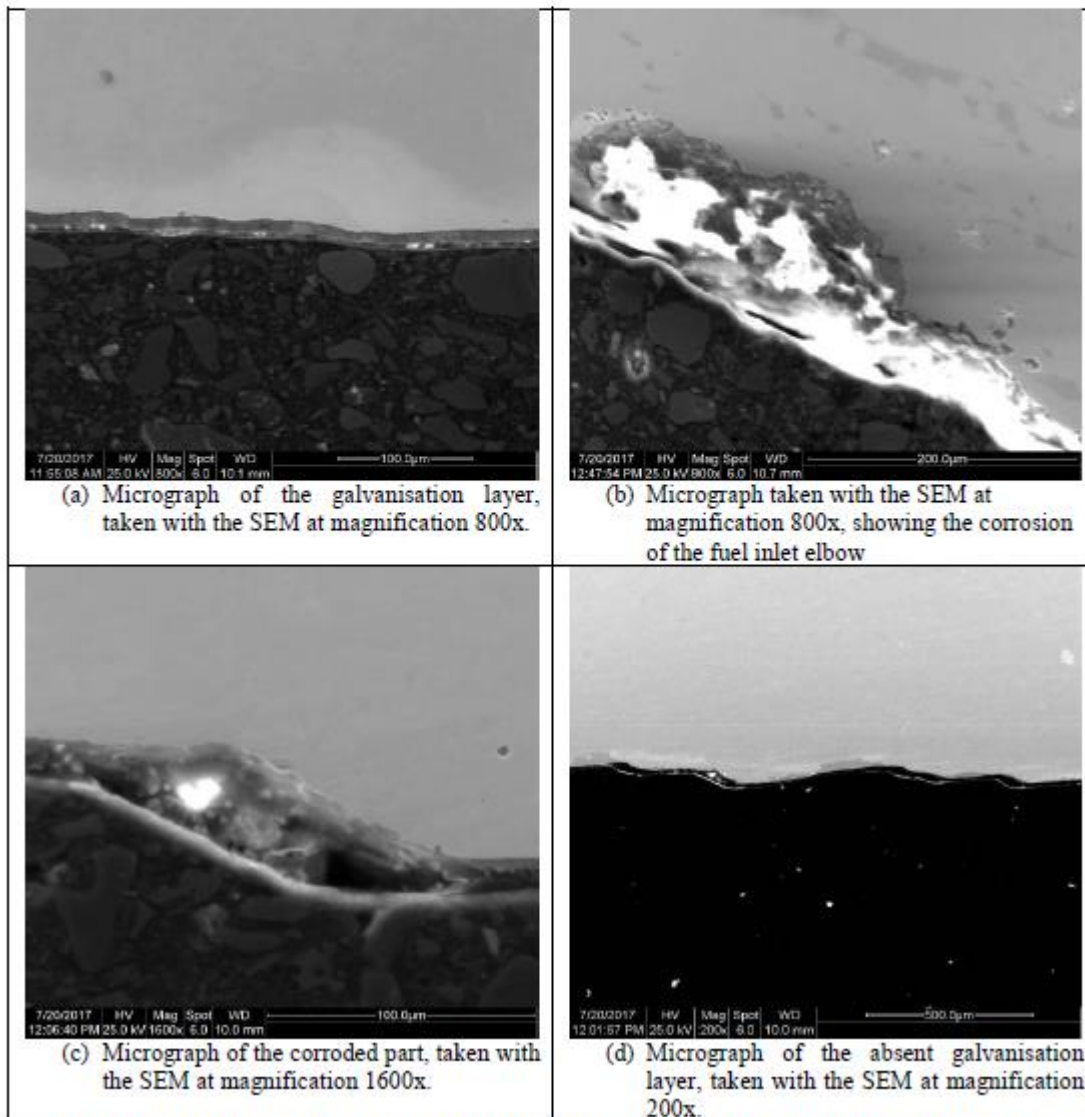
Figure 15: Micrographs of the embedded longitudinal cuts of the fuel inlet elbow, taken with the SEM.

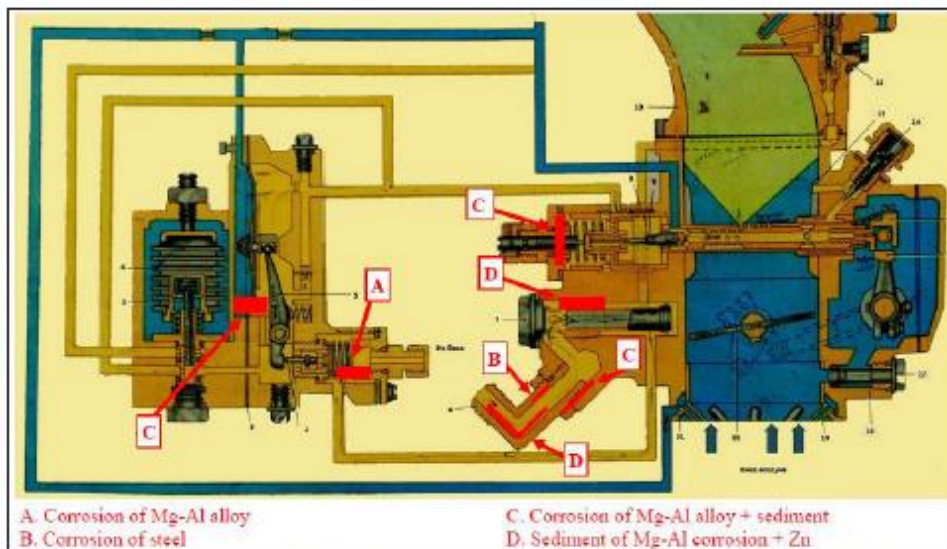
A summary of all the parts analysed by EDX or the FTIR analysis is found in table 2. A graphical representation of the found particles, whether as sediment or direct corrosion, is given in figure 20 for the carburettor and in figure 21 for the fuel system.

Figure 20: Graphical representation of the corrosion and sediment found inside the carburettor system
