# Safety Investigation Report

**Ref.:**  
AAIU-2018-06-08-01

## **ACCIDENT AIR COPTER A3C-T IN MATAGNE-LA-PETITE ON 8 JUNE 2018**

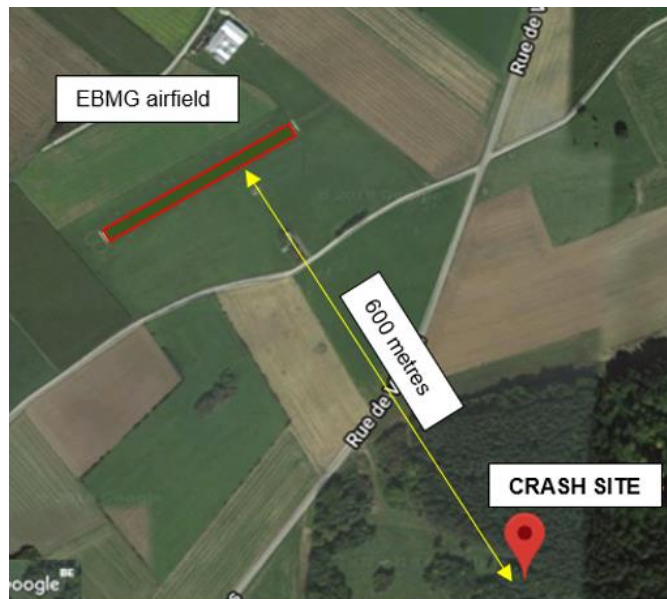
The wreckage is located at about 600 metres south-east of EBMG, in a wooden area. The gyrocopter crashed after a steep descent into a wood.

Figure 2: Aerial view showing the position of the crash site in relation to EBMG airfield.

Damage to the surrounding trees indicates that the gyrocopter flew southwards and had a rather low forward ground speed at impact.

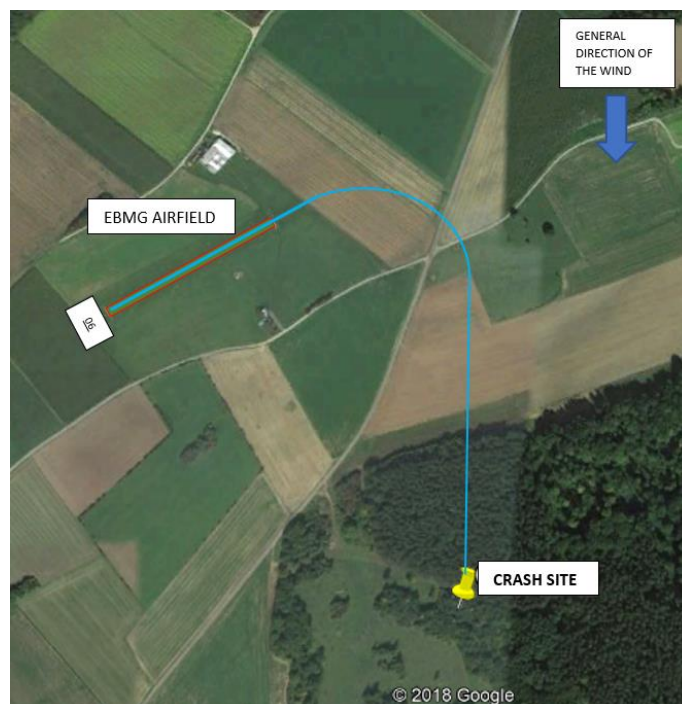
As the wind came predominantly from the north, the gyrocopter very likely took off on runway 06. Assuming (see above) the accident occurred shortly after take-off, the gyrocopter would have made a right turn toward the south while climbing. Note that the aerodrome circuit is on the left side for runway 06. The accident site is located at 600 metres from the runway. Comparing this with the still-air distance of 1500 m when travelled at a 90 km/h climb speed, this would indicate that the accident occurred within 1 minute after take-off.

This scenario is also compatible with the direction of the damage found to the trees around the crash site.

Figure 17: Probable flight path.
