# Safety Investigation Report

**Ref.:**  
AAIU-2020-09-13-01

**ACCIDENT  
RANS COYOTE  
AT LASNE  
ON 13 SEPTEMBER 2020**

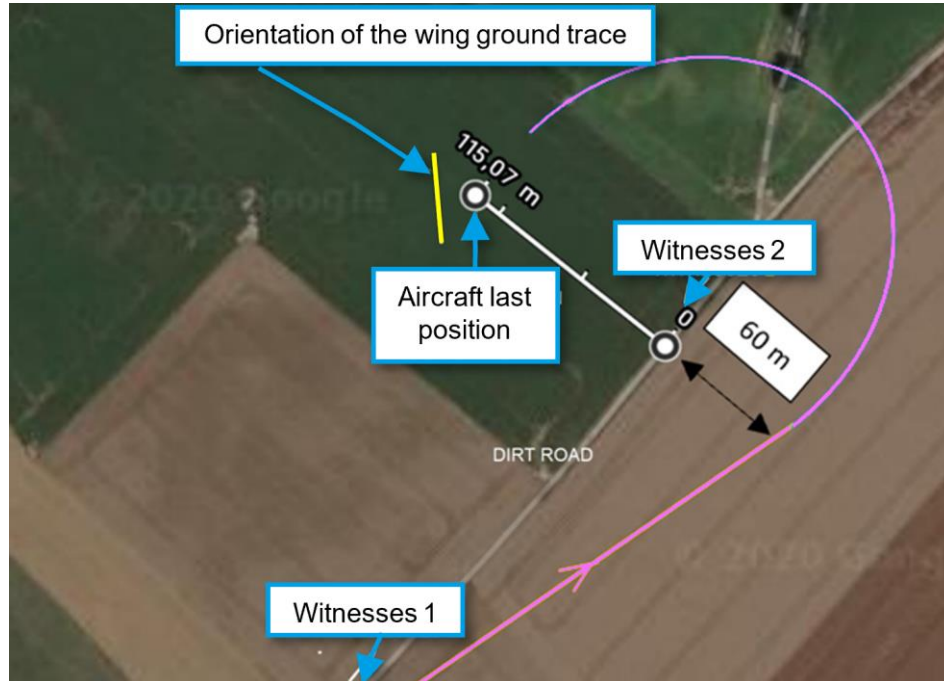
Figure 8 : Last part and dimensions

A couple (hereafter named witnesses 1) was walking on the dirt road, northwards, when they heard the airplane coming behind them. The witnesses stated : “the airplane came towards us at a very low height, so that we felt the need to duck”. The airplane continued its flight above the field next to the dirt road, going up a little (estimated 30 m above ground), then initiated a turn to the left, going back in our direction. We saw the airplane turning in front of the small wood with the wings at a bank angle of 45-60 degrees. The witnesses then saw the wings levelling off and the airplane immediately plunging to the ground. The fuselage and wing were clearly visible. Before the crash the engine made a regular noise.

Another couple (hereafter called witnesses 2) was walking down the dirt road, They saw the airplane coming towards them, from Waterloo. He turned and came at a very low altitude, above the dirt road. The airplane went up a little when passing their position, above the field next to the dirt road. The couple saw one of the occupants of the airplane waving to them and as all appeared to be normal with the airplane, they waved back. . They estimate the airplane was 60 m away from the dirt road at that moment. The airplane then initiated a turn to the left. The bank angle of the airplane during the turn was estimated between 45 and 60 degrees. The next thing the witnesses saw was that when the airplane completed the 180 degrees turn, suddenly it plunged vertically to the ground.

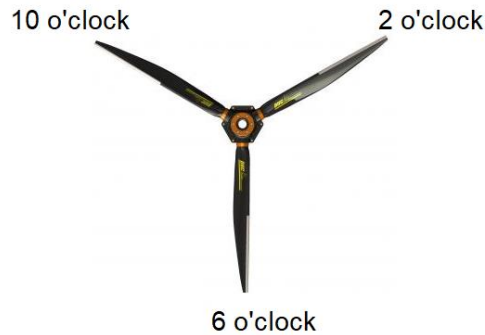
**Figure 18: Blade position convention (view from the front of the aircraft)**

The blade located at 2 o'clock remained attached to the engine hub, damaged (severely burned) and longitudinally delaminated (split) from the root.
